**HYUNDAI**  
**Technical Service Bulletin**

GROUP <b>RECALL</b>	NUMBER <b>23-01-004H</b>
DATE <b>JANUARY 2023</b>	MODEL(S) <b>SANTA FE SPORT (AN) SANTA FE (NC) SANTA FE XL (NC) TUCSON (LM)</b>

**SUBJECT:** ABS MODULE MULTI-FUSE INSTALLATION  
(RECALL 218)

**THIS TSB SUPERSEDES 22-01-029H-4 TO ADD 2016MY SANTA FE (NC).**

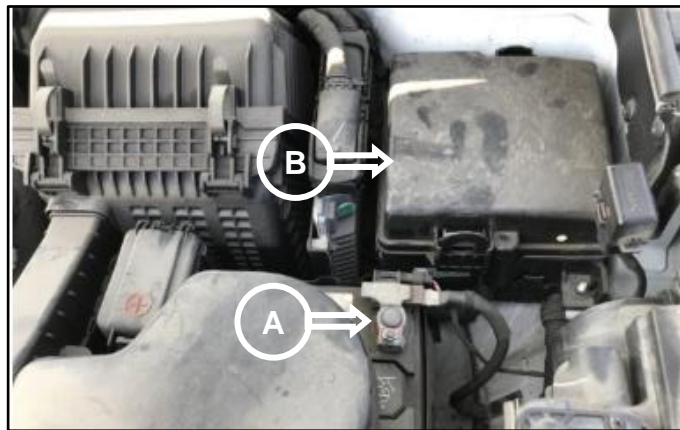
2. Disconnect the battery negative (-) terminal (A) and remove the junction box upper cover (B).

**Negative (-) Battery Terminal Nut****Tightening Torque:****4.0~6.0 N.m (0.4~0.6 kgf.m, 3.0~4.4 lb-ft)**

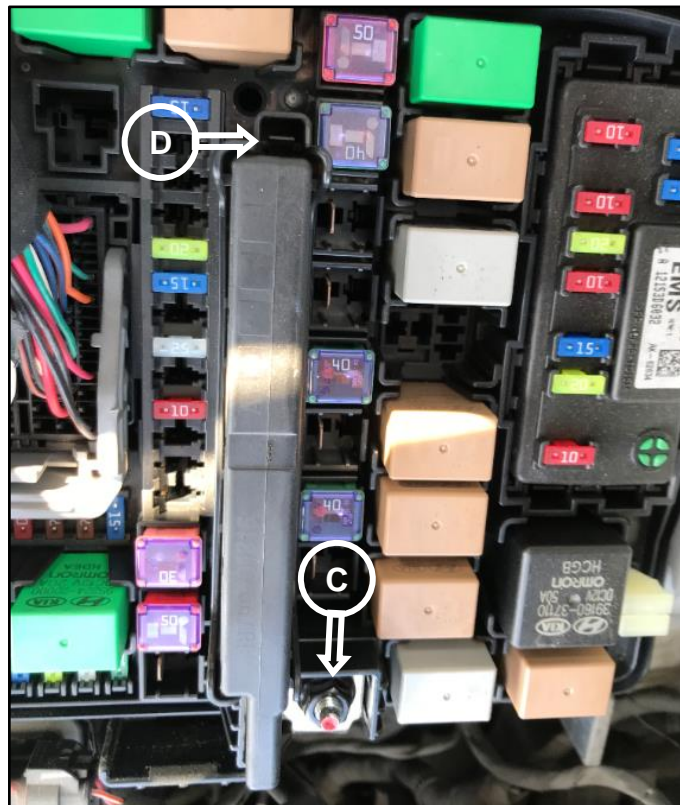
3. Remove the 10 mm nut (C) and lift the junction cable over the stud. Release the locking tab (D) and remove the multi-fuse.

Do not re-use the multi-fuse nor upper cover. A new multi-fuse and upper cover from the service kit must be installed.

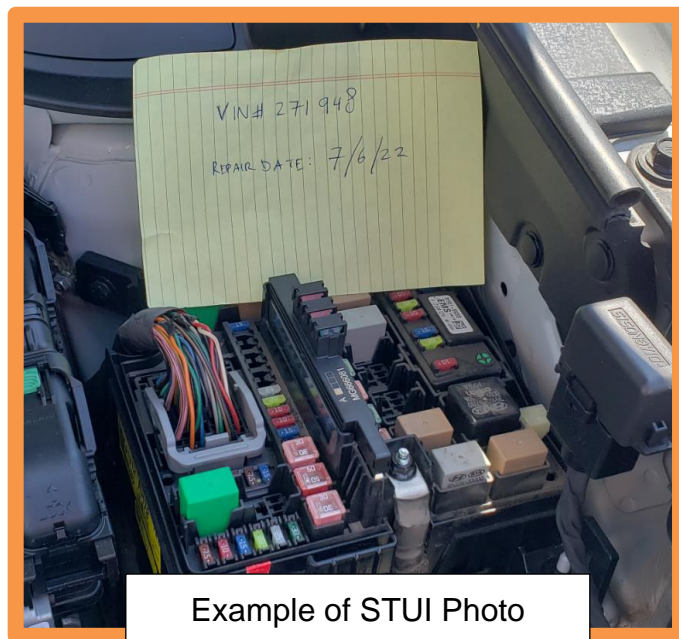
4. Install the new multi-fuse, placing the junction cable over the multi-fuse mounting tab, and the retaining washer on top. Torque the nut to specification.

**Junction Cable Nut Tightening Torque:  
9.8~11.7 Nm (1.0~1.2 kgf.m, 7.2~8.7 lb-ft)**

Using STUI, take a photo of the installed new multi-fuse with the last 6 digits of the VIN and the date of repair on a piece of paper.
