## IMPORTANT SAFETY RECALL

**NHTSA Recall Number:** 22V058

## Rotation Bearing Washer Inspection

**Units Affected:** LS60 aerial devices built from October 2017 to October 2021. Verify your unit is affected by reviewing the attached list or accessing Altec Connect.

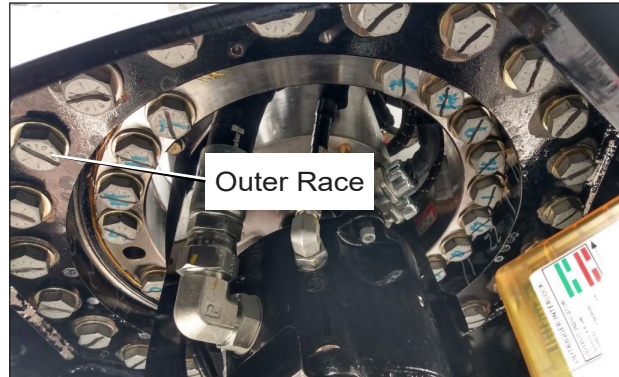
**Figure 2 — Outer Race Rotation Bearing Cap Screws and Washers**

1. Position the unit on a level surface, apply the parking brake, and turn off the engine. Remove the key from the ignition, and secure it following your employer’s vehicle lockout/tagout procedure. Chock the wheels.
2. Remove the four pedestal covers to access the inside of the pedestal (refer to Figure 1).
3. Locate the rotation bearing outer race mounting cap screws and washers under the top plate of the pedestal (refer to Figure 2).

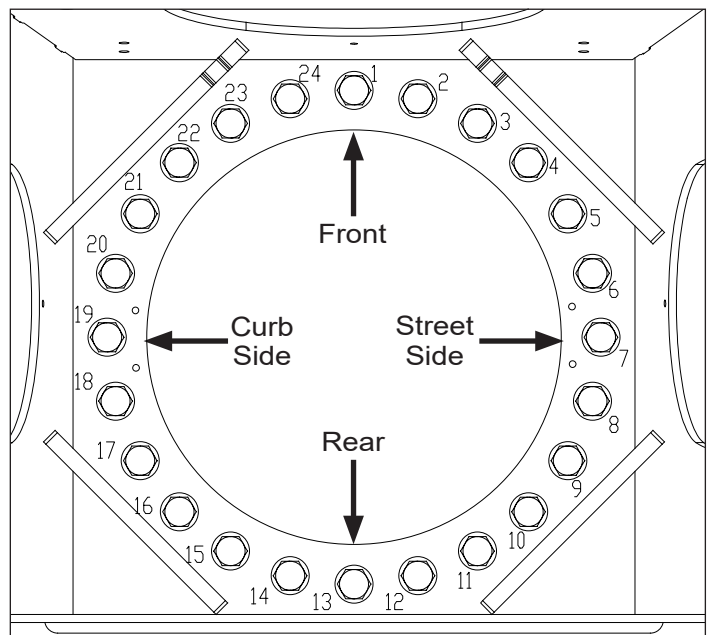
**Figure 3 — Outer Race Washer Numbering Pattern (Bottom View)**

4. Using a flashlight or work light, look closely at the washer shown as number 1 in Figure 3 to determine if the washer is overlapping the weld next to the pedestal wall (refer to Figures 4 and 5). Mark Figure 6 to indicate the inspection result for this washer.

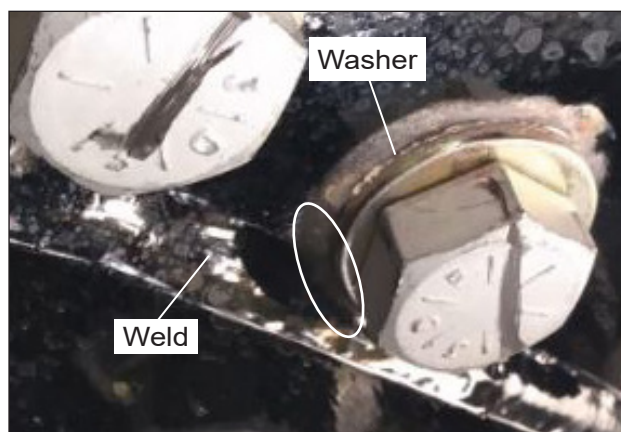
**Figure 4 — Washer Overlapping Weld**

**Background:** Altec has learned of the potential for washers on the outer race rotation bearing cap screws to overlap the adjacent weld on the affected units. While there have been no reports of machine failures to date, interference with weld under the washer could cause cap screw failure.

- If only one washer overlaps the adjacent weld, call Altec to schedule the installation of kits 991457702, Outer Race Field Repair Kit, and 991457789, Outer Race Rotation Bearing Hardware Kit. The repair must be completed within 60 days. Put the unit back into service while awaiting the repair. Do not complete the Inspection Sheet at the end of the CSN. Completion of the CSN will be documented when the repair is complete.

- If two or more washers overlap the adjacent weld, take the unit out of service until repair is completed. Call Altec to schedule the installation of kits 991457702, Outer Race Field Repair Kit, and 991457789, Outer Race Rotation Bearing Hardware Kit. Do not complete the Inspection Sheet at the end of the CSN. Completion of the CSN will be documented when the repair is complete.
