June 2021  
 FL884 (D21R6)  
 NHTSA #21V-256 (Non-School Bus)  
 NHTSA #21V-255 (School Bus)  
 NHSTA #21E-029  
 Transport Canada #2021-219

**Subject: DETROIT™ Tie Rod & Steer Arm Bolt Replacement**

**Models Affected: DETROIT™ Model 2 and Model 3 Steer Axles**

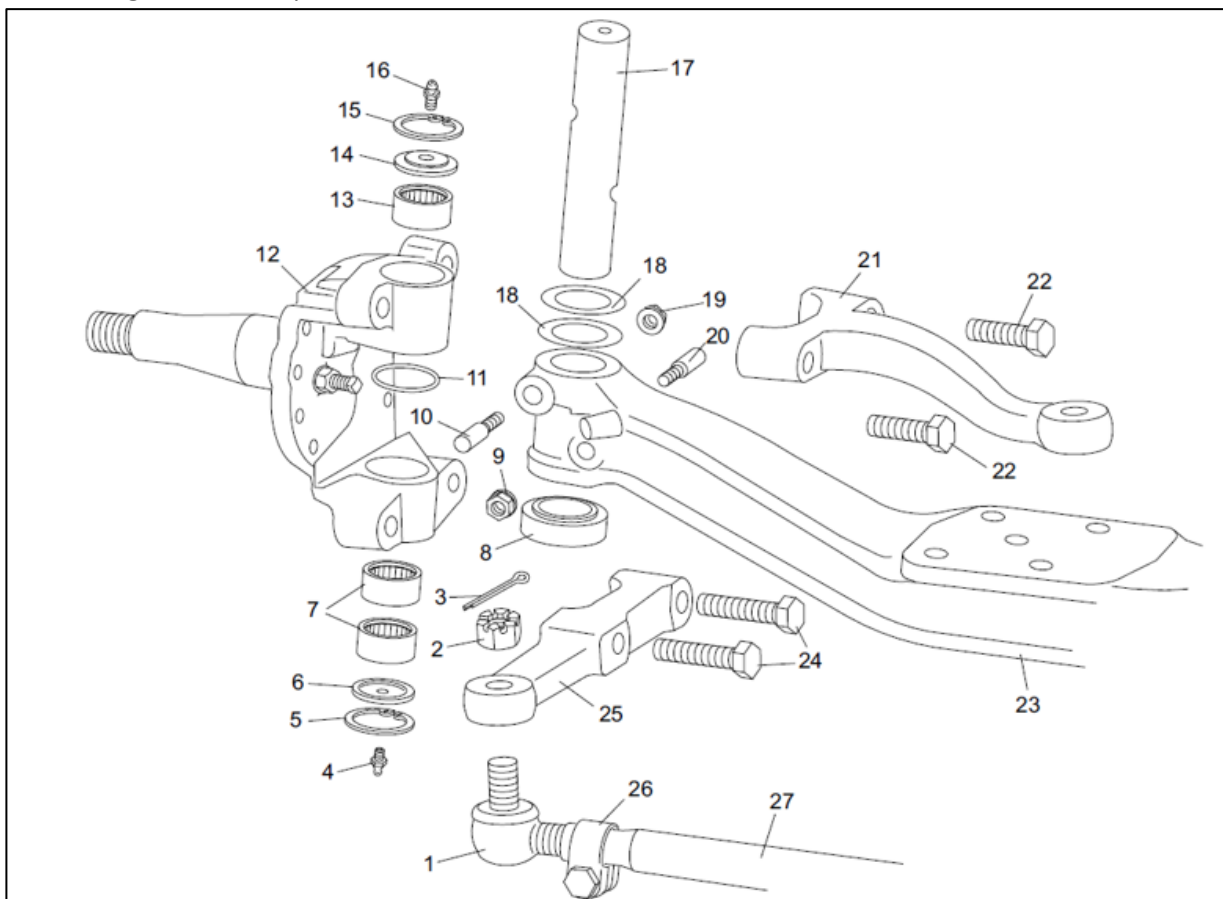
**Fig. 1, Front Axle Components, Integral Steering Gear (driver side shown)**

On certain Detroit Model 2 and 3 steer axles, the tie rod arm and steering arm bolts used to assemble front axle assemblies have a lengthwise “seam” defect which increases stress concentration, potentially leading to bolt failure or loss of pre-load.

**Only one bolt must be replaced at a time. If both tie-rod arm bolts, or both steering arm bolts are removed at the same time, a full truck alignment is required to be performed, which is not covered in this recall.**

8. At the passenger side, replace one tie-rod arm bolt as follows.
  - 8.1. Remove and discard the bolt.
  - 8.2. Clean the threaded hole from which the bolt was removed, and remove all oil and debris.

- 8.3. Clean a new bolt, remove any oil, and dry it completely.
  - 8.4. Apply Loctite® 277 to the bolt threads.
  - 8.5. Install the bolt on the steering knuckle. Tighten bolt to 425 lbf.ft (575 N.m).
