**Campaign code:**  
L62X-R.01.22

**Campaign Name:**  
Front headlight horizontal adjustment screw's blanking cap

**Model:**  
Huracán

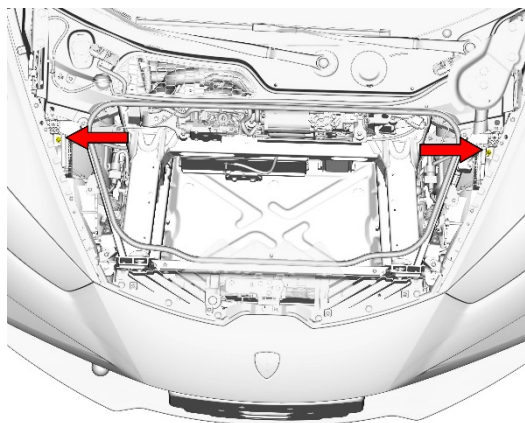
#### 2. Pinpoint the blanking cap installation position (on the right and left).

#### **WARNING**

Install the blanking caps on the headlights' front horizontal adjustment screws (green arrow, black screw).

Do not install the blanking caps on the vertical adjustment screws (yellow arrow, white screw).
