SUBJECT: NEW VEHICLE DEMONSTRATION / DELIVERY HOLD -

Safety Recall 22S09 – Supplement #1

Certain 2017 - 2022 Model Year F-250/F-350 Vehicles Equipped with a 6.2L/7.3L Gas Engine, Crew Cab/Super Cab, 160"/164" Wheelbase, 4x4, and One-Piece

Loose/Sagging Underbody Insulator

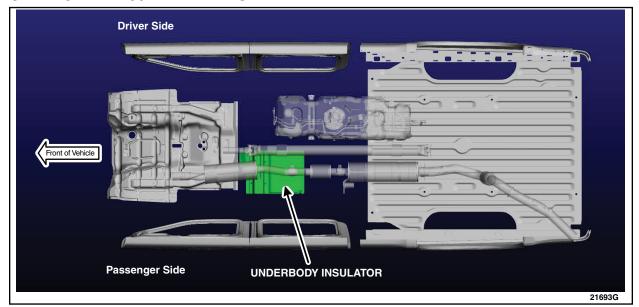
FIGURE 1

NOTE: The underbody insulator is located directly above the exhaust.

CREW CAB - 160" WHEELBASE

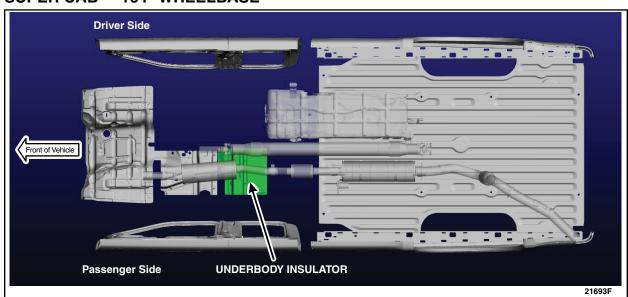
FIGURE 2

SUPER CAB - 164" WHEELBASE

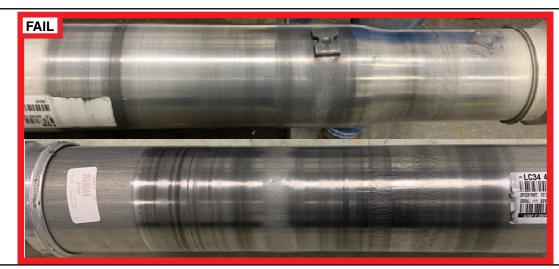
FIGURE 4

- 1. With the vehicle in NEUTRAL, position it on a hoist. Please follow Workshop Manual (WSM) procedures in Section 100-02.
- 2. Inspect the rear driveshaft for any marks caused by the passenger side insulator. Are there any marks present on the driveshaft due to contact from the insulator? See Figures 3 and 4.
 - Yes Does not pass inspection. Contact the SSSC and provide a picture of the driveshaft with the marks. Once approved and replacement driveshaft is available, proceed to step 3.
 - No Passes inspection. Proceed to step 4.
