SUBJECT: NEW VEHICLE DEMONSTRATION / DELIVERY HOLD -Safety Recall 22S09 – Supplement #3 Certain 2017 - 2022 Model Year F-250/F-350 Vehicles Equipped with a 6.2L/7.3L Gas Engine, Crew Cab/Super Cab, 160"/164" Wheelbase, 4x4, and One-Piece Aluminum Driveshaft Loose/Sagging Underbody Insulator

ATTACHMENT III PAGE 2 OF 12 SAFETY RECALL 22S09-S3

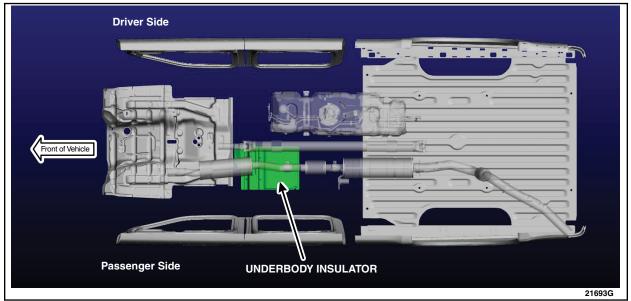
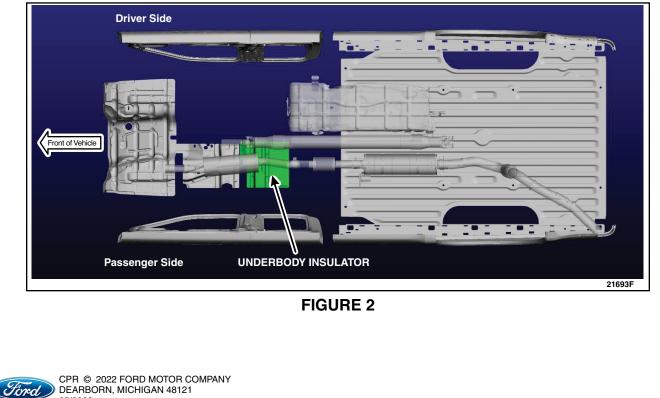
FIGURE 1

NOTE: The underbody insulator is located directly above the exhaust.

CREW CAB - 160" WHEELBASE

SUPER CAB - 164" WHEELBASE

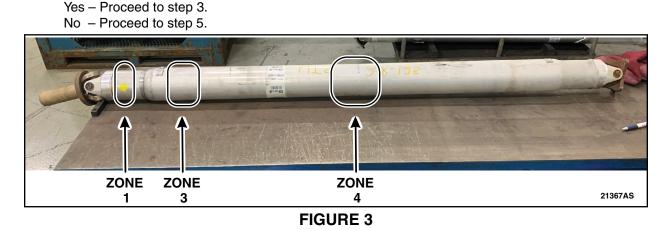
2. Inspect <u>Zones 1, 3 and 4</u> of the rear driveshaft for any marks caused by the front and/or rear edges of the passenger side insulator. Are there any marks present in Zones 1, 3 or 4? See Figure 3.

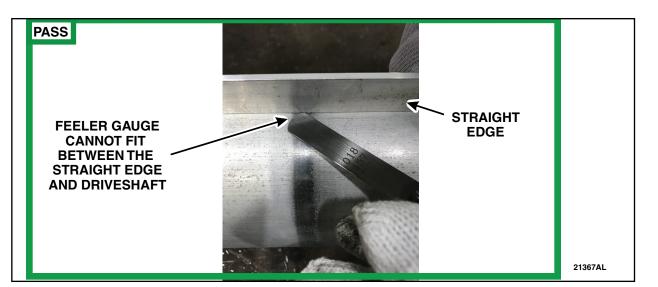
FIGURE 4

- 3. What is the current odometer reading?
 - > 2,500 miles Proceed to step 4.
 - < 2,500 miles Proceed to step 7.
- 4. Place a straight edge along the driveshaft over the wear mark and attempt to fit a 0.018in (0.45mm) feeler gauge between the flat edge and the wear mark. Can the feeler gauge fit between the straight edge and anywhere along the wear mark? See Figures 4 and 5.
 - Yes Does not pass inspection. Contact the SSSC and provide a picture of the driveshaft with the feeler gauge fitting between the straight edge and wear mark. Once approved, rear driveshaft replacement will be required, but do not install at this time. Proceed to step 7.
 - No Passes inspection. Proceed to step 5.

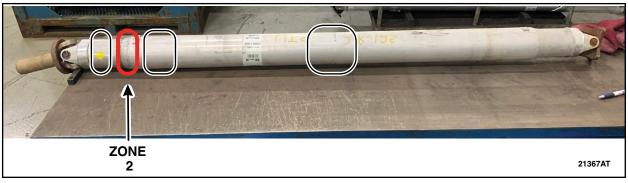
FIGURE 6

- Inspect <u>Zone 2</u> (transition from larger tube diameter to smaller diameter section) of the driveshaft tube for any marks caused by the front edge of the passenger side insulator. Are there any marks present? See Figure 6.
 - Yes Does not pass inspection. Proceed to step 6.
 - No Passes inspection. Driveshaft may be reused. Proceed to step 7.

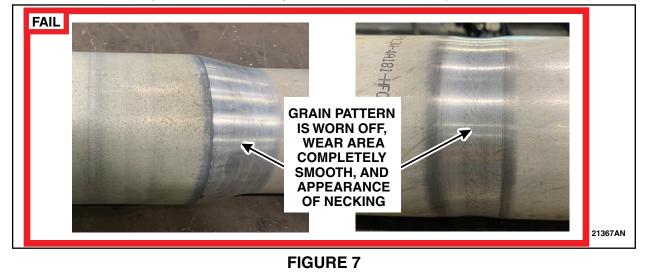
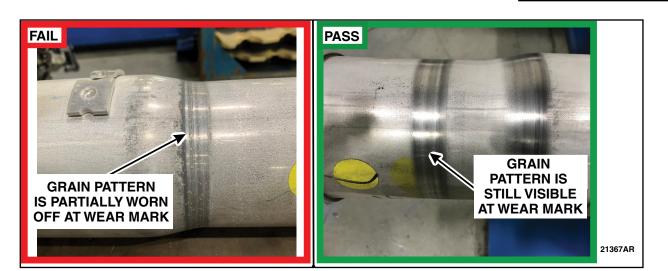
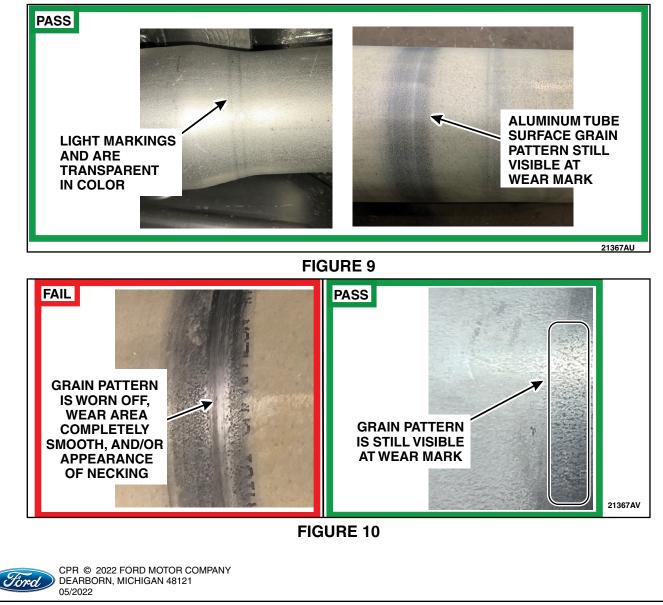
FIGURE 8

- 6. Inspect the marks found on Zone 2. Is the aluminum tube surface grain pattern worn off, completely smooth, or have an appearance of necking? See Figures 7 through 10.
 - Yes Does not pass inspection. Contact the SSSC and provide a picture of the driveshaft with the grain pattern worn off. <u>Be sure to show a clear image of the grain pattern missing</u>. Once approved, rear driveshaft replacement will be required, but do not install at this time. Proceed to step 7.
 - No Passes inspection. Driveshaft may be reused. Proceed to step 7.
