May 11, 2022

**SUBJECT: NEW VEHICLE DEMONSTRATION / DELIVERY HOLD -
 Safety Recall 22S09 – Supplement #2**

Certain 2017 - 2022 Model Year F-250/F-350 Vehicles Equipped with a 6.2L/7.3L Gas Engine, Crew Cab/Super Cab, 160"/164" Wheelbase, 4x4, and One-Piece Aluminum Driveshaft
 Loose/Sagging Underbody Insulator

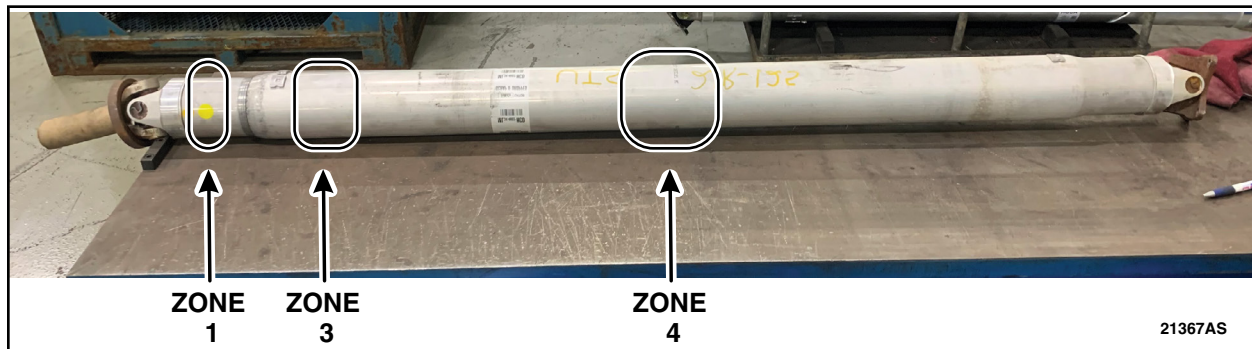
FIGURE 3

2. Inspect Zones 1, 3 and 4 of the rear driveshaft for any marks caused by the front and/or rear edges of the passenger side insulator. Are there any marks present in Zones 1, 3 or 4? See Figure 3.

Yes – Proceed to step 3.
No – Proceed to step 5.

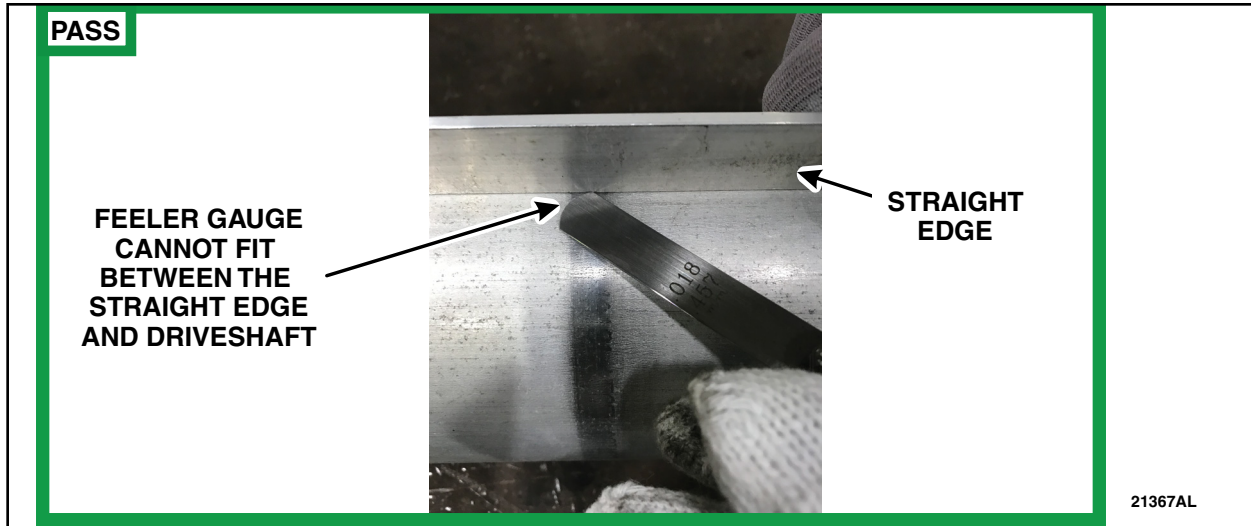
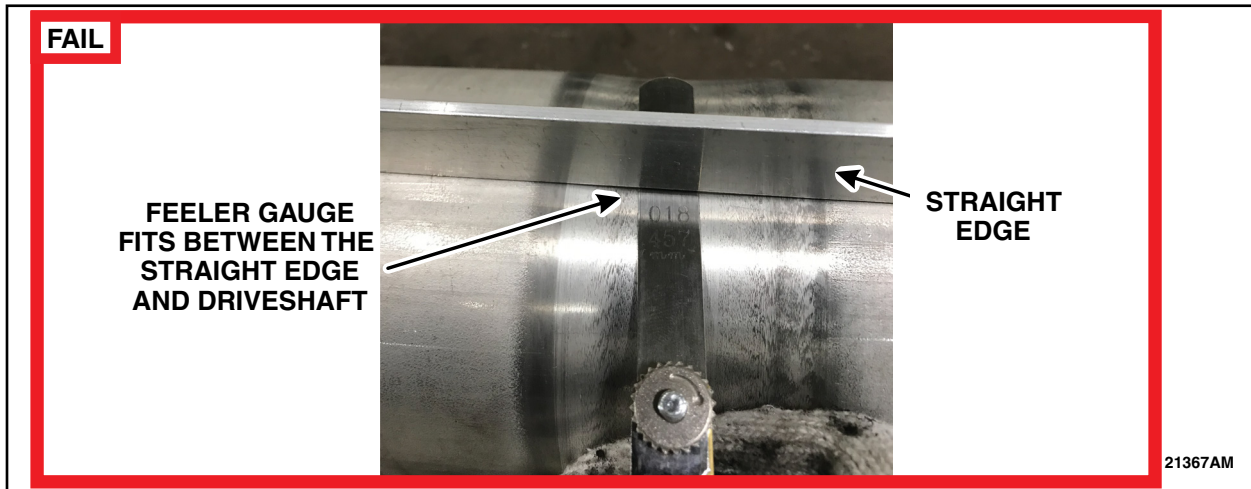
4. Place a straight edge along the driveshaft over the wear mark and attempt to fit a 0.018in (0.45mm) feeler gauge between the flat edge and the wear mark. Can the feeler gauge fit between the straight edge and anywhere along the wear mark? See Figures 4 and 5.

Yes – Does not pass inspection. Contact the SSSC and provide a picture of the driveshaft with the feeler gauge fitting between the straight edge and wear mark. Once approved, rear driveshaft replacement will be required, but do not install at this time. Proceed to step 7.
No – Passes inspection. Proceed to step 5.

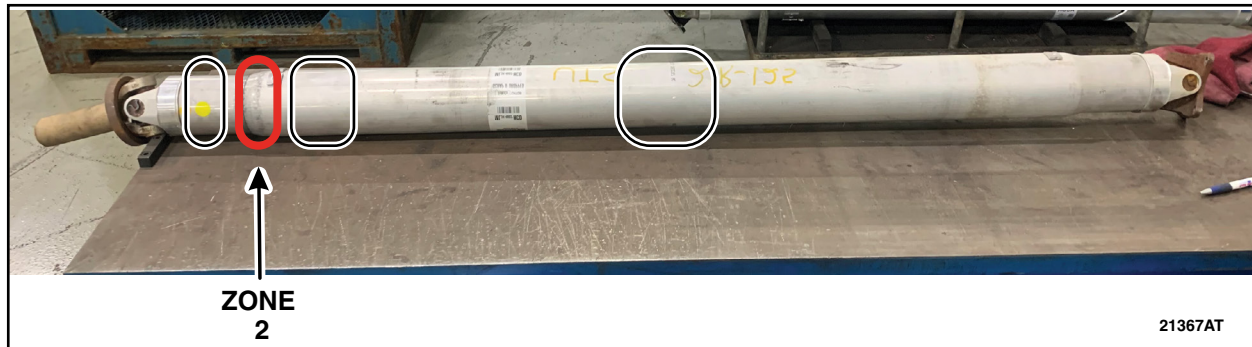
FIGURE 6

5. Inspect Zone 2 (transition from larger tube diameter to smaller diameter section) of the driveshaft tube for any marks caused by the front edge of the passenger side insulator. Are there any marks present? See Figure 6.

Yes – Does not pass inspection. Proceed to step 6.

No – Passes inspection. Driveshaft may be reused. Proceed to step 7.

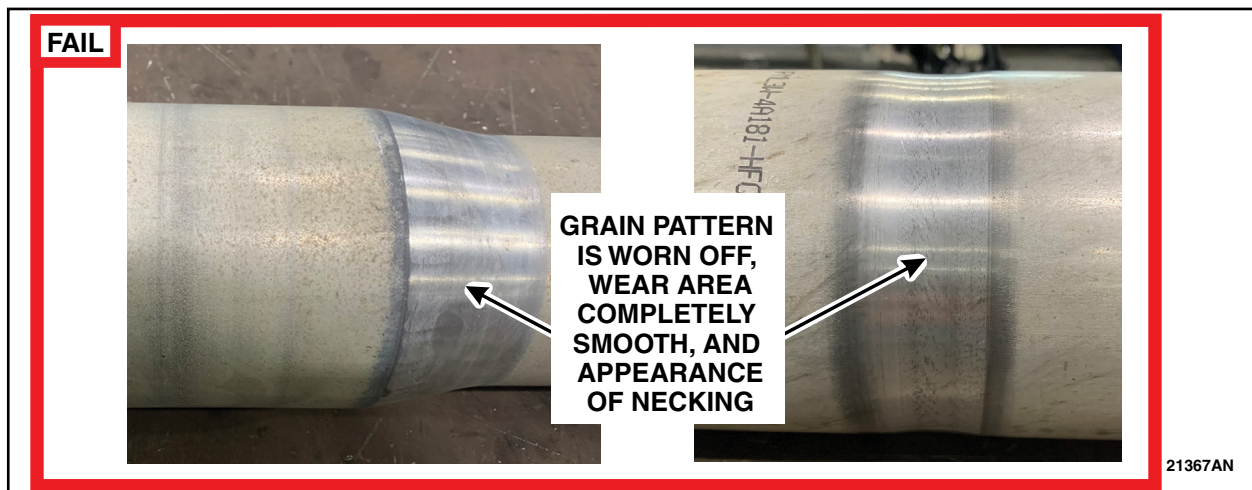
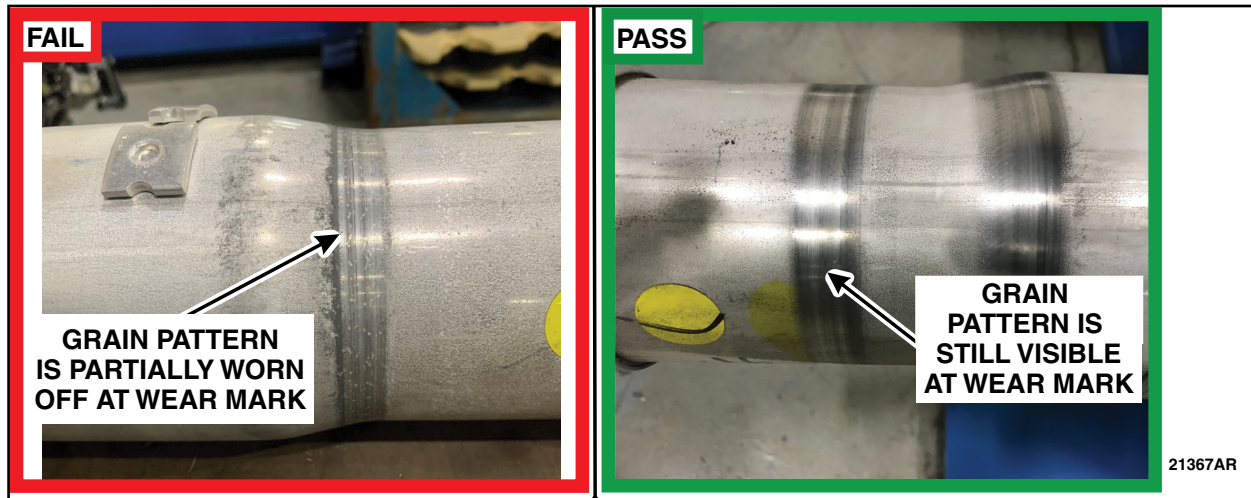
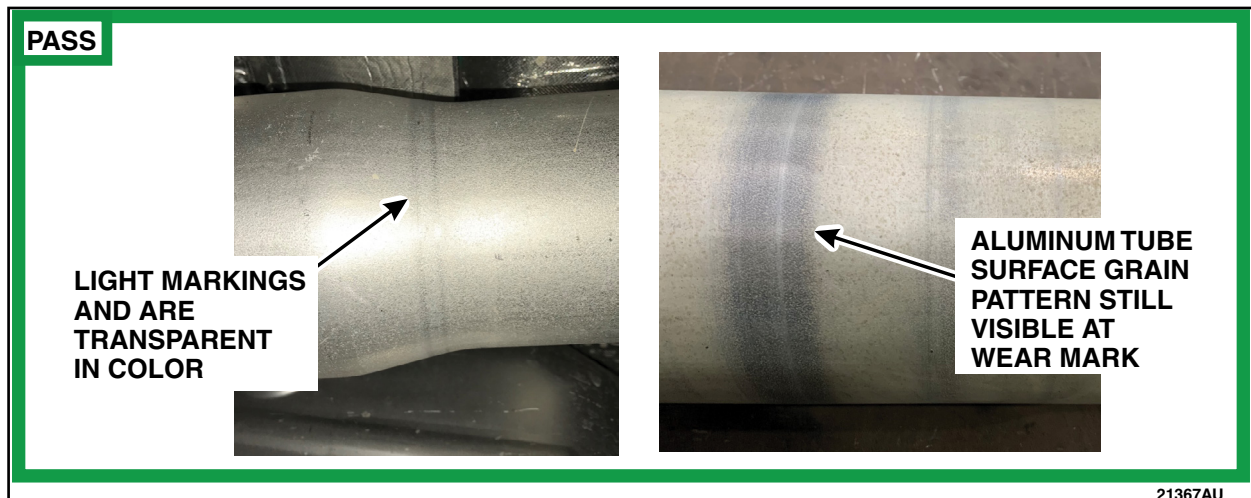
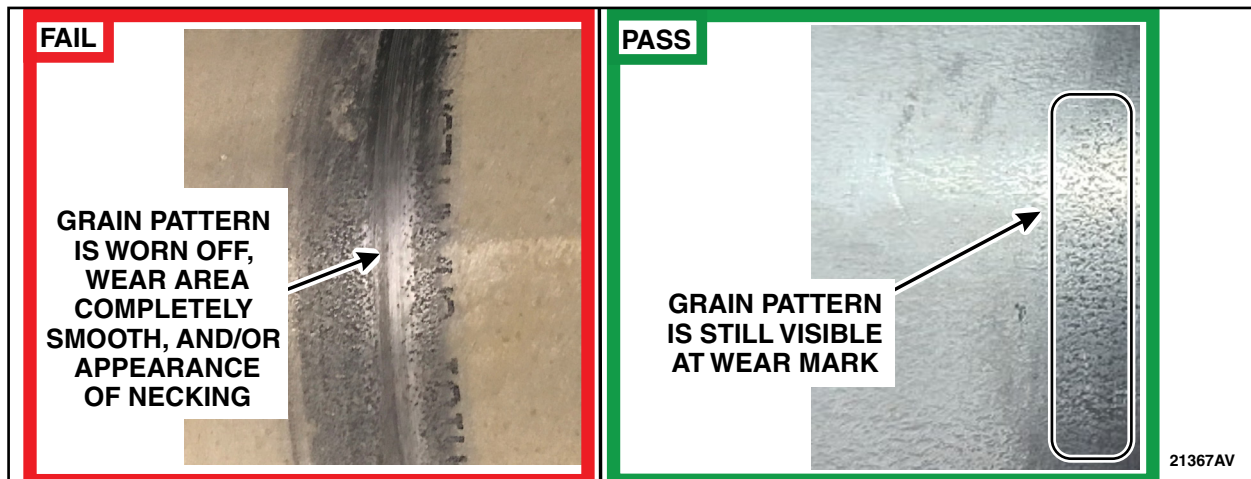
6. Inspect the marks found on Zone 2. Is the aluminum tube surface grain pattern worn off, completely smooth, or have an appearance of necking? See Figures 7 through 10.

Yes – Does not pass inspection. Contact the SSSC and provide a picture of the driveshaft with the grain pattern worn off. Be sure to show a clear image of the grain pattern missing. Once approved, rear driveshaft replacement will be required, but do not install at this time. Proceed to step 7.

No – Passes inspection. Driveshaft may be reused. Proceed to step 7.
