# Thor Motor Coach Recall Repair Instructions

Recall #	<b>22V-094 2022-076</b>		
Description/Title:	<b>LP Hose Routing Expansion Recall</b>		
Affected Product Line(s):	<b>Certain model year 2020-2021 Magnitude &amp; Omni motorhomes</b>		
Service Campaign # :	<b>RC000242</b>	Released Date:	<b>3/24/2022</b>
Repair Code:	<b>Inspect Only: TMCRC10109Y</b>  <b>Inspect &amp; Repair: TMCRC10109V</b>	Document Date:	<b>3/24/2022</b>
Time Allowed:	<b>Inspect Only: 0.2</b>  <b>Inspect &amp; Repair: 0.5</b>	Document Revision:	<b>A</b>

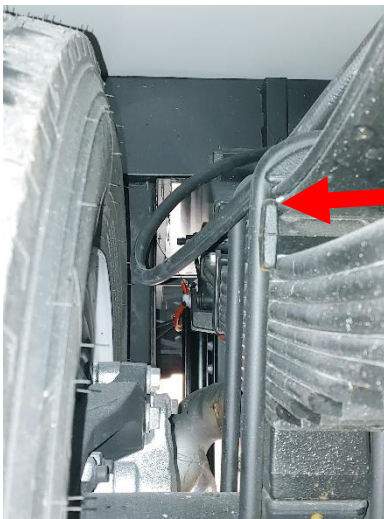
On certain model year 2020-2021 Magnitude and Omni motorhomes, the LP hose may have been inadvertently ran through the rear suspension leaf springs during production. The LP hose has the potential to rub on the leaf springs and possibly lead to a leak in the LP hose. This could cause a fire, which could result in serious injury or death.

1. Inspect routing of LP hose in rear axle area in wheel well for presence of excess hose that has possibility of rubbing on rear suspension leaf springs. Reference the attached prints by floor plan as needed.
  - a. There should be three (3) p-clamps (front, middle, rear). Add clamps over the wheel well as needed to eliminate the concern of the LP line falling in that area.
  - b. If LP hose looks like below photo, re-routing will be required.
