Recall Campaign Launch Notification

Check Ground and Potential Equalization Connections

Campaign No. 2022030019, April 2022

SUBJECT: **Model EQS (297 platform)**
Model Year 2022

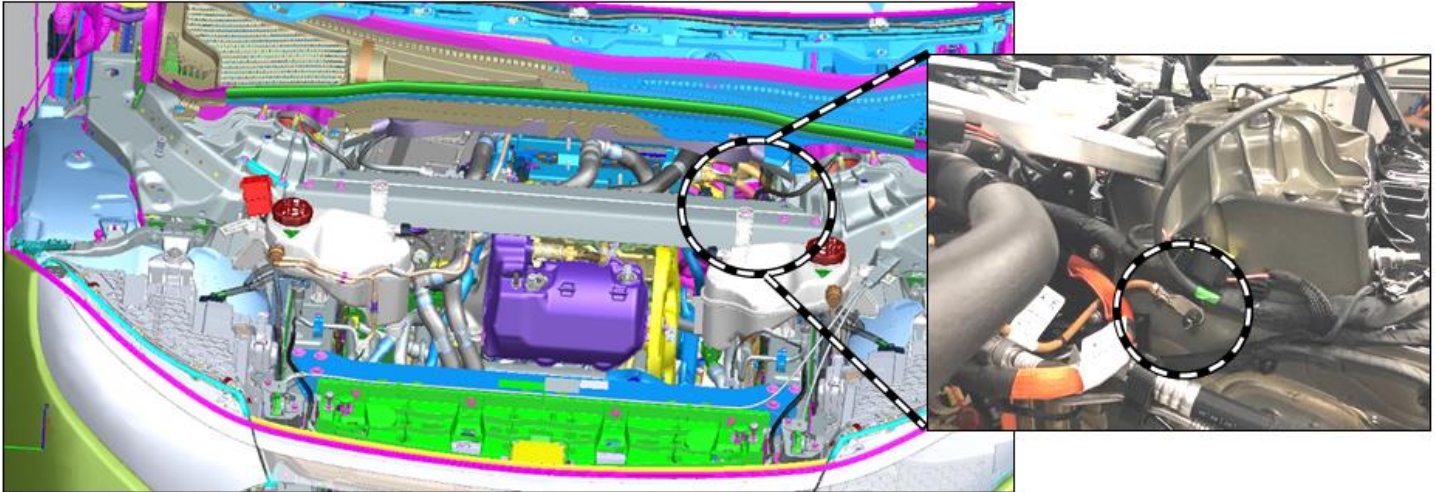
Figure 1

3. Loosen the threaded connection of ground point "W92w2" of equipotential bonding line of high-voltage PTC heater (N33/14) for vehicle interior in area of inner front left longitudinal member and left spring dome and screw on correctly (**figure 1**).

It is possible that the torque of the threaded connection may not have been tightened correctly and this could cause the threaded connection to loosen!

Threaded connection of equipotential bonding line for the vehicle interior front left longitudinal member high-voltage PTC heater

When tightening the ground point "W92w2" of the equipotential bonding line, make sure that the contact surface of the threaded connection is clean and correct!

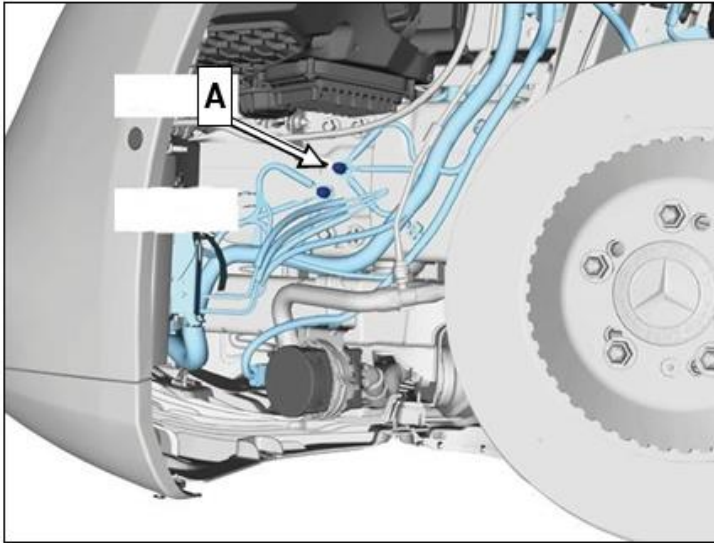
Figure 2

6. Check whether the threaded connection (**A, figure 2 and 3**) of the ground point "W52/8" has been installed correctly on the outer front left longitudinal member.

i It is possible that the threaded connection may be loose!

i The area of the threaded connection shall also be checked for traces of signs of electrical arcing or sparks!

- a. **Arc/spark traces** on threaded connections for ground point "W52/8" **present**: **Perform work procedures A and B.**
- b. **Arc/spark traces** on threaded connections for ground point "W52/8" **not present**: **Perform work procedure B**

1. Remove ground line of ground point "W52/8".
2. Eliminate traces of arcing/sparks on the ground point "W52/8".
 - i** Replace cable lug of ground line, to do this, see basic data under **AR00.19-P-0100A**.
 - i** The corresponding cable lugs shall be determined according to the diameter of the diameter of the ground line!
3. Install ground line of ground point "W52/8".

1. Correct torque of threaded connections of ground point "W52/8".
 - i** Threaded connection of ground point "W52/8" outer front left longitudinal member **Hm** 7!
2. Assemble in reverse order.
3. Perform commissioning of the high-voltage on-board electrical system.
 - i** For basic data, see **AR47.70-P-1000EQS**.
