Technical BULLETIN

SAFETY RECALL

CERTAIN 2021 AND 2022 MODEL MT09M/MC/N/NC (MT-09), MT09SPM/MC/N/NC (MT-09 SP), AND MTT9GTM/MC/N/NC (TRACER 9 GT) MOTORCYCLES FACTORY MODIFICATION CAMPAIGN – Limited Throttle Response / Engine Stall – ECU Reprogramming

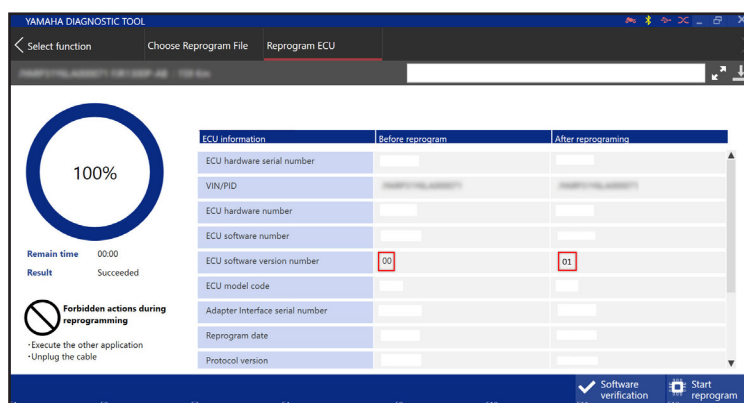
*After reprogramming, you can confirm the Software Version number as shown below.

Reprogram the ECU with the corresponding software update using YDT version 3.1.14 or later.
