Safety Recall

Code: 97GF

Subject Front Door Wiring Harness

Release Date July 22, 2022

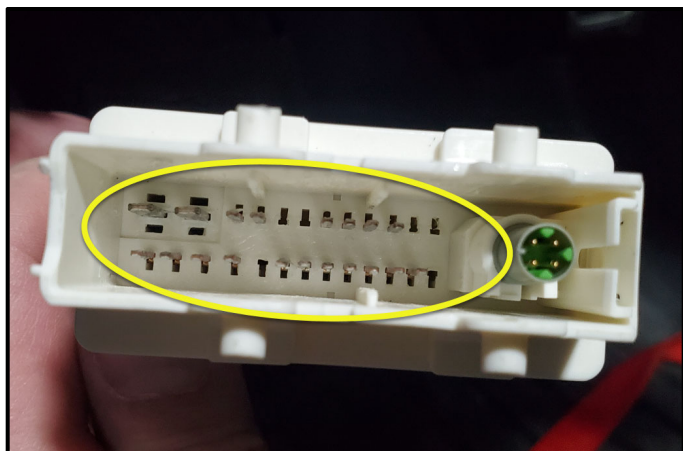
In the event of a side crash, when the side airbag deployment may be necessary, the side airbag may deploy later than designed, which can lead to an increased risk of injury to vehicle occupants. This issue may be caused by excessive micromovement, leading to fretting corrosion of the door wiring harness terminal contacts.

- Check DTC memory for faults related to faulty front door harnesses.
- Modify or replace door harness.
