May 2022
FL921A
NHTSA #22V-153

Subject: Thomas Built Buses EFX Seat Bolts

Models Affected: Specific model years 2020-2023 Thomas Built Saf-T-Liner EFX school buses manufactured June 6, 2019, through November 30, 2021.

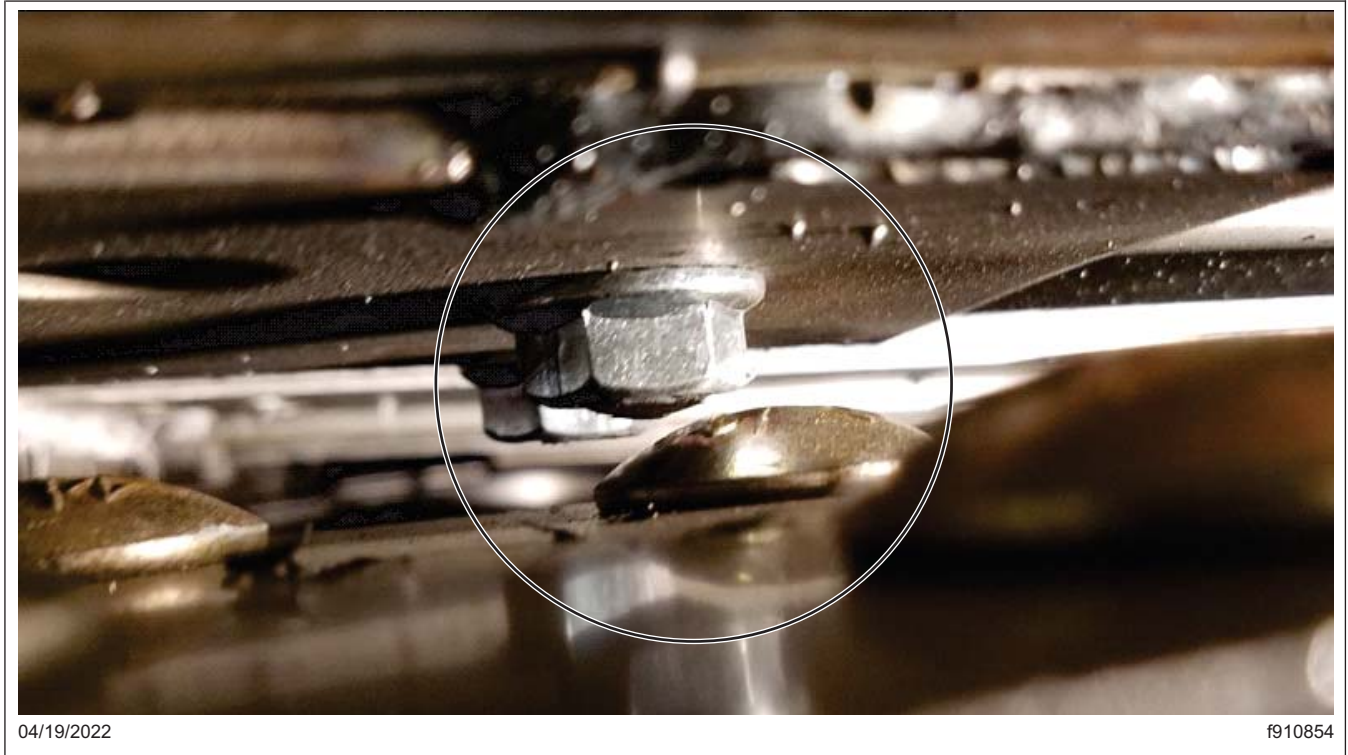
Fig. 16, Clearance Between the Seat Bolt and the Body Secured to the Chassis

On the affected EFX school buses, certain passenger seats have a mounting bolt that may contact a chassis cross-member bolt which can cause fatigue from vibration and side loading. A broken seat mounting bolt may impact the ability of the seat to meet the seat and belt requirements of FMVSS 210 and/or FMVSS 222.

14. After the body is secured to the chassis, inspect the seat bolt for clearance, as shown in [Fig. 16](#).
