GROUP	MODEL
Safety Recall Campaign	2014-2016MY Cadenza (VG)
NUMBER	DATE
SC232	May 2022

# SUBJECT: WINDSHIELD INSPECTION & REATTACHMENT (SC232)

This bulletin provides information to inspect and, if necessary, reattach the front windshield glass on 2014-2016MY Cadenza (VG) vehicles produced from February 1, 2013 through January 7, 2016. Certain sections of the front windshield glass may not have sufficient primer resulting in reduced adhesion of the windshield glass to the vehicle body. Although the exact cause of this condition is unknown, it is believed to be due to a deviation in the application of primer to the front windshield glass, causing windshield separation. A separated windshield increases the risk of a crash and/or injury. Follow the procedure outlined in this publication to inspect the windshield for water leakage and, if necessary, remove and reattach the windshield. Before conducting the procedure, verify that the vehicle is included in the list of affected VINs.

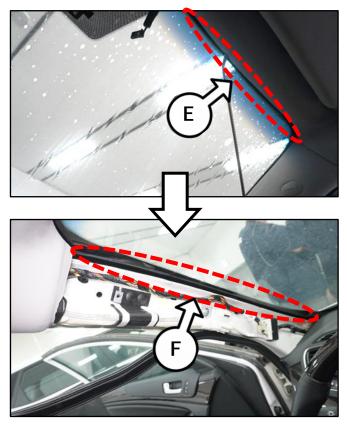
- Immediately after blowing with the air gun, check for bubbles appearing on the outside of the windshield glass as shown.
  - If air bubbles are not present, no further action is required. Reinstall all removed parts in the reverse order of removal.
  - If air bubbles are present, proceed to the 'Repair Procedure' on page 4 to remove and reattach the front windshield glass.
