**KZRV, LP**  
**Repair Instructions**

**Coupler Recall**  
**NHTSA #22V-161**  
**Transport Canada #2022-120**  
**KZ # KZ-2022-01**

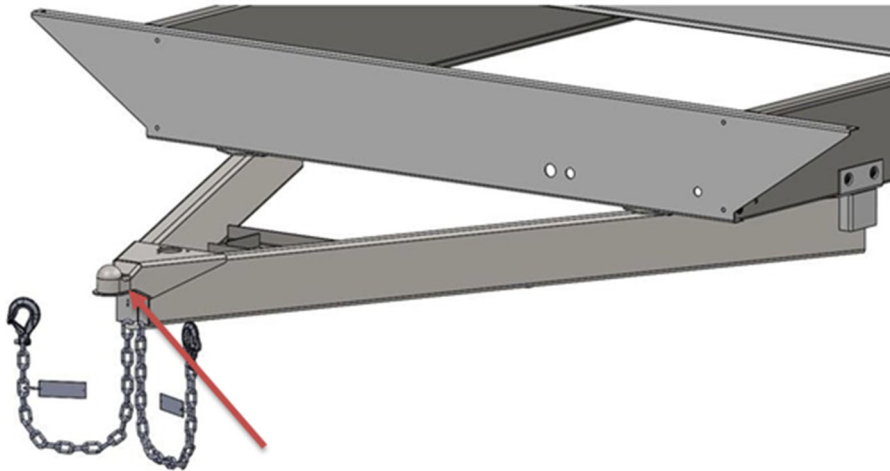
1. Inspection location: Bottom side of coupler located at the front end of the a-frame.

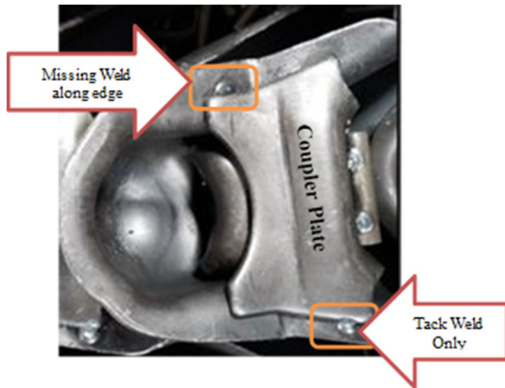
2. Underneath the coupler, use a flashlight to inspect the welds at each side of the bottom coupler plate.
  - a. To Pass Inspection: A weld bead should run along each side of the plate.

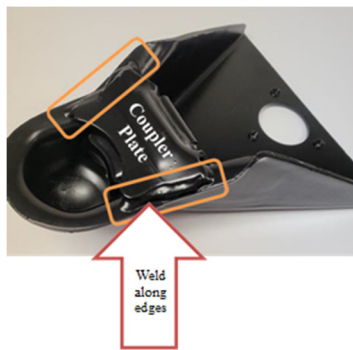
To Fail Inspection: A weld bead will not run along the side of the plate and there will only be tack welds

1. In a circumstance that the coupler is only tack welded on the underneath plate, the coupler will need to be replaced by a qualified welder.
2. Safely support the front of the RV with jack stands and remove the tongue jack.
3. Carefully cut through the perimeter welds of the coupler allowing the defective coupler to be removed. *Use caution not to damage the draw tubes when cutting through the welds.*
