## PRODUCT CONTAINMENT REQUEST 50A Shore Power Inlets (93379)

March 15, 2022

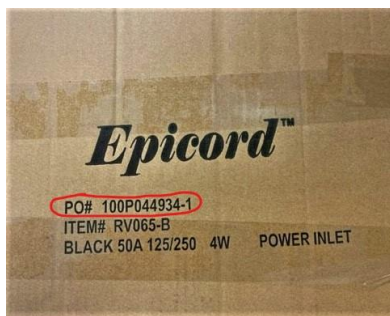
Patrick Distribution was made aware that a number of 50A Shore Power Inlets (93379) manufactured and imported by ZH Brothers International and distributed by Patrick Distribution were not manufactured to specifications. Specifically, the lugs for the inlets in two shipment lots were produced using an excessively hard material that may prevent proper torquing of the lug to the required 20in/lbs. If the lugs are not properly torqued, they may loosen and cause arching, overheating and, potentially, a fire.

Upon consultation with the manufacturer, we determined that the issue was isolated to two (2) recent import shipments, which can be identified by the PO numbers "100P044900" and "100P044934" stamped on the box, as shown here:

- (1) Please check your parts inventory for any remaining parts and return them to Patrick Distribution. Patrick Industries will cover return freight charges. Again, this action applies only to products with container markings of 100P044900 and 100P044934.
- (2) For any vehicles on which parts were installed between February 2, 2022 and the date by which your inventory was contained, we recommend that the torque be checked and confirmed as meeting the 20in/lbs. specification. If the lugs are unable to be torqued to 20-in/lbs., the inlet should be removed and replaced with a new inlet. If the lugs are confirmed as meeting the

torque specification (20in/lbs.), no further action is necessary. We will reimburse you 0.25 hours for inspection and, if the inlet needs replacing, an additional 0.25 hours for replacement, in accordance with our standard warranty procedure.
