# Safety Recall

## Code: 42L8

<b>Subject</b>	<b>Rear Suspension Knuckles</b>																									
<b>Release Date</b>	June 7, 2022																									
<b>Affected Vehicles</b>

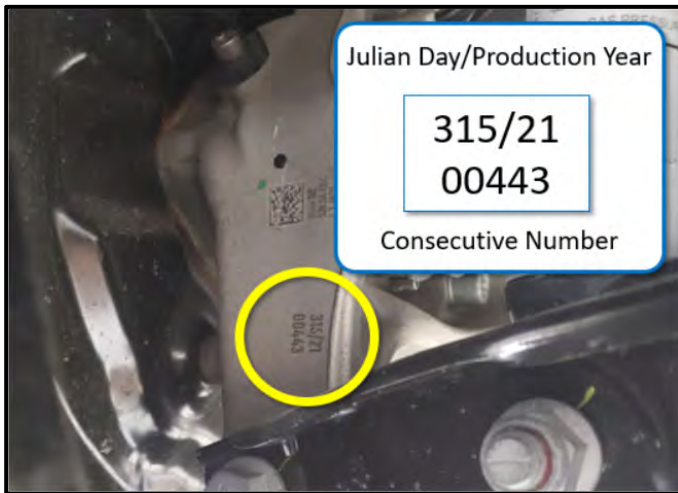
Julian Day/Production Year

315/21  
00443

Consecutive Number

- Both rear wheel bearing housings must be inspected.
- Check the build date on each wheel bearing housing from the rear of the vehicle.

- The wheel bearing build date is read in the example shown.
- The build dates vary by model.

<b>Julian Production Day</b>	<b>Production Year</b>	<b>Consecutive number</b>
141	21	291 to 336
144	21	66 to 134
216	21	203 to 329

<b>Julian Production Day</b>	<b>Production Year</b>	<b>Consecutive number</b>
188	21	300 to 321
231	21	196 to 237

- If the build date of the wheel bearing housing matches the chart of affected build dates:
  - The wheel bearing housing must be replaced.
  - See Section C for wheel bearing housing replacement.
- If the build date does not match the chart:
  - The wheel bearing housing is OK.
  - Proceed to Section D if both wheel bearing housings are OK.

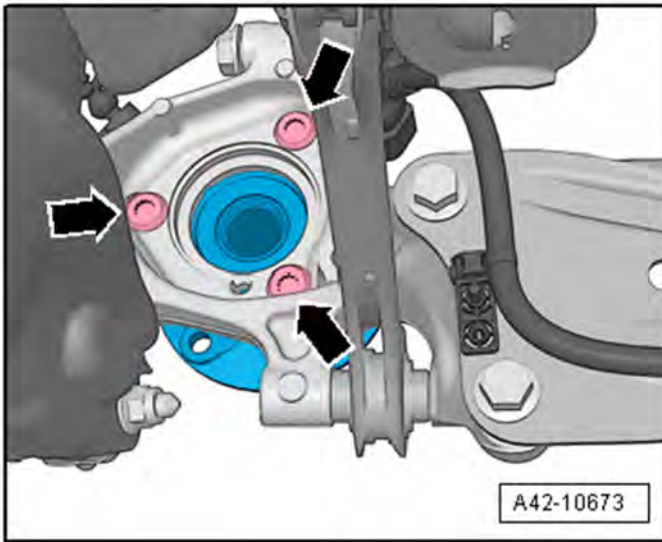
If the wheel bearing is seized to the wheel bearing housing, the wheel bearing should be replaced.

- Remove the bolts <arrows>.
- Remove the wheel bearing unit from the wheel bearing housing.
