Bentley Bulletin

22-032

Subject: RECALL CAMPAIGN – Bentley Continental GT, Continental GT Convertible and Flying Spur Incorrect Seat Belt Fitted Recall (RE22/08)

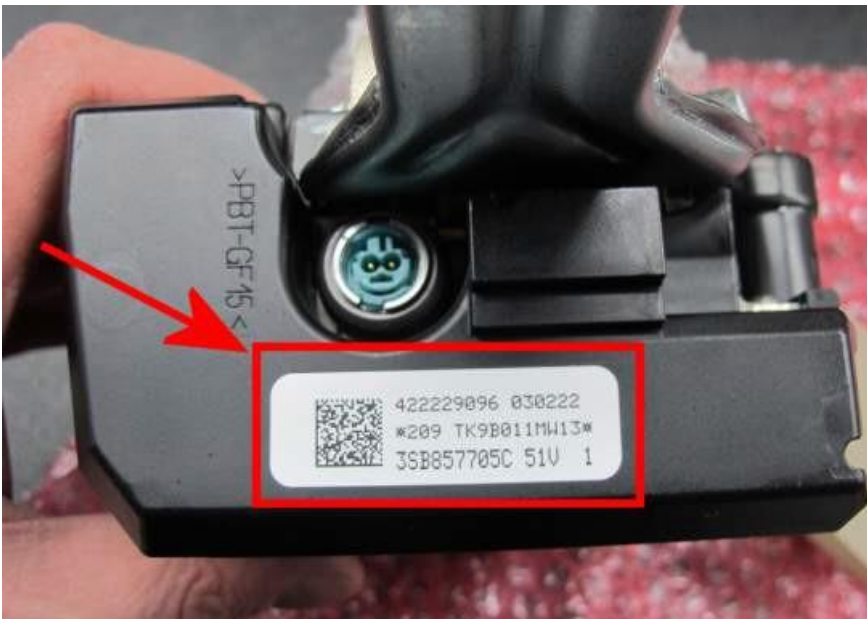
NOTE: Should the part numbers and seat belt operation be to specification, access to both front seat belt assemblies is required to capture a photograph of a specific identification label, Figure 1 shows the label which is required to be photographed

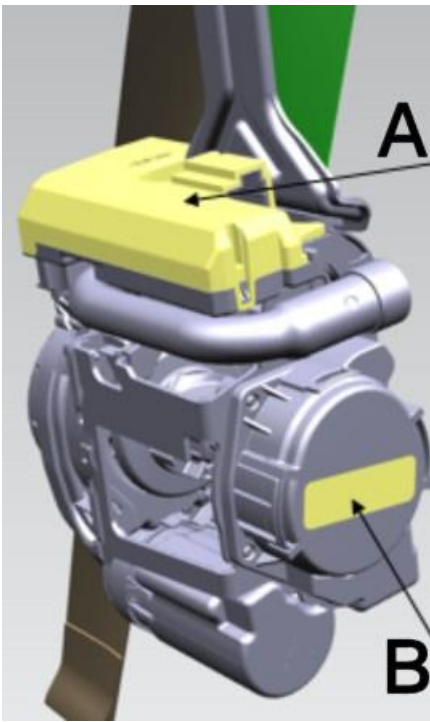
Figure 2 shows the location in which the label is fitted (Depending on Model Year)

- Point A - 22 M/Y onwards
- Point B - Up to 22 M/Y

HINT: In the event that a front seatbelt has previously been replaced on a vehicle prior to 22 M/Y please be aware that the required identification label may not be at Point B as the part supplied could be a later/superseded part

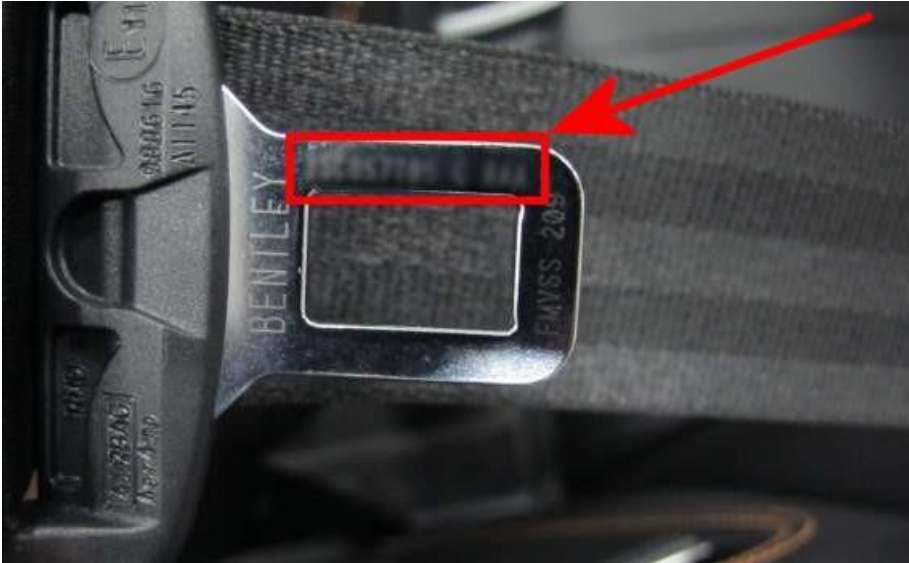
Figure 3

1) Locate the part number of the left hand side seat belt (Figure 3)

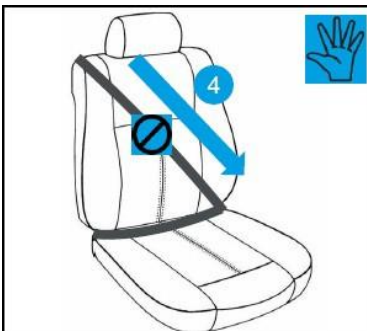
Figure 9

9) Grasp the torso portion of the seatbelt, With care, (Ensuring the inertia lock is not initiated), pull on the belt in an attempt to pull the seatbelt back out of the retractor. The belt should not pull out of the retractor (Figure 9)

Does the passenger seatbelt lock so that the strap cannot be pulled out of the retractor (as shown in Figure 9) five times in succession?

No: The seatbelt **MUST** be replaced Refer to Rep.Gr 69 **IMPORTANT**: please ensure a photograph of the replacement seat belt identification label is taken and saved as this will be required later in the process - Referring back to Figure 1 locate the identification label (Depending on model year see Figure 2 for label location)

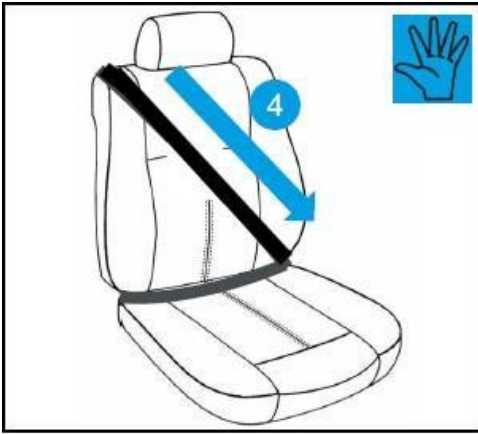
Figure 13

15) Grasp the torso portion of the seatbelt and carefully, (Ensuring the inertia lock is not initiated), pull the seatbelt back out of the retractor. The belt should pull out of the retractor as there is no ALR function on the driver's seat (Figure 13)

Does the driver's seatbelt lock so that the strap cannot be pulled out of the retractor (step 15) five times in succession?

Yes: The seatbelt MUST be replaced Refer to Rep.Gr 69 IMPORTANT: please ensure a photograph of the replacement seat belt identification is taken and saved as this will be required later in the process - Referring back to Figure 1 locate the identification label (Depending on model year see Figure 2 for label location)

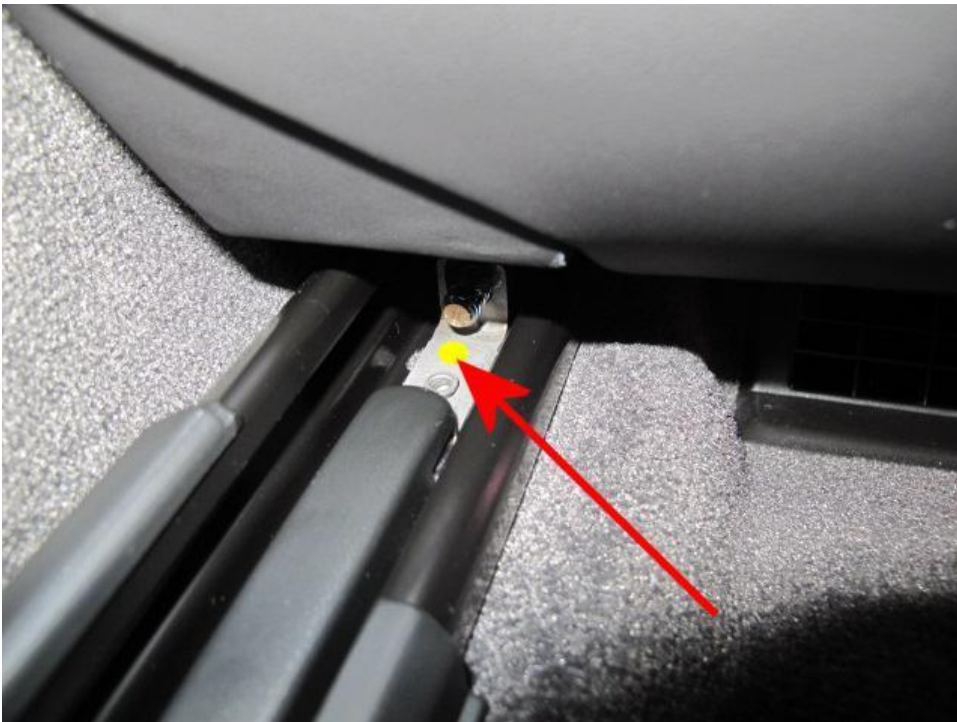
Yellow paint completion mark on the driver's side inner seat rail (Figure 14)

- If one or both seat belts were replaced photographs of the replacement identification label is required
- Apply a yellow paint completion mark on the driver's side inner seat rail (Figure 14)

NOTE: For clarity Figure 14 shows an inner seat rail from a right hand drive vehicle, for left hand drive vehicles apply the completion mark in the same location (driver's side inner seat rail)
