# Safety Recall

## Code: 21H7

<b>Subject</b>	Oil Strainer				
<b>Release Date</b>	August 04, 2022				
<b>Affected Vehicles</b>	<b>Country</b>	<b>Beginning Model Year</b>	<b>Ending Model Year</b>	<b>Vehicle</b>	<b>Vehicle Count</b>
	USA	2013	2017	A8	7,874
	USA	2014	2017	RS7	3,305
	USA	2013	2017	S6 SEDAN	6,385
	USA	2013	2017	S7	5,040
	USA	2013	2017	S8	3,449
	CAN	2013	2017	A8	326
	CAN	2014	2017	RS7	808
	CAN	2013	2017	S6 SEDAN	567
	CAN	2013	2017	S7	548
	CAN	2013	2017	S8	292
	<p>Check Campaigns/Actions screen in Elsa on the day of repair to verify that a VIN qualifies for repair under this action. Elsa is the <u>only</u> valid campaign inquiry &amp; verification source.</p> <ul style="list-style-type: none"> <li>✓ Campaign status must show "open."</li> <li>✓ If Elsa shows other open action(s), inform your customer so that the work can also be completed at the same time the vehicle is in the workshop for this campaign.</li> </ul>				
<b>Problem Description</b>	<p>The oil strainer within the oil supply for the turbocharger might become blocked by oil/carbon deposits contained in the engine oil. A blocked oil strainer within the oil supply for the turbocharger leads to a lack of lubricat

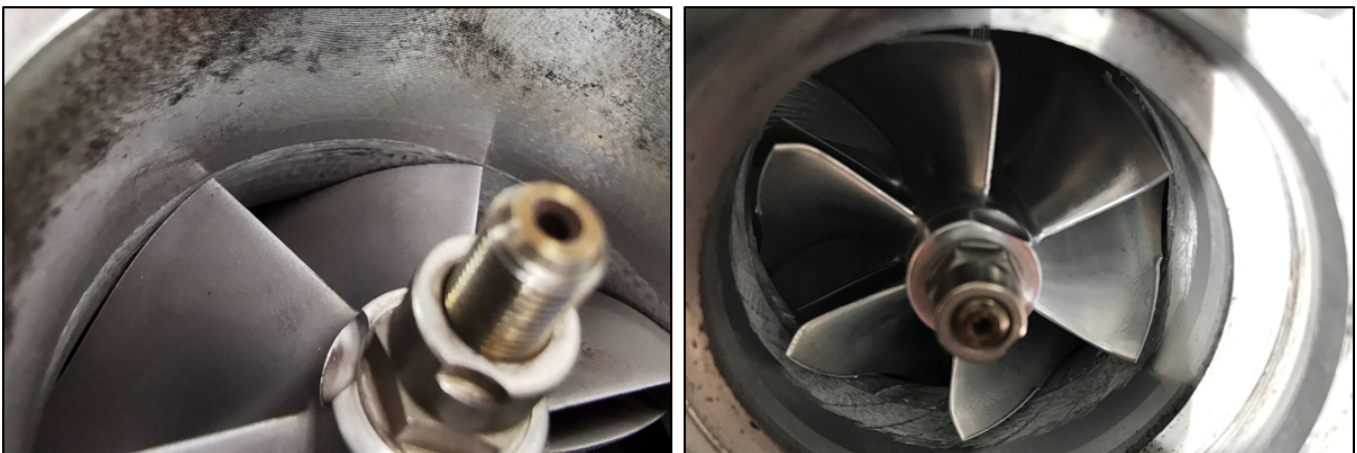
Below are examples of damaged turbos with excessive wear due to failed impeller bearings.

- If faults related to a failed turbocharger are stored:
  - Work through the populated test plan(s) for the fault.
  - If diagnosis leads to replacing the turbos due to damage from the impellers making contact with the housing:

- Send diagnosis log to GFF Paperless.
    - Stop the ODIS session.
    - Take photos of damaged turbo(s).
    - U.S. dealers: Upload photos of damaged turbos to Doc-It for review. Contact Audi Warranty for authorization.

- Canadian dealers: Create an ATA WEB ticket and attach photos of damaged turbos for review.
    - The oil strainer must still be replaced, Proceed to Section C.

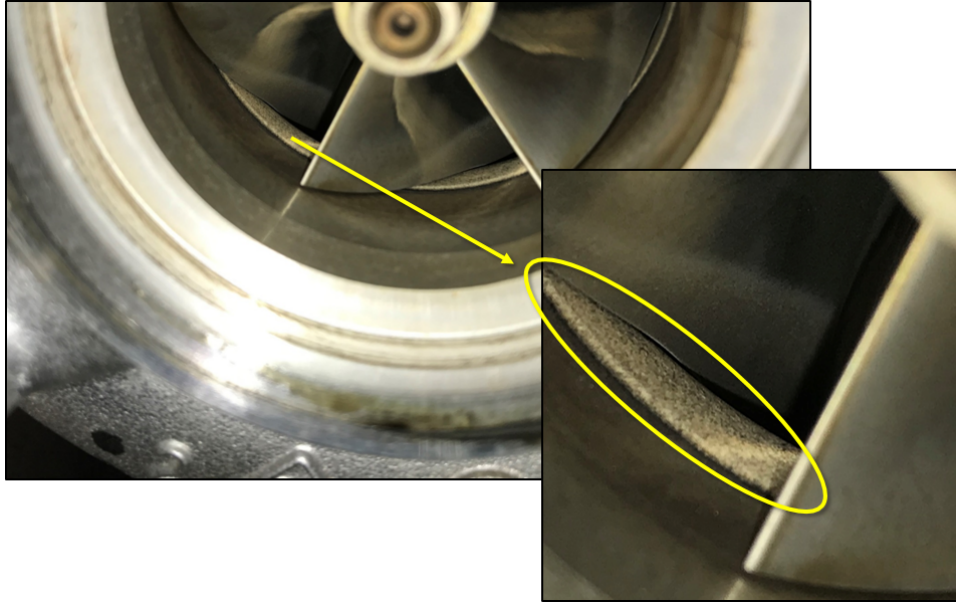
- Turbos on engine codes CRDB, CWUB, CWUC and DDTA have an integrated and abradable sealing ring.
- Visible contact marks (as shown below) in the area of the sealing ring are OK.
- Visible contact marks (shown in the previous photos of excessive wear) outside the area of the sealing ring are NOT OK.

Example of acceptable contact on turbos with an integrated and abradable sealing ring.
