## RECALL 22V185, 2022-139 REMEDY INSTRUCTIONS

Make(s): SURVEYOR Model(s): SVT19MDBLE Model Year(s): 2022	Repair Code: RC-024-01-00-004174 Allotted Time: .50 HRS. Inspection Code: RC-024-05-00-004173 Allotted Time: .10 HRS.
	Concern: The fresh air intake tube length was not lengthened when the furnace was moved.	Photo(s) Required: YES Prior Authorization Required: YES Part(s) Kit Number: 052162 Part(s) Return: NO

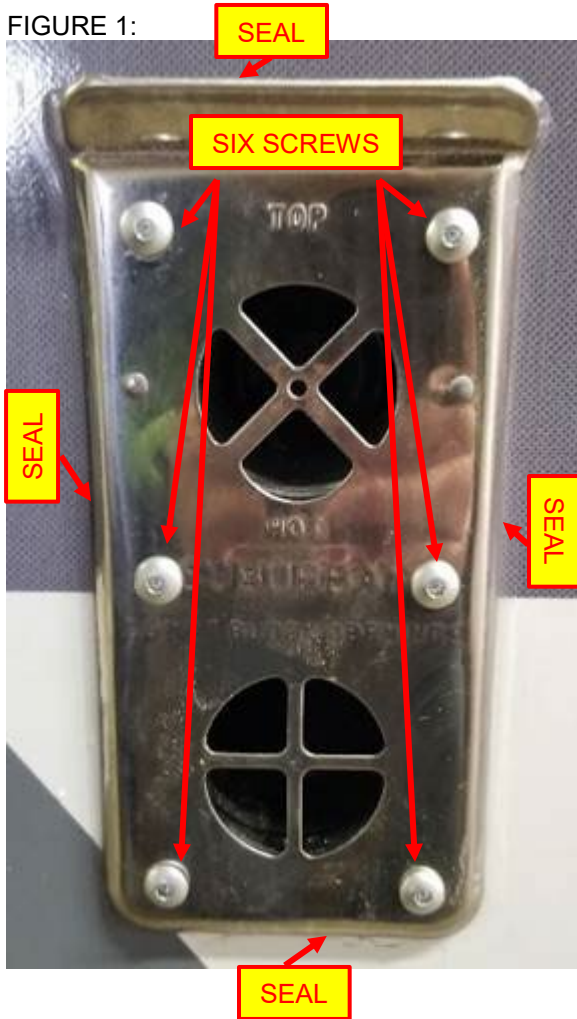
FIGURE 1:

Concern:  
The fresh air intake tube length was not lengthened when the furnace was moved.

STEP 2: REMOVE SIX SCREWS FROM THE FURNACE FLUE EXTERIOR (FIGURE 1);

STEP 3: USING A UTILITY KNIFE TO CUT THE SEAL AROUND THE VENT (FIGURE 1);

STEP 10: REPLACE THE INTAKE TUBE WITH THE LONGER 052162 INTAKE TUBE;
