GROUP	NUMBER			
GENESIS		RECALL	22-01-046G			
		DATE	MODEL(S)			
Technical Service Bulletin		MAY, 2022	G70 (IK)			
SUBJECT:	SUBJECT: TRUNK LATCH BASE REPLACEMENT (RECALL 010G)

TRUNK LATCH BASE REPLACEMENT (RECALL 010G)

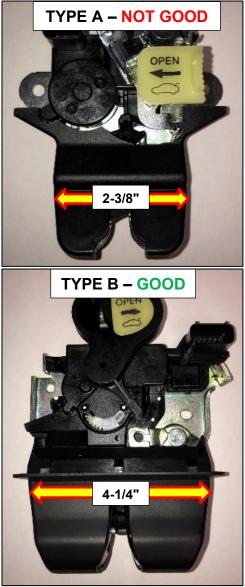
If the trunk latch is approximately 2-3/8" (58 mm) wide at the base, it is a type A latch and the trunk latch base needs to be replaced. Proceed to the next section for the repair procedures.

If the trunk latch is approximately 4-1/4" (101 mm) wide at the base, it is a type B latch and does not need to be replaced. No further action is required and the inspection is complete.
