# Technical Service Bulletin

GROUP <b>RECALL</b>	NUMBER <b>22-01-035H</b>
DATE <b>APRIL 2022</b>	MODEL <b>SANTA FE (TMA) SANTA CRUZ (NXT)</b>

<b>SUBJECT:</b>	TURBO OIL FEED PIPE REPLACEMENT (RECALL 222)
-----------------	--

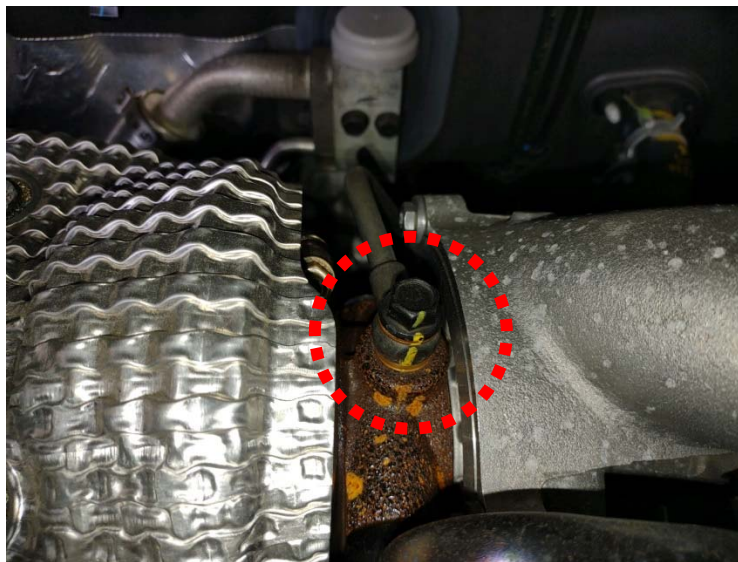
**Description:** On certain 2022MY Santa Fe (TMA) and Santa Cruz (NXT) vehicles equipped with 2.5T engines, the turbo oil feed tube may be cracked at the fitting on the turbo which may result in an oil leak. Engine oil exposed to certain hot surfaces in the engine compartment could ignite and increase the risk of a fire. Follow the service procedure to identify and replace the turbo oil feed pipe.

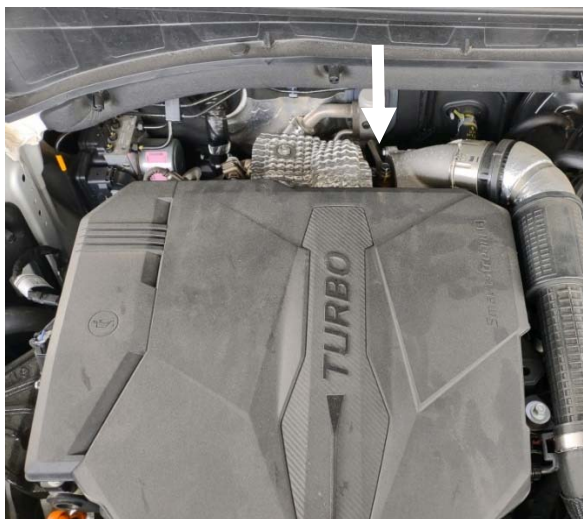
2. The indicated area is the oil feed pipe fitting portion of the turbocharger.

1. Open the hood and identify the oil feed pipe fitting on the top side of the turbocharger assembly.
