Vehicle Report

Manufacturer: Terex South Dakota, Inc.

Terex XT Pro 2020 - 2022

Terex Utilities**SAFETY NOTICE****SN710****DATE:** 4/6/2022**REVISED:****TO:** Owners, Users, Dealers, and Installers**MODELS AFFECTED:** XT Pro**SUBJECT:** Pivot Pin Lubrication**Issue:**

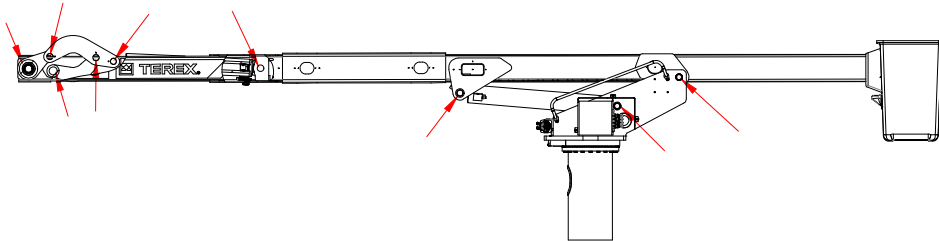
Figure 1. Areas of Machine to Inspect for Lubrication

1. Immediately inform all users, operators, and supervisors of the content of this bulletin.
2. Immediately inspect all pivot points for indications of lubrication, refer to Figures 1 through 3, and for any damaged components, including all pins, pin retainers, and fasteners.

3. If pins are seized or the pin retaining components are damaged, do not use the machine until repaired. Contact the Terex Technical Support department by calling 1-844-837-3948 or by emailing utilities.service@terex.com for further inspection requirements.
4. If no issues are found during the inspection, lubricate the machine per the lubrication chart on the machine or in the machine's manuals.
5. After completing the inspection and lubrication, complete the enclosed Completion Form and return to Terex using one of the contact methods listed in this bulletin.
6. Always follow the daily pre-shift inspection, periodic inspection, and maintenance requirements as specified in the manuals.

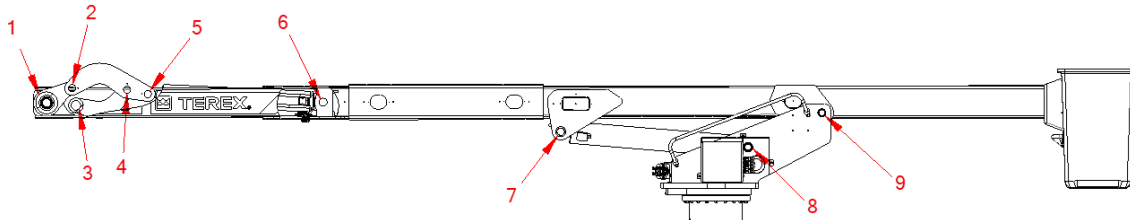
Inspected all pivot points for indications of lubrication and for any damaged components, including all pins, pin retainers, and fasteners. If damage is found, consult the Terex Technical Support at 1-844-837-3948 for further instructions, and remove the machine from service until corrected.

Circle any of the above numbers which do not show signs of lubrication.

Lubricate the machine per the maintenance manual or lubrication chart.
