### **IMPORTANT SAFETY RECALL 22V-213**

## SN710A

MODELS AFFECTED: XT Pro

SUBJECT: Pivot Pin Lubrication

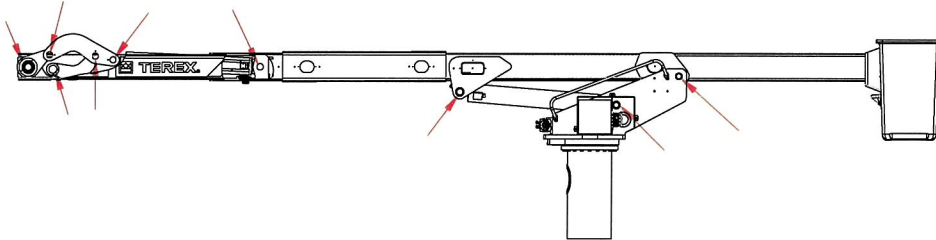
Figure 1. Areas of Machine to Inspect for Lubrication

Terex model XT Pro aerial devices, produced from October 2020 through March 2022, may not have received the required initial lubrication for all pivot pins. Lack of lubrication may result in seized pins which may break the pin retainers. **Failure of the pin retainers may cause the pin to become disconnected causing the boom to fall resulting in serious injury.**

1. Immediately inform all users, operators, and supervisors of the content of this bulletin.
2. Immediately inspect all pivot points for indications of lubrication, refer to Figures 1 through 3, and for any damaged components, including all pins, pin retainers, and fasteners.

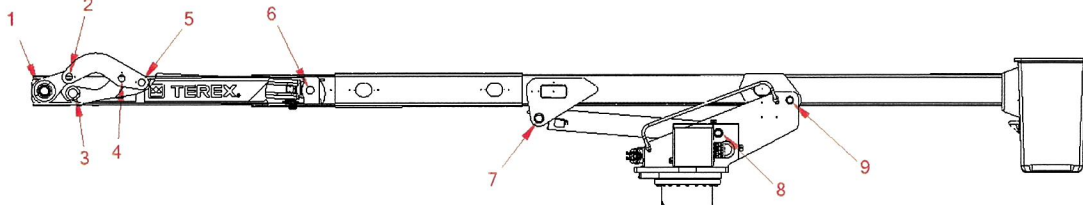
Inspected all pivot points for indications of lubrication and for any damaged components, including all pins, pin retainers, and fasteners. If damage is found, consult the Terex Technical Support at 1-844-837-3948 for further instructions, and remove the machine from service until corrected.

**Circle any of the above numbers which do not show signs of lubrication.**

Lubricate the machine per the maintenance manual or lubrication chart.
