SAFETY RECALL BULLETIN

NHTSA RECALL 22V216

AUTOCAR, LLC SAFETY RECALL ACX-2201

ABS Modulation Valve Wiring Correction

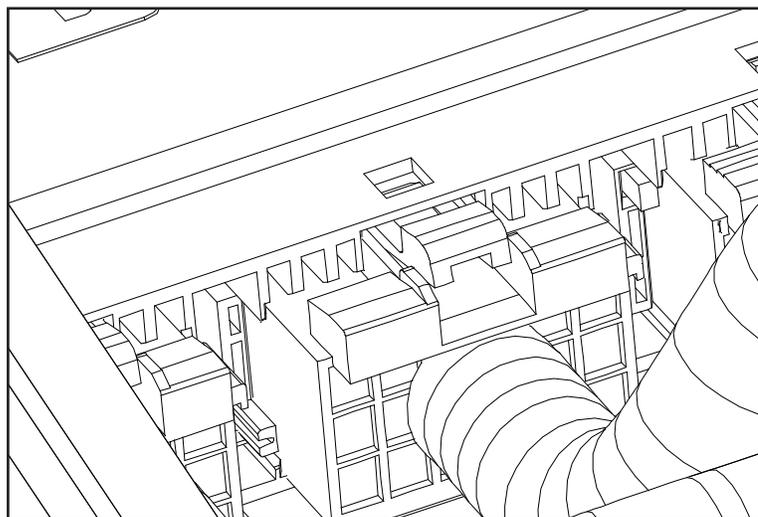
Figure 3, X2 Connector

Autocar, LLC has determined that a defect which relates to motor vehicle safety exists in certain Xpeditor (ACX) chassis. The anti-lock braking system (ABS) modulation valve wiring may be incorrect.

5. Locate and remove the X2 connector from the ABS controller (see Figures 2 and 3).

6. Verify the X2 connector cavity 3 wire 733-A and cavity 6 wire 732-A are properly pinned. If the X2 connector is properly pinned, no repair is required.

If the X2 connector is not properly pinned, adjust the pinning as required.(see *Figure 4*).
