June 2022
FL926A
NHTSA #22V-230
Transport Canada #2022-172

Subject: Western Star Wiper Arms

Models Affected: Specific model years 2021-2022 Western Star 47X, and 49X vehicles manufactured February 10, 2020, through July 28, 2021.

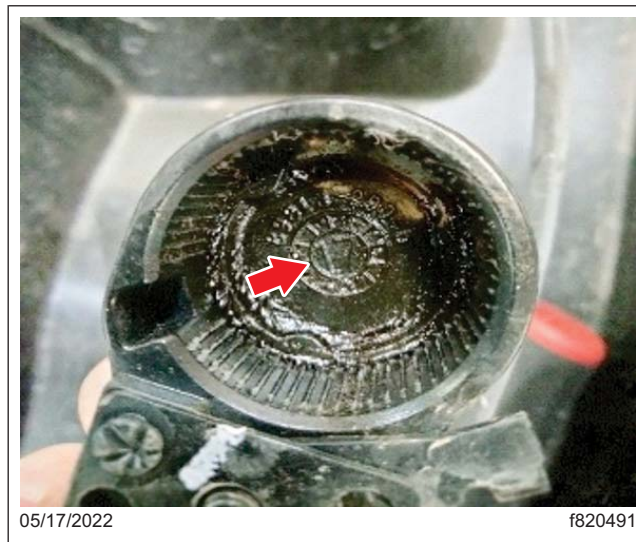
Fig. 2, Date Stamping on the Wiper Arm

On the affected vehicles, the spline teeth in the windshield wiper arm may wear and break. Wipers that do not function properly reduce the driver's visibility under certain operating conditions. This may increase the risk of a crash.

- Clean the grease on the splined area.
- Inspect the date stamping on the wiper arm. See [Fig. 2](#).

Is the date stamping #21, or newer?

YES → Install the existing wiper arms in the parked position so they are aligned with the index marks on the windshield. Then go to step 18.

11. Replace the wiper arm with the new wiper arm that has date stamping #21 or newer.
