# Recall Campaign Bulletin

Campaign No. 2022040017, June 2022

SUBJECT: **Model GLE-Class and GLS-Class (167 platform)**  
**Model Year 2020-2022**

## **Check the 48V Ground Connection**

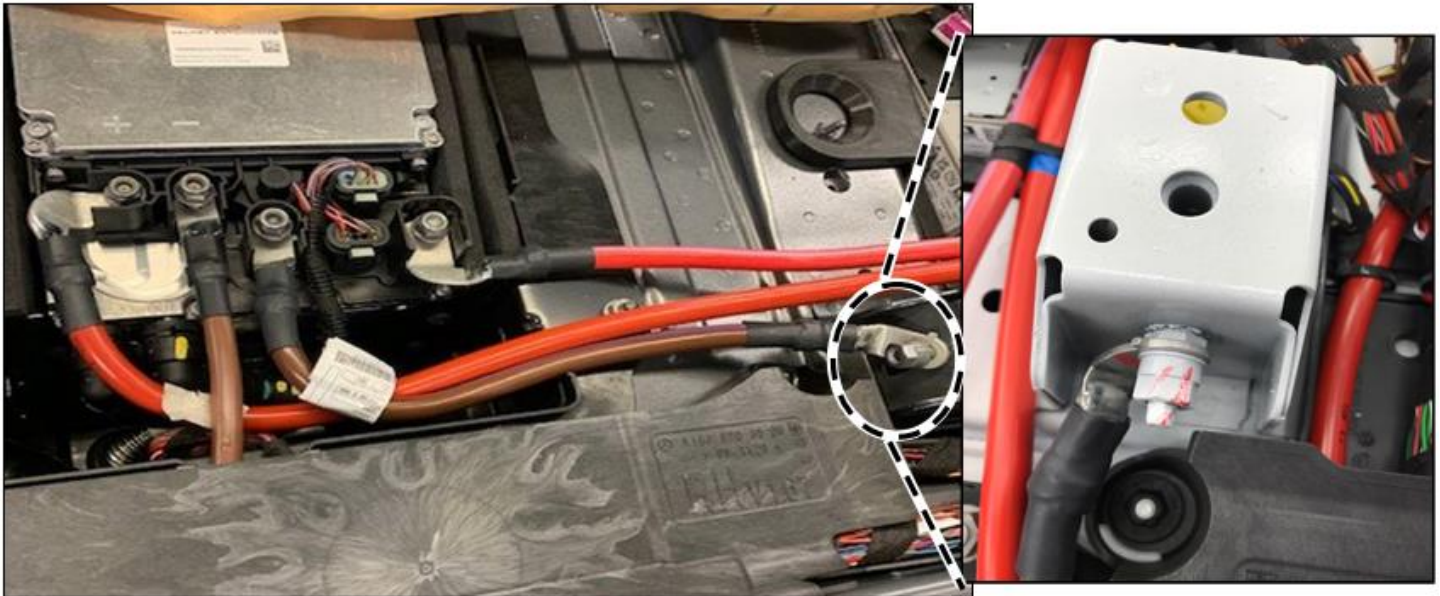
**Figure 1**

5. Expose right rear floor covering to the extent that the "W106/1" ground point is accessible for the electrical wiring harness of the 48 V on-board electrical system battery (**Figure 1**).

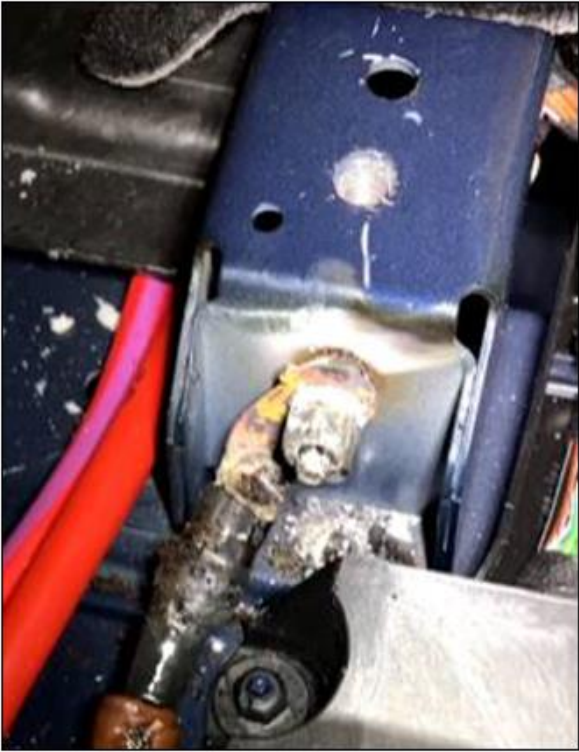
Figure 1 (not OK image)

7. Disconnect and check threaded connection of the electrical wiring harness of 48 V on-board electrical system battery of "W106/1" ground point on the body (**Figures 1 and 2**).

- i** Ensure there are no traces of thermal overload, arching, or scaling.
  - i** Figure 2 is showing an image that is **not** OK!

- a. If **traces of debris/arching** are **present** on the wiring harness to "W106/1" ground point: :  
Carry out **work procedures A and B**.
- b. If **traces of debris/arching** are **not** present on the wiring harness to "W106/1" ground point:  
Carry out **work procedure B**.

1. Replace the electrical wiring harness from the "W106/1" ground point to 48 V on-board electrical system battery.
  - i** Thoroughly clean area of debris/arching traces.
  - i** If the ground bolt also shows signs of arching or damage, the ground bolt must be replaced.
  - i** If traces of arching or damage are present at the surrounding component parts, such as the floor covering, these component parts must be replaced.

1. Connect electrical wiring harness of the 48 V on-board electrical system battery to "W106/1" ground point.
  - i** Torque of the electrical wiring harness "W106/1" ground point threaded connection **Nm** 16!
  - i** During installation of the electrical wiring harness to the "W106/1" ground point, a clean contact surface of the cable lug from the electrical wiring harness and the "W106/1" ground point shall be ensured.
2. Assemble in reverse order.
3. Connect XENTRY Diagnosis.
4. Erase fault memory.
5. Disconnect XENTRY Diagnosis.
