TECHNICAL INSTRUCTIONS
FOR
SAFETY (NONCOMPLIANCE) RECALL 22LA01

Vehicle Stability Control System May Not Default to "On"

Certain 2021 – 2022 Model Year LS 500h
Certain 2022 Model Year LX 600
Certain 2022 Model Year NX 350h
Certain 2022 Model Year NX 450h+

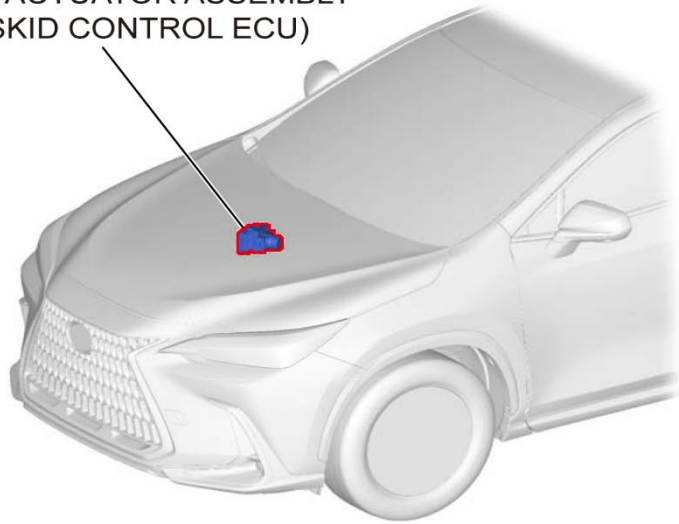
BRAKE ACTUATOR ASSEMBLY
(No. 2 SKID CONTROL ECU)

A software error can cause the Vehicle Stability Control system (VSC) not to default to “ON” the next time the car is started under certain circumstances. This can result in noncompliance with a federal safety requirement. Operating the vehicle with VSC deactivated could increase the risk of a crash in certain driving conditions.
