April 2022

Safety Recall Z35 / NHTSA 22V-249

Turn Signal Flash Rate

2022 (WL) Jeep® Grand Cherokee and Grand Cherokee L

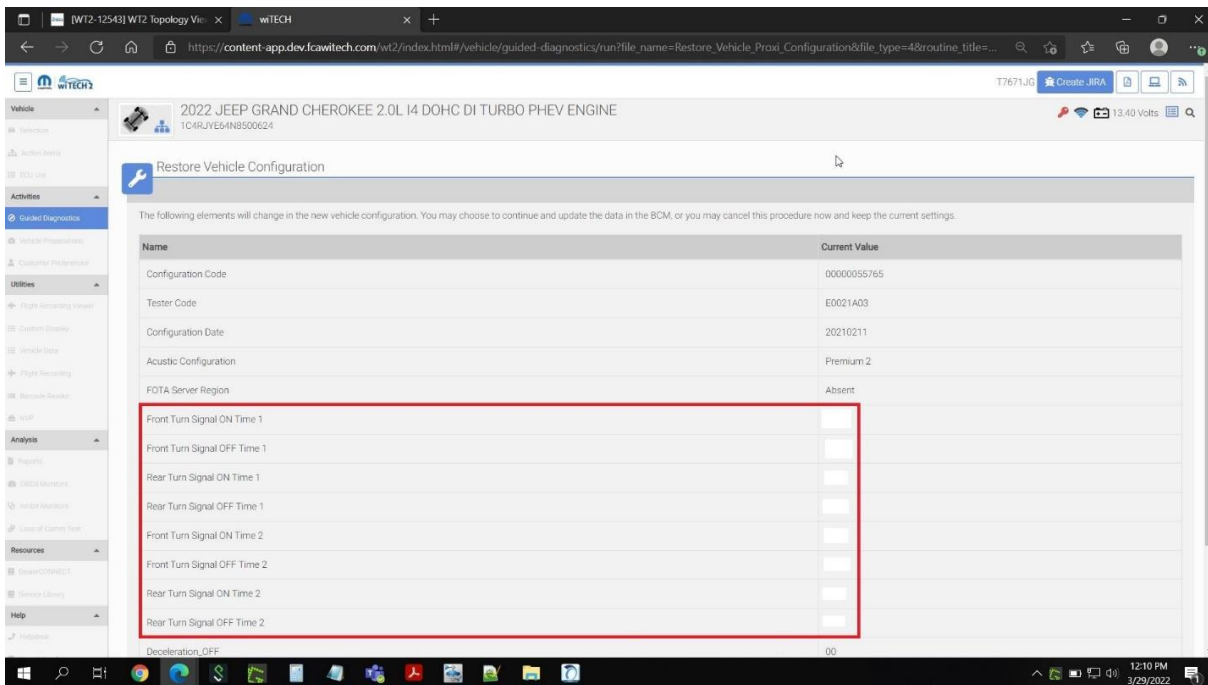
Figure 1 – Turn Signal Flash Rate

Note: Ensure the following parameters change throughout the routine (Figure 1).

- **Front Turn Signal ON Time 1/Front Turn Signal OFF Time 1: Value = 660ms**
- **Rear Turn Signal ON Time 1/Rear Turn Signal OFF Time 1: Value = 660ms**
- **Front Turn Signal ON Time 2/Front Turn Signal OFF Time 2: Value = 400ms**
- **Rear Turn Signal ON Time 2/Rear Turn Signal OFF Time 2: Value = 400ms**

9. After configuration is updated, confirm the flash rate of all 4 lamps (front headlamps and rear tail lamps) are the same.
