**SUBJECT: NEW VEHICLE DEMONSTRATION / DELIVERY HOLD  
 Safety Recall 22S24**

Certain 2022 Model Year F-150 Vehicles Equipped with Power Adjustable Steering Column – Deployable Column Connector Wiring Harness Takeout Length Inspection

Certain 2022 Model Year F-150 Vehicles Equipped with Power Adjustable Steering Column Deployable Column Connector Wiring Harness Takeout Length Inspection

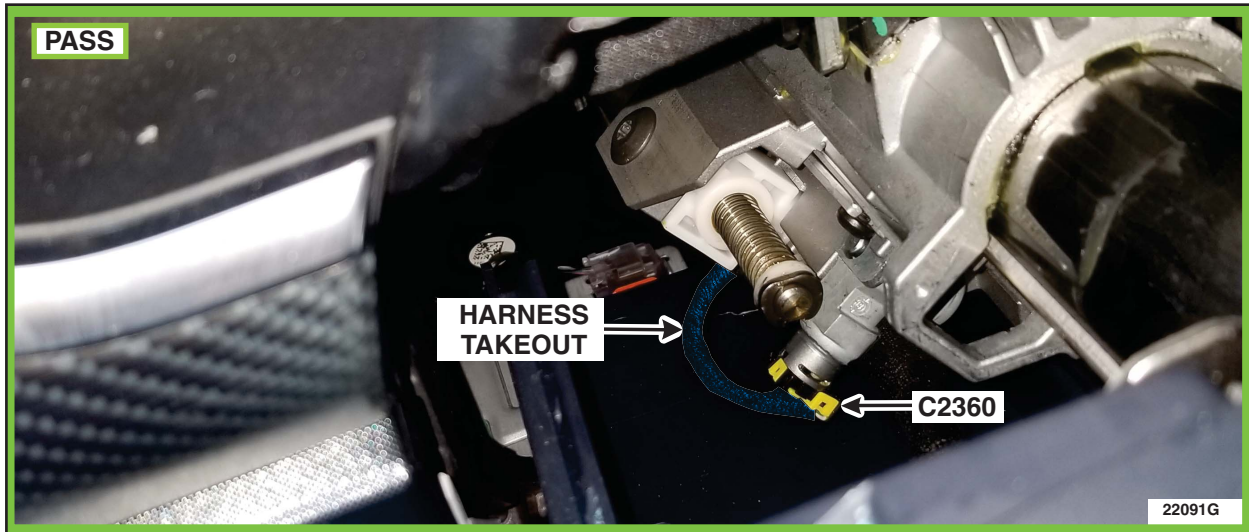
FIGURE 2

3. Lift the gap hider up and inspect the deployable column wiring harness takeout for a tight condition, indicating potential strain on the wires going into the SRS connector C2360, and inspect C2360 for damage. See Figures 2 and 3.

**NOTE:** Deployable column wiring harness takeout and C2360 shown from the side with steering column shrouds off for clarity.

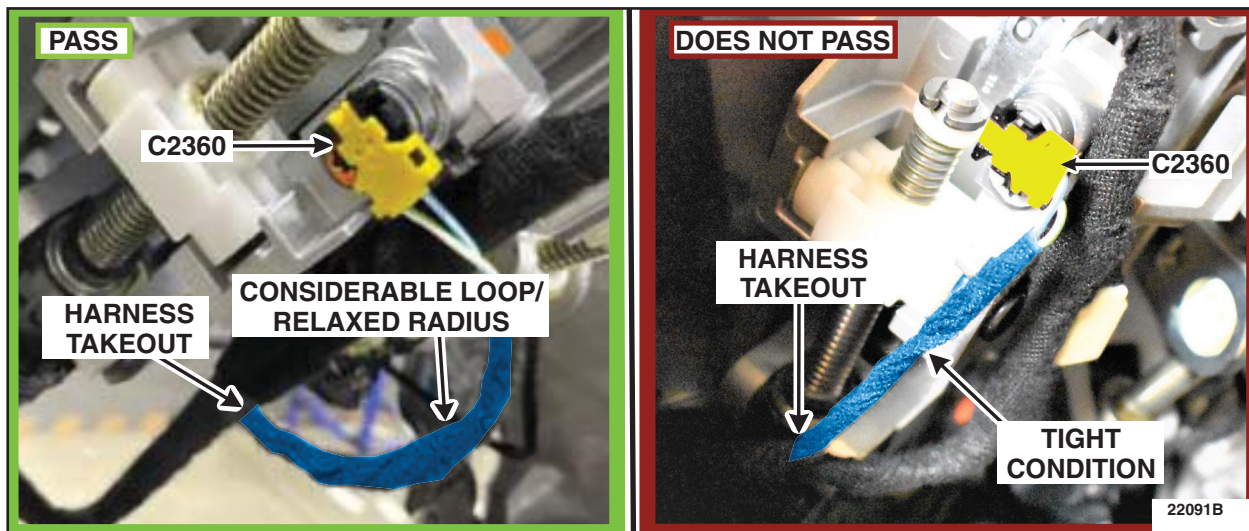
FIGURE 3

- Does the deployable column wiring harness takeout exhibit a tight condition as shown in the 'Does Not Pass' image of Figure 3 or is C2360 visibly damaged?

- Has the deployable column wiring harness takeout developed a tight condition as shown in the 'Does Not Pass' image of Figure 3?

**YES** - Does not pass inspection. Proceed to the **SERVICE PROCEDURE**. (Page 3)

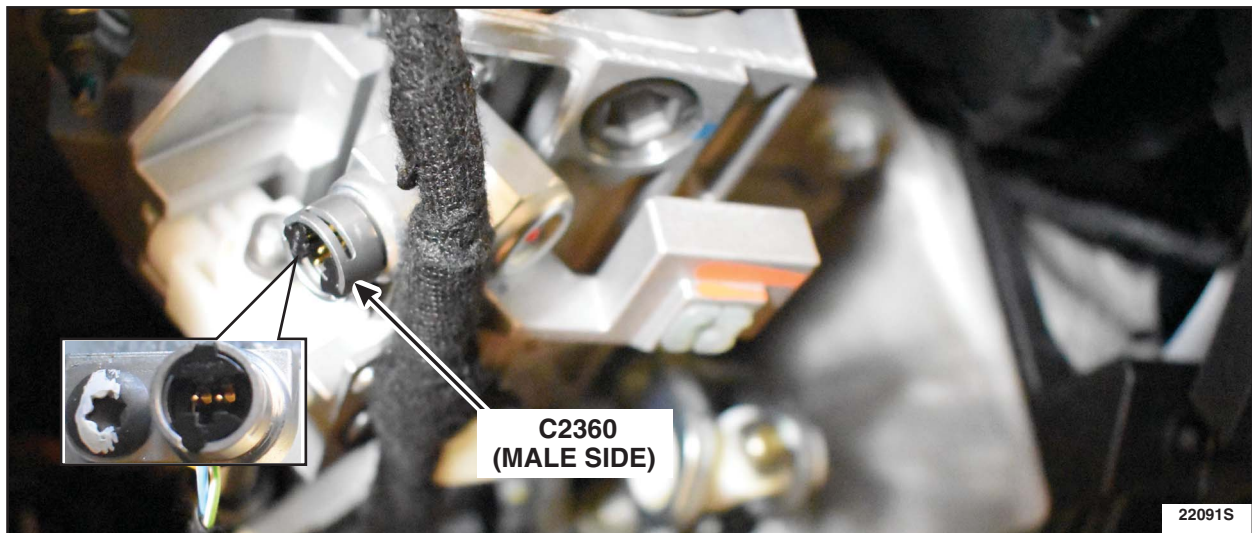
**FIGURE 5**

4. Inspect the male side (steering column side) of C2360 for any sign of damage. See Figure 5.

- Is the male side of C2360 damaged?

**NOTE:** Male side of C2360 shown for clarity. This connector exhibits no signs of damage.

**YES** - Does not pass inspection. Special Service Support Center (SSSC) approval is required for steering column assembly replacement. Capture and submit clear photo(s) to the SSSC showing the damage to the male side of C2360. If approved, the steering column will be replaced later within this procedure. Proceed to Step 5.
