SUBJECT: **NEW VEHICLE DEMONSTRATION / DELIVERY HOLD**
Safety Recall 22S27 - Supplement # 4
 Certain 2020-2022 Model Year Explorer Vehicles
 Rear Axle Bolt Fractures

In some of the affected vehicles, the rear axle mounting bolt may fracture during vehicle acceleration. A fractured rear axle bolt will allow the rear axle housing to move out of position, resulting in severe noise and vibration. If the rear axle bolt breaks, the driveshaft/half shafts may become disconnected, resulting in loss of transmission torque to the rear wheels which is necessary to hold the vehicle in park. If the parking brake is not applied, the loss of the primary park torque will allow the vehicle to roll in park increasing the risk of crash and injury.

CERTAIN 2020 - 2022 MODEL YEAR EXPLORER VEHICLES — EQUIPPED WITH A 3 BOLT DIFFERENTIAL HOUSING PCM REPROGRAMMING

CERTAIN 2020 - 2022 MODEL YEAR EXPLORER VEHICLES — EQUIPPED WITH A 3 BOLT DIFFERENTIAL HOUSING BUSHING REPLACEMENT (POLICE UNITS ONLY)

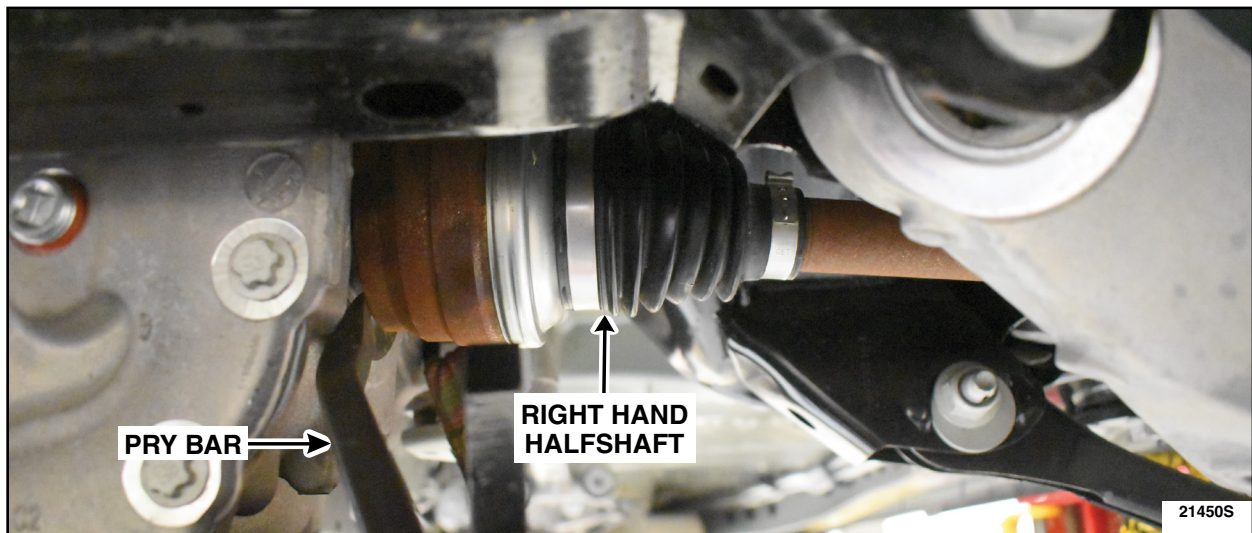
FIGURE 1

4. Using a pry bar, disengage the Right Hand (RH) halfshaft inner halfshaft circlip. See Figure 1.

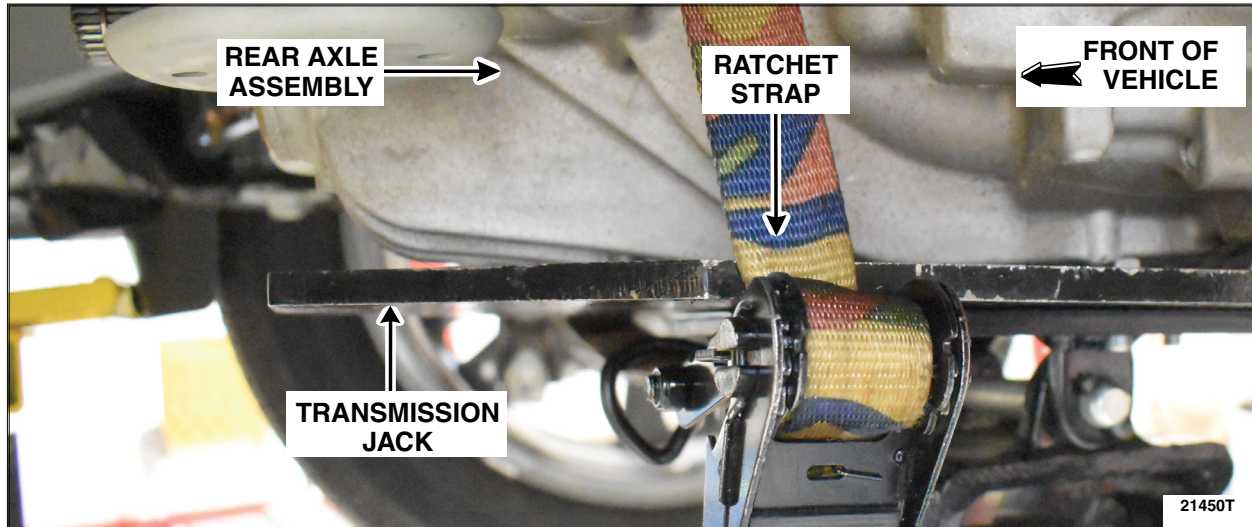
FIGURE 2

5. Secure the rear axle assembly to the transmission jack using a ratchet strap. See Figure 2.

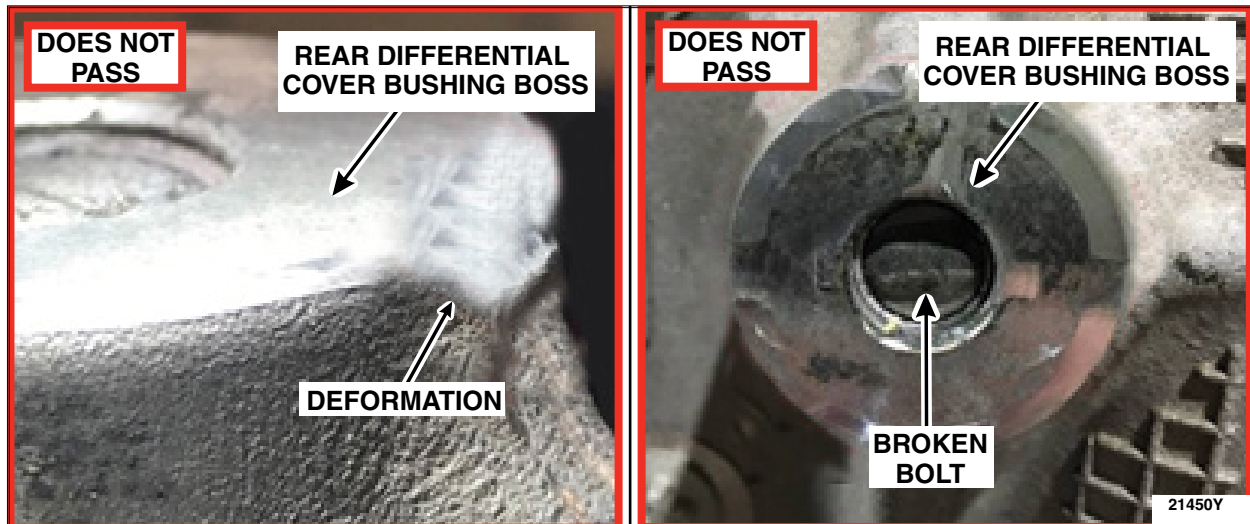
FIGURE 3

7. Visually inspect the rear differential cover bushing boss for damage (broken fastener, scoring, cracks and/or deformation and damaged threads). Is the rear differential cover bushing boss damaged? See Figure 3.

YES - Does not pass inspection. Install a *new* differential housing cover. Please follow the WSM procedures, in Section 205-02. Proceed to Step 10.

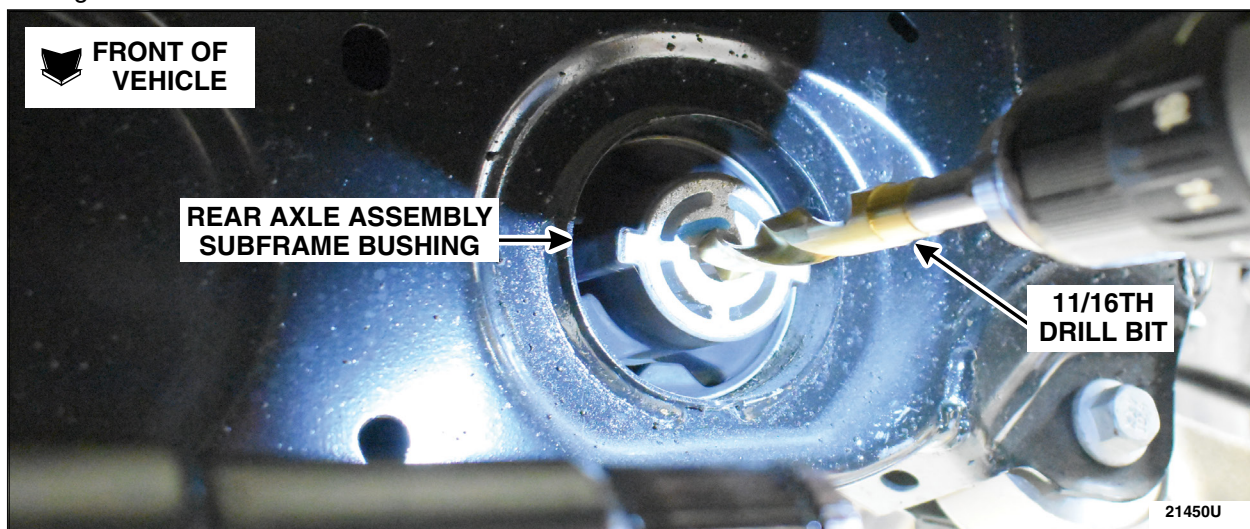
FIGURE 4

10. Using an 11/16th or larger drill bit drill out the rear axle assembly subframe bushing bolt hole. See Figure 4.

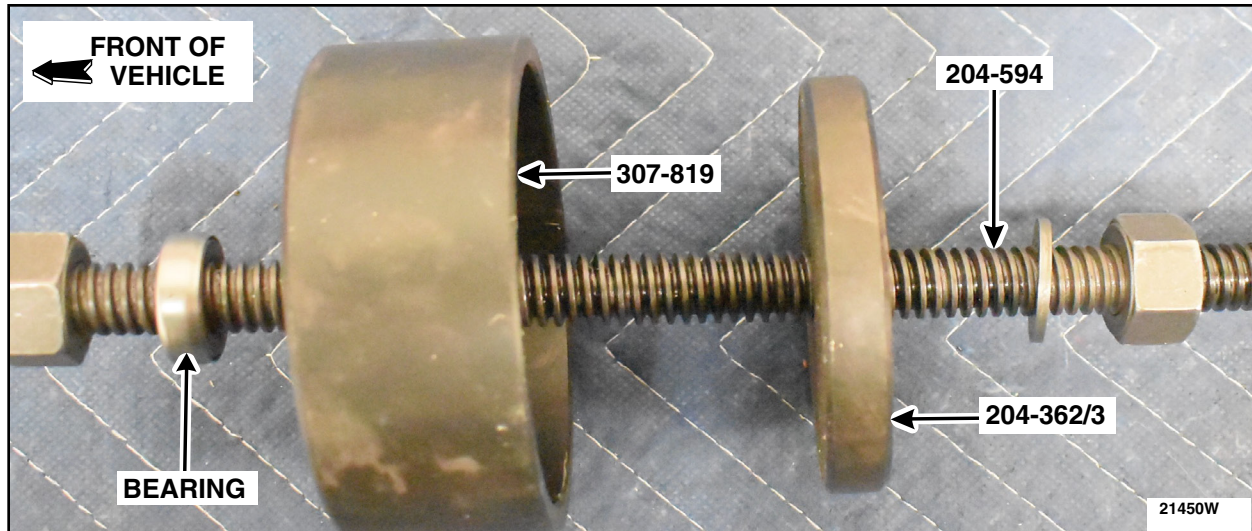
FIGURE 7

NOTE: The bearing, and 307-819 Cup, Receiver go towards the front of the vehicle.

NOTE: The *new* rear axle assembly subframe bushing will be pressed in from the rear of the vehicle.
