David J. Johnson
 Director
 Service Engineering Operations
 Ford Customer Service Division

September 23, 2022

SUBJECT: **NEW VEHICLE DEMONSTRATION / DELIVERY HOLD**
Safety Recall 22S27 - Supplement #3
 Certain 2020-2022 Model Year Explorer Vehicles
 Rear Axle Bolt Fractures

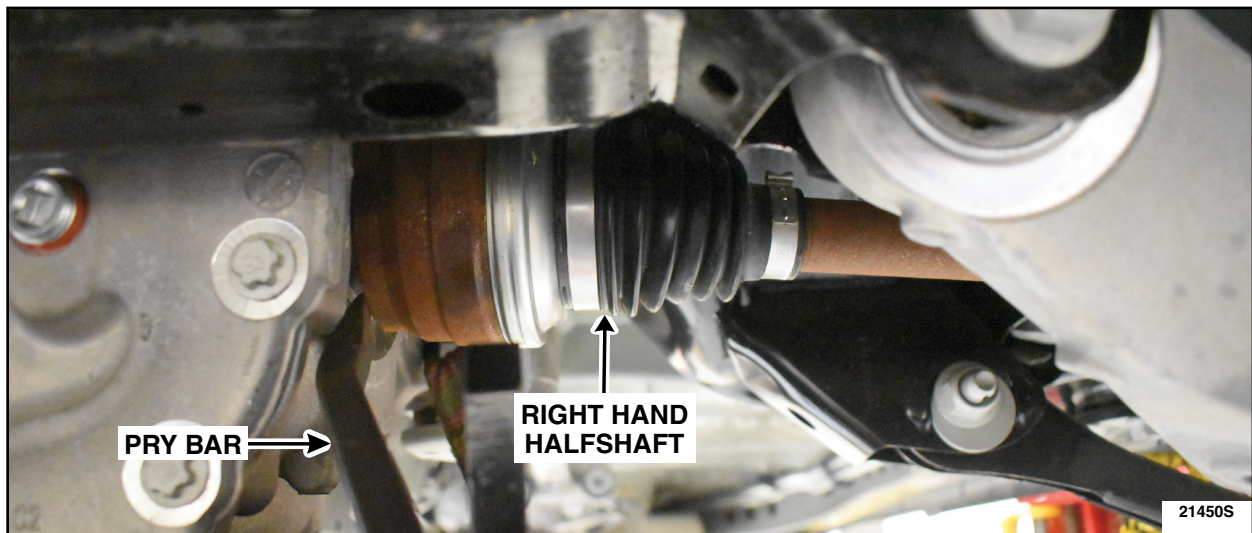
FIGURE 1

4. Using a pry bar, disengage the Right Hand (RH) halfshaft inner halfshaft circlip. See Figure 1.

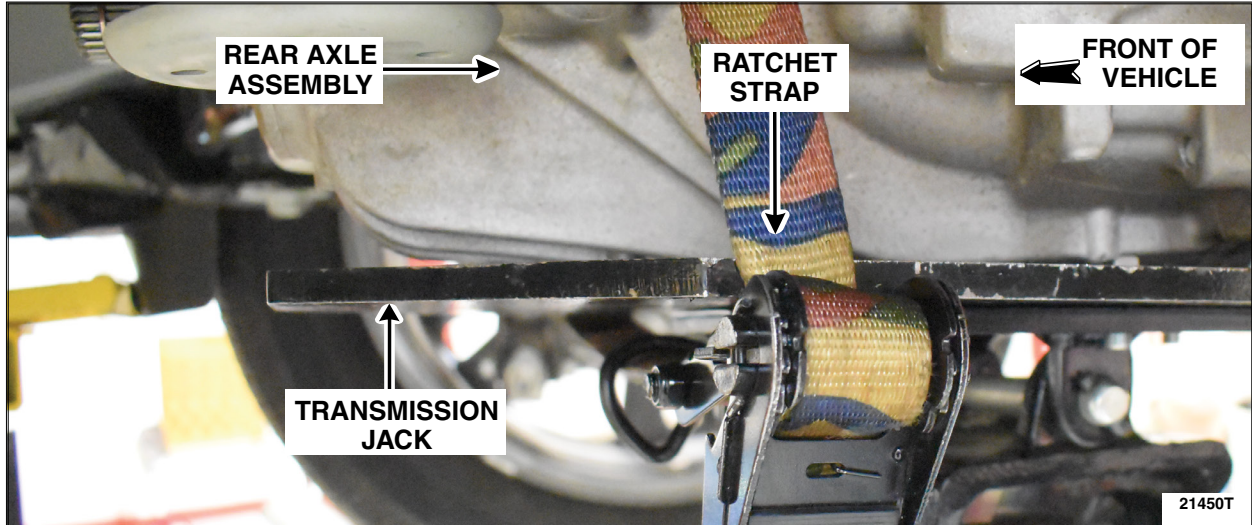
FIGURE 2

5. Secure the rear axle assembly to the transmission jack using a ratchet strap. See Figure 2.

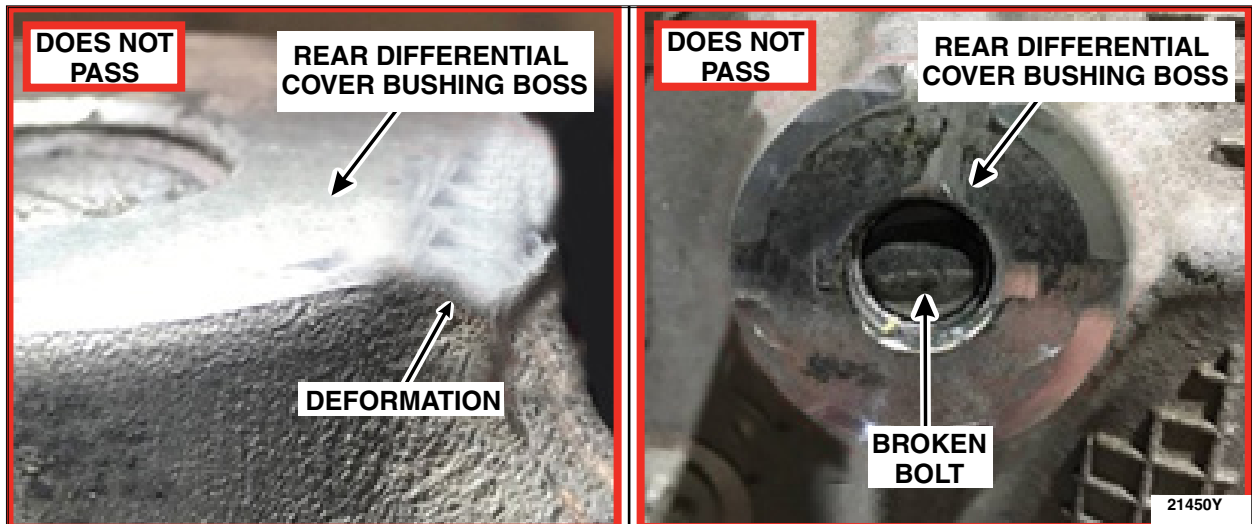
FIGURE 3

7. Visually inspect the rear differential cover bushing boss for damage (broken fastener, scoring, cracks and/or deformation and damaged threads). Is the rear differential cover bushing boss damaged? See Figure 3.

YES - Does not pass inspection. Install a *new* differential housing cover. Please follow the WSM procedures, in Section 205-02. Proceed to Step 10.

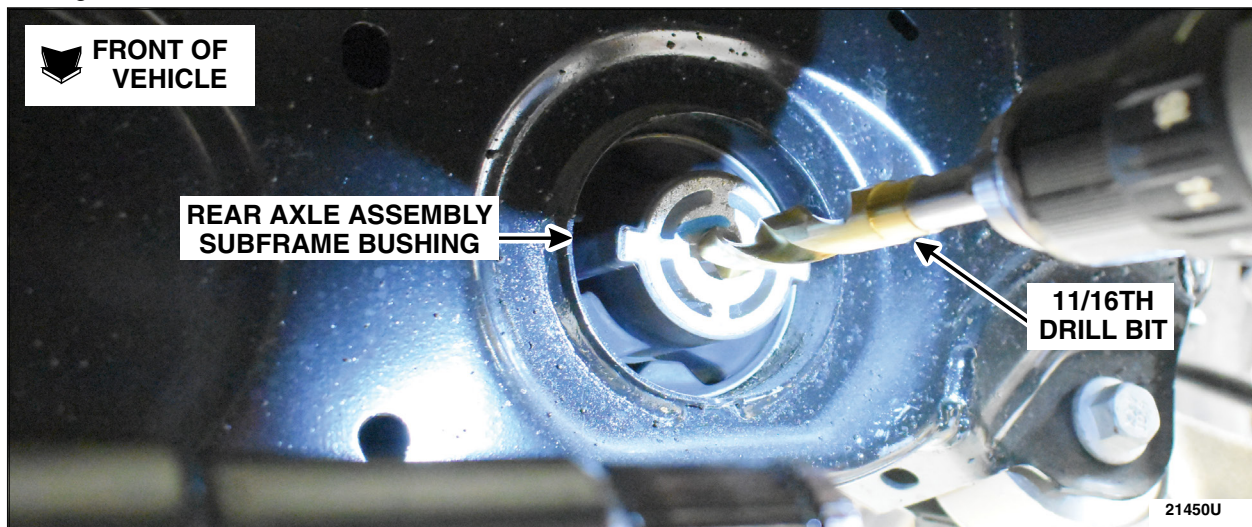
FIGURE 4

10. Using an 11/16th or larger drill bit drill out the rear axle assembly subframe bushing bolt hole. See Figure 4.

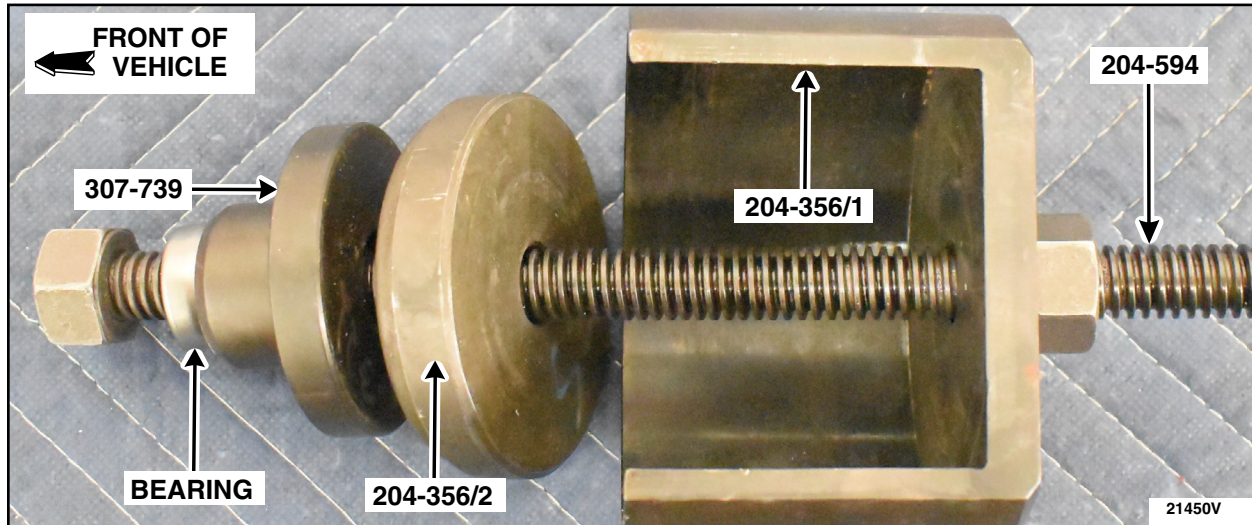
FIGURE 5

NOTE: The rear axle assembly subframe bushing will be pressed out towards the rear of the vehicle.

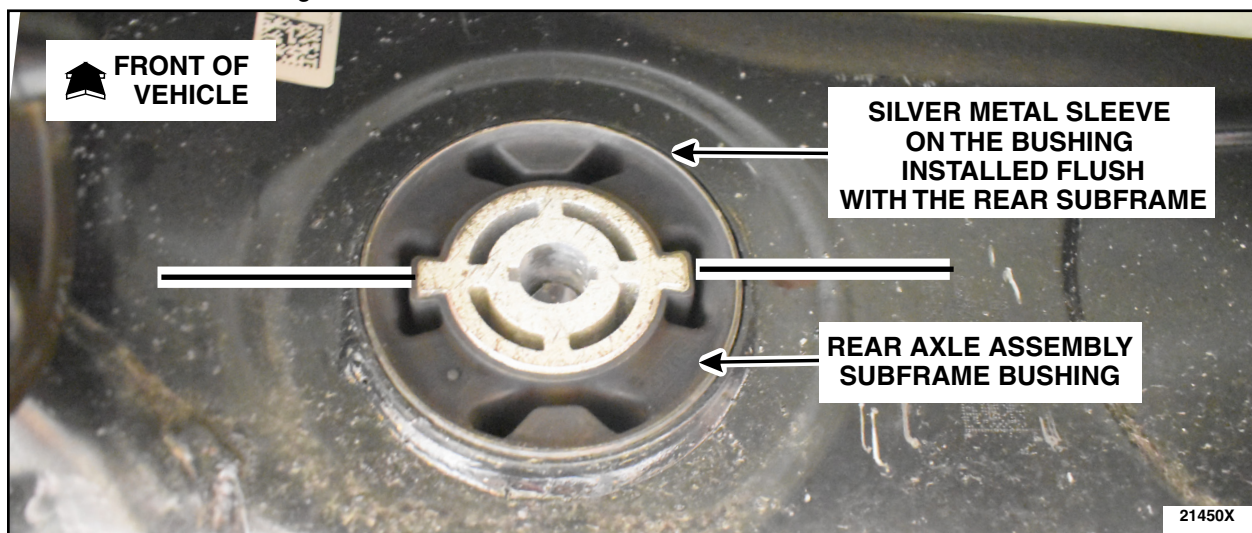
FIGURE 6

NOTE: Make sure the tabs on the *new* rear axle assembly subframe bushing are horizontal with the subframe. See Figure 6.

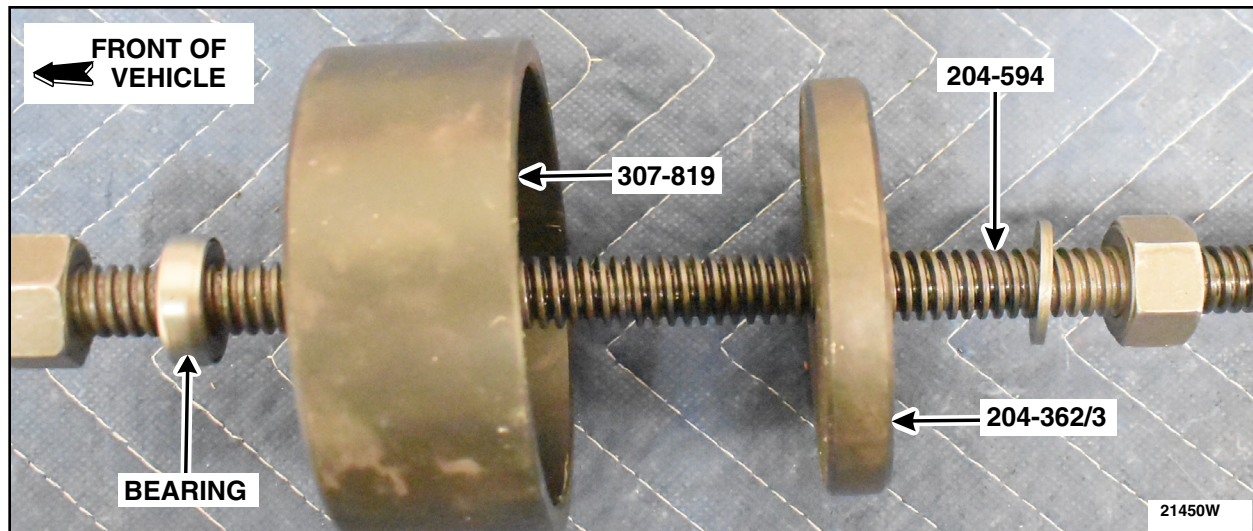
FIGURE 7

NOTE: The *new* rear axle assembly subframe bushing will be pressed in from the rear of the vehicle.
