Recall Campaign Bulletin

Campaign No. 2022050005, May 2022

SUBJECT: **Model GLC-Class (253 platform)**
Model Year 2021

Check Headlight Electrical Connections

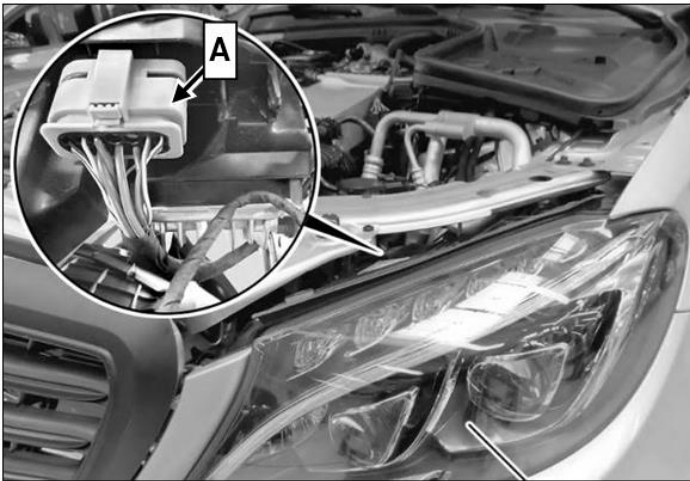
Figure 1

1. Open hood.
2. Check whether the blind plugs are present and installed correctly at the left and right front headlight assemblies on the electrical connector **(A, Figure 1)**.
 - i** Use a mirror to check the electrical connectors on the installed headlight assemblies.
 - i** **Figure 2** shows an OK image.
 - i** **Figure 3** shows a not OK image in which one blind plug is missing.
 - i** **Figure 4** shows a not OK image in which one blind plug was not installed correctly.
 - i** The blind plugs must be at least flush with the electrical connector (housing).

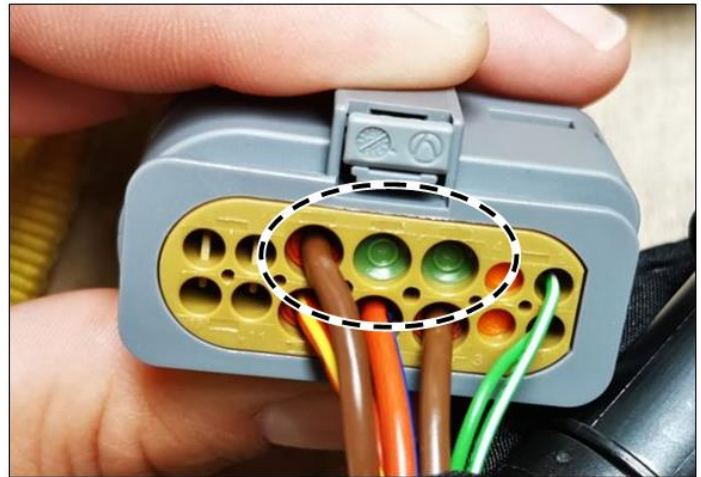
Figure 2 (OK image)

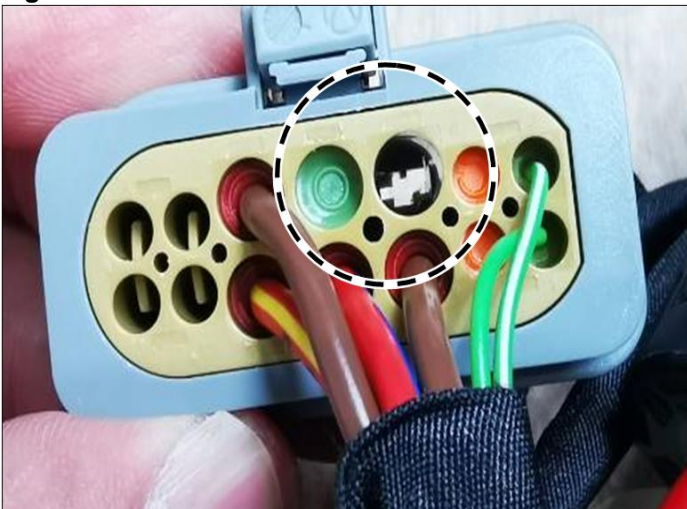
Figure 3 (not OK image)

- a. Electrical connector **not** OK: Carry out **check/test procedure B**.
- b. Electrical connector **OK**: **End measure**.

1. Retrofit or correct blind plug on electrical connector.
i For basic data, see AR00.19-P-0100A.
2. Assemble in reverse order.

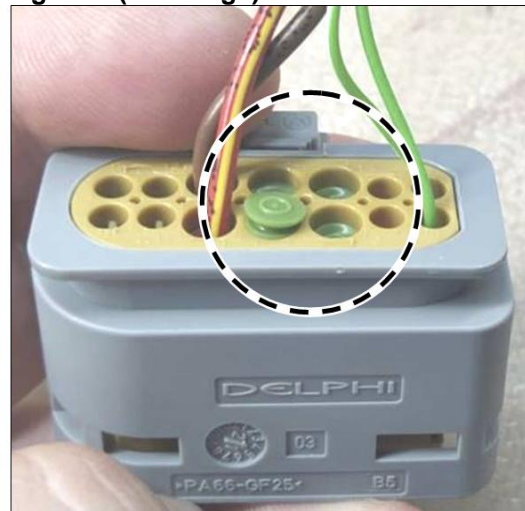
Figure 4 (not OK image)
