RECALL

R22BU: Gasoline Supply Line Rubbing Condition on Ford 7.3L

Models Affected: Certain model year 2022 and 2023 Blue Bird Visions, equipped with the 7.3L gasoline engine and 100-gallon fuel tank.

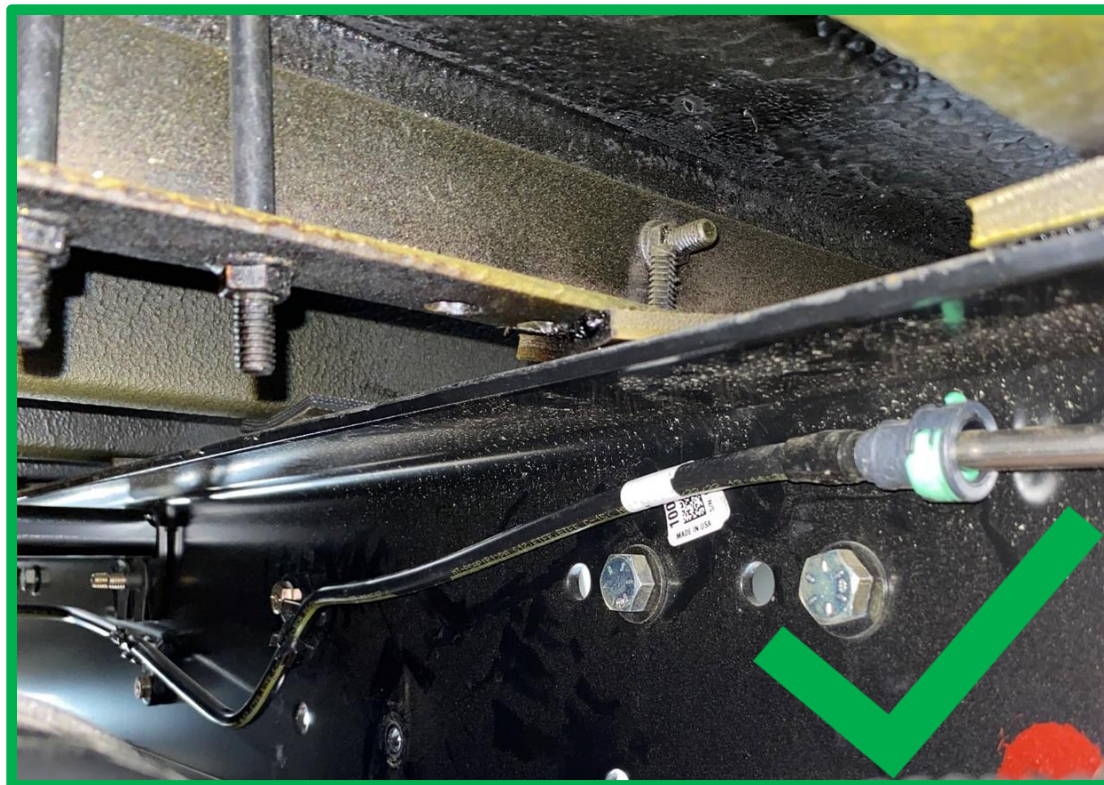
FIGURE 1

Issue: Improper routing and securement of the fuel line could cause unintended contact with certain fasteners on the chassis and cause a potential fuel leak.

Corrective Action: Inspect the fuel supply line for proper routing and determine if further action(s) are necessary. Possible corrective actions are relocating clamp position and/or replacement of the fuel supply line. Reference Figures 1-4 for proper routing and securement.

- **Repair A – Inspection Only** - Inspection finds no physical damage to the fuel line, and is routed properly, per Figure 1
 - No action required
- **Repair B – Inspect and Re-route** - Inspection finds no physical damage to the gasoline fuel pressure line, but it is routed improperly
