June 2022
FL930AB
NHTSA #22V-299

Subject: Western Star Brake Caliper Mounting Bolts

Models Affected: Specific model years 2022-2023 Western Star 47X and 49X vehicles manufactured December 6, 2021, through February 9, 2022.

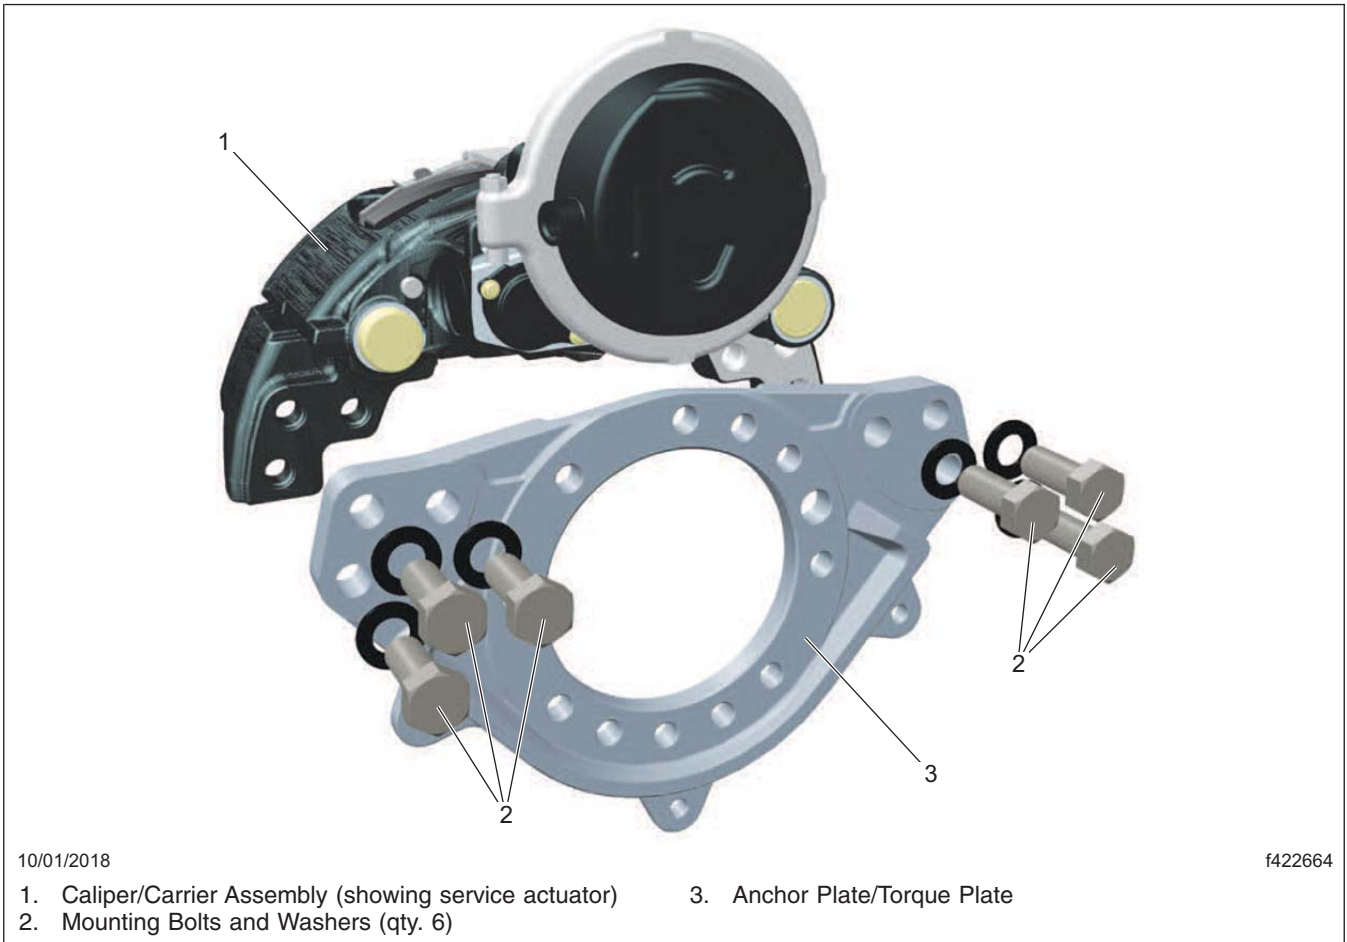
Fig. 2, Bendix Axial Mounted Caliper

NOTE: The Meritor axial mounted caliper is similar to the Bendix axial mounted caliper shown in [Fig. 2](#).

9. Align the caliper/carrier assembly with the rotor by pushing the caliper against the shelf on the torque plate, then install the caliper/carrier assembly using new caliper mounting bolts. See [Fig. 2](#).
10. Tighten the carrier mounting bolts in two steps as follows.
 - 10.1 Start on one side of the caliper and tighten all three bolts 20 to 60 lbf-ft (27 to 81 N·m), beginning with the inner-most bolt and moving to the outer-most bolt. Then tighten the three bolts on the other side of the caliper 20 to 60 lbf-ft (27 to 81 N·m), beginning with the inner-most bolt and moving to the outer-most bolt. See [Fig. 3](#).
 - 10.2 Repeat this process, increasing the torque value to 350 to 400 lbf-ft (475 to 542 N·m). If tool DDC DSNCHA018005 referenced in tool letter 18TL18 is used, see [Table 5](#) for torque specifications.
