TO: Mercedes-Benz Dealer Principals, General Managers, Sales Managers, Service Managers, Parts Managers	FROM: Gregory Gunther, Department Manager, Vehicle Compliance and Analysis, Engineering Services
RE: Updated Recall Campaign Launch Notification STOP DRIVE Inspect and Replace Brake Booster with Pedal Rework MY06-12 GL-Class, ML-Class, R-Class (X164, W164, V251 platform)	UPDATE: March 24, 2023

Campaign No. 2022050014, May 2022

SUBJECT: **Model GL-Class, ML-Class, and R-Class (X164, W164 and 251 platform)
Model Year 2007-2008**

Inspect Brake Booster – with Pedal Rework

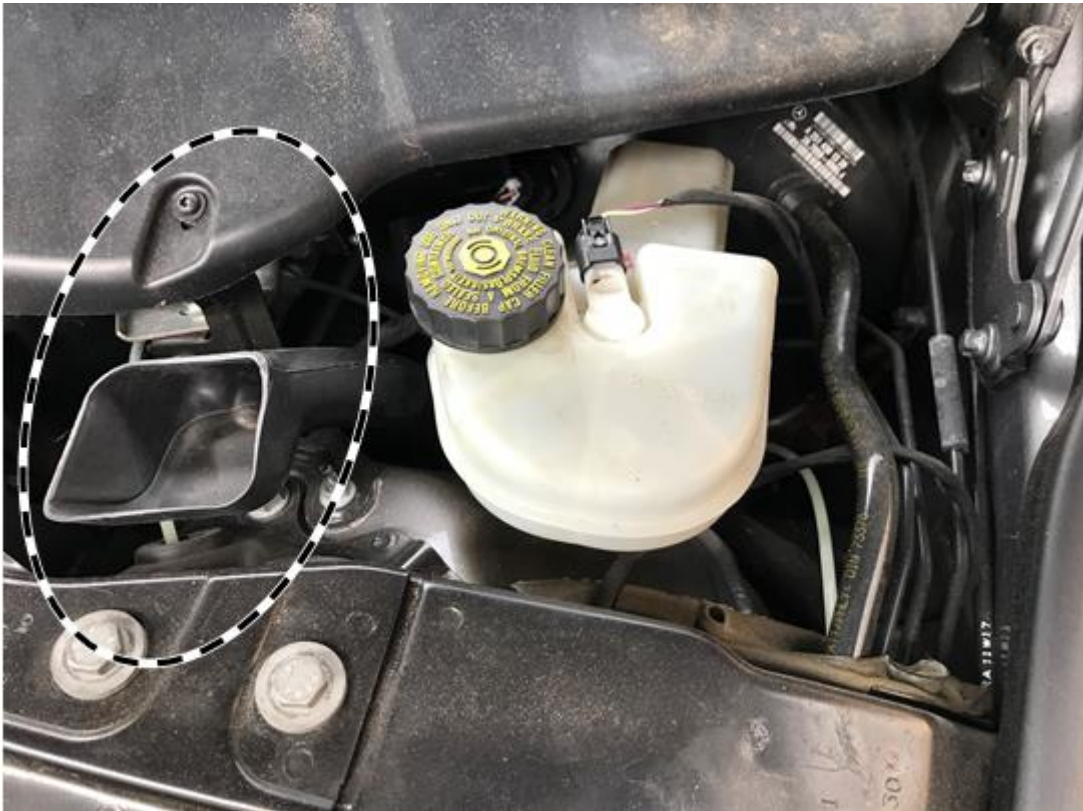
Figure 1

1. Open the hood and check the water drains (**marking, Figure 1**) for correct installation and ability to drain.

i Clean and correctly install water drains if necessary.

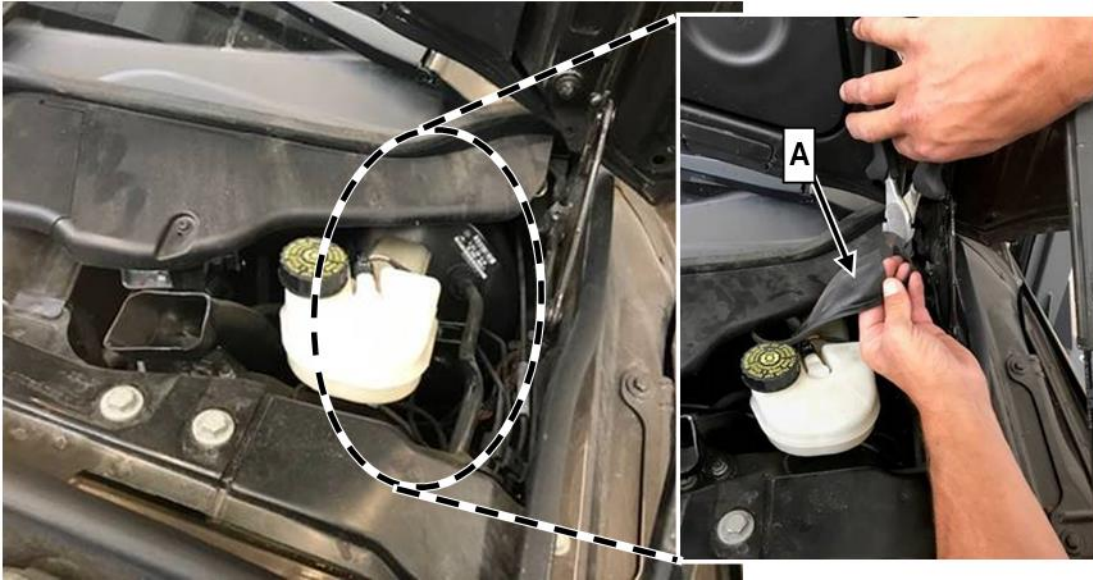
Figure 2

2. Remove the rubber sleeve wrapped around the brake booster (A, Figure 2) with a suitable tool (hook and side cutting pliers).

i The rubber sleeve should be separated above the barcode label on the brake booster as seen in (A, Figure 2).

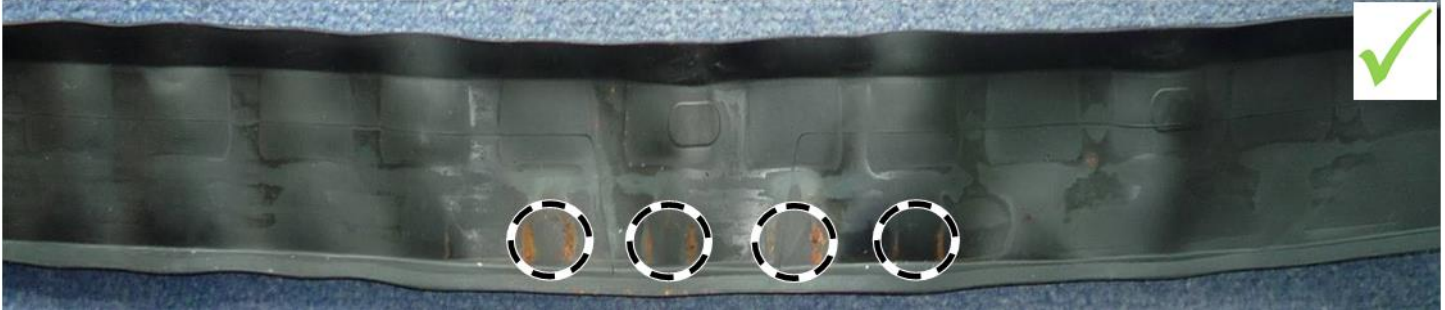
Figure 5 (OK)

Multiple point-shaped corrosion marks (Figure 5) are permissible.

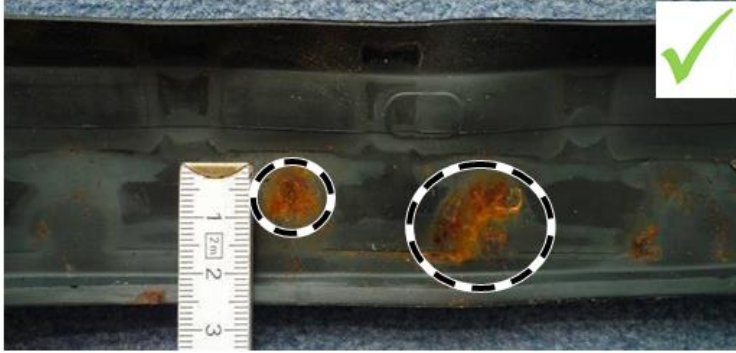
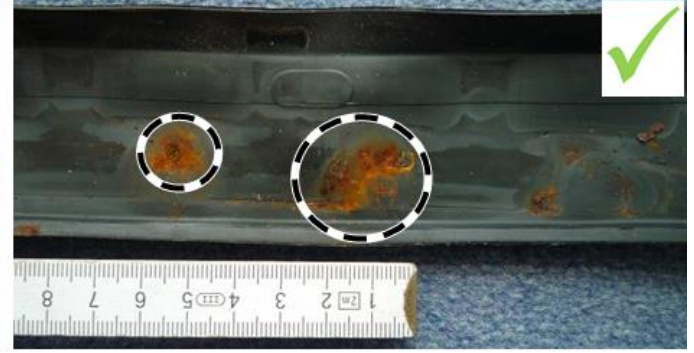
A maximum of **one point-shaped corrosion mark** with a diameter **greater than 15 mm** (Figures 6 and 7) is permitted.

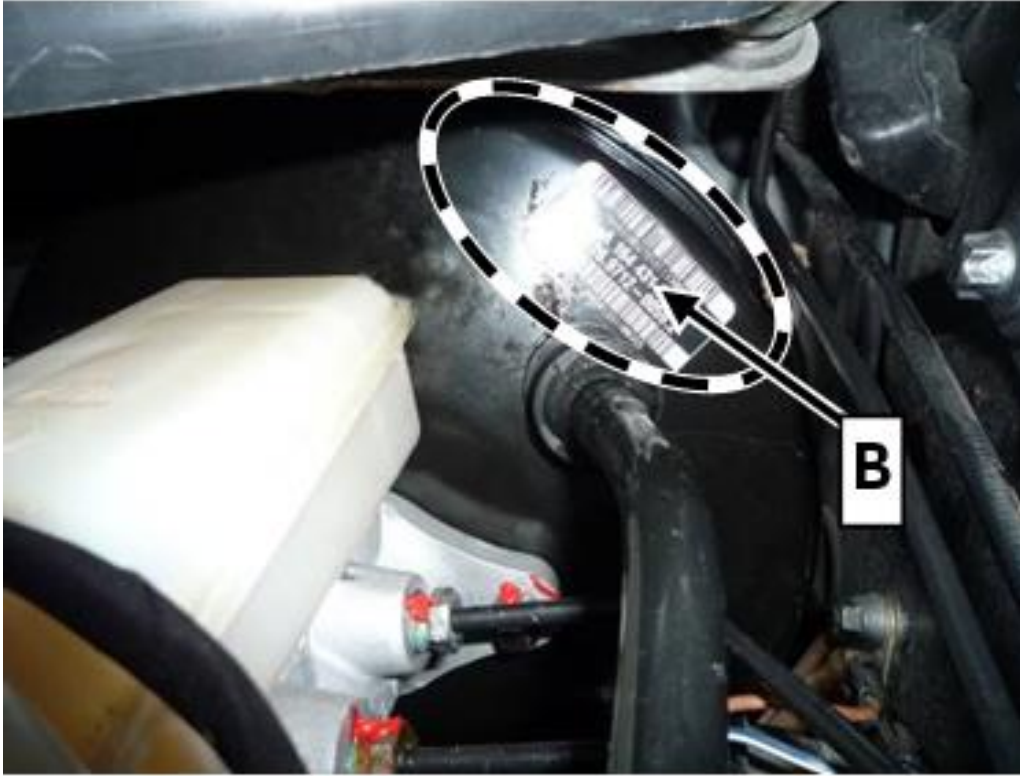
Figure 8

1. Take a photo of the barcode label (B, Figure 8) on the brake booster and store to a local HDD/computer storage location with the vehicle service file and attach to the warranty claim in EVA.

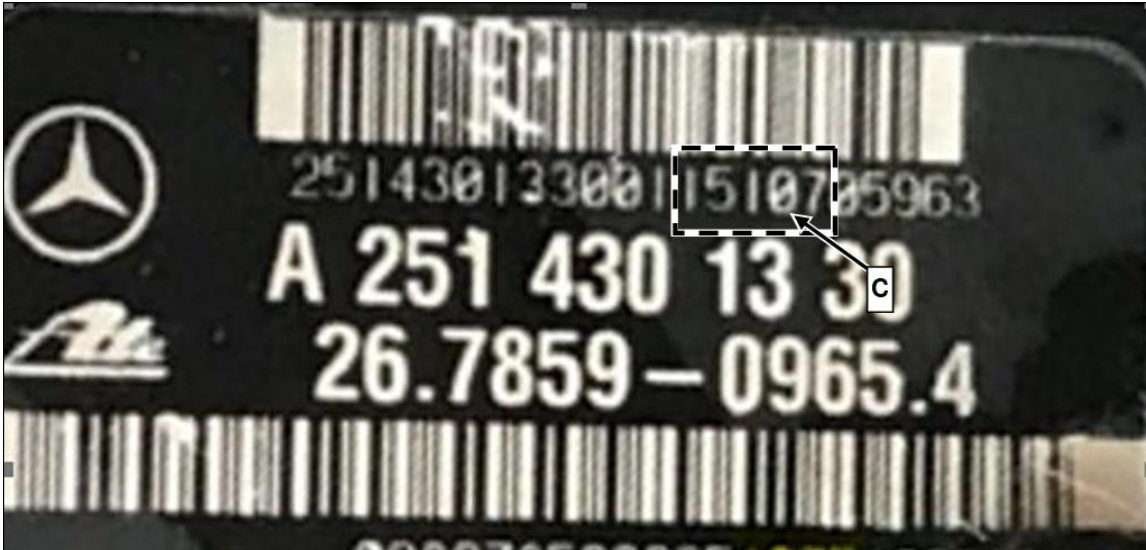
Figure 9

2. Check sequence of numbers on the barcode label (**C**, Figure 9).

- a. If the numeric sequence between the 13th and 17th digits are **less than** "15126": Carry out **work procedure below**.
- b. If the numeric sequence between the 13th and 17th digits are **greater than or equal to** "15126": **End measure**.
