IMPORTANT RECALL CAMPAIGN UPDATE

Recall Campaign Launch Notification			March 10, 2023
Campaign No. :	NHTSA ID	Campaign Desc. :	Inspect Brake Booster Without Pedal Rework
2022050014	22V315	22P4290006	
<p>This is to notify you of an update to the Recall Campaign Launch to inspect the brake booster on 14,123 Model Year (“MY”) 2006-2012 GL-Class, ML-Class, and R-Class (X164, W164 and V251 platform) vehicles. The recall campaign will be visible on the www.safercar.gov website and may generate questions from customers. Affected VINs were flagged in VMI as “OPEN” on May 28, 2022.</p>			
Background			
Issue	<p>Mercedes-Benz AG (“MBAG”), the manufacturer of Mercedes-Benz vehicles, has determined that on certain Model Year (“MY”) 2006-2012 ML-Class, GL-Class (W164/X164 platform) and R-Class (V251 platform) vehicles, the function of the brake booster might be affected due to advanced corrosion in the joint area of its housing. After extended time in the field and in conjunction with prolonged water exposure, this corrosion might lead to a vacuum leak at the brake booster. If this were to occur, the brake force support might be reduced, leading to an increase in the brake pedal forces require

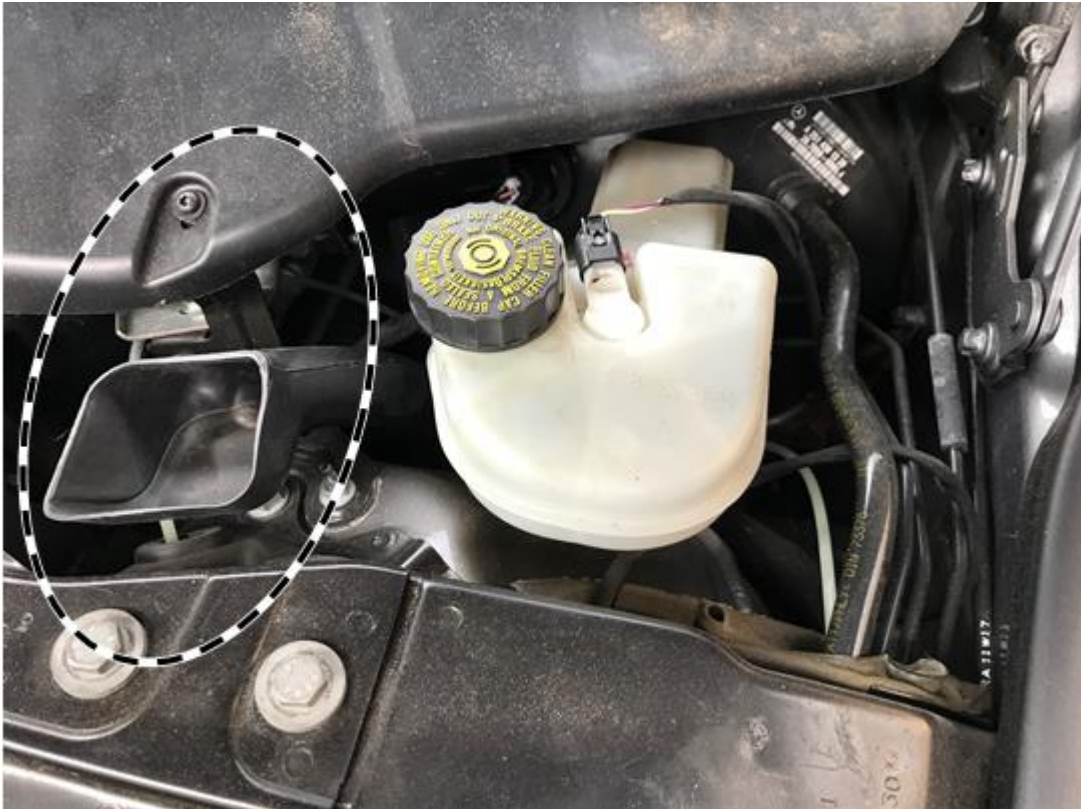
Figure 1

1. Open the hood and check the water drains (**marking, figure 1**) for correct installation and ability to drain.

i Clean and correctly install water drains if necessary.

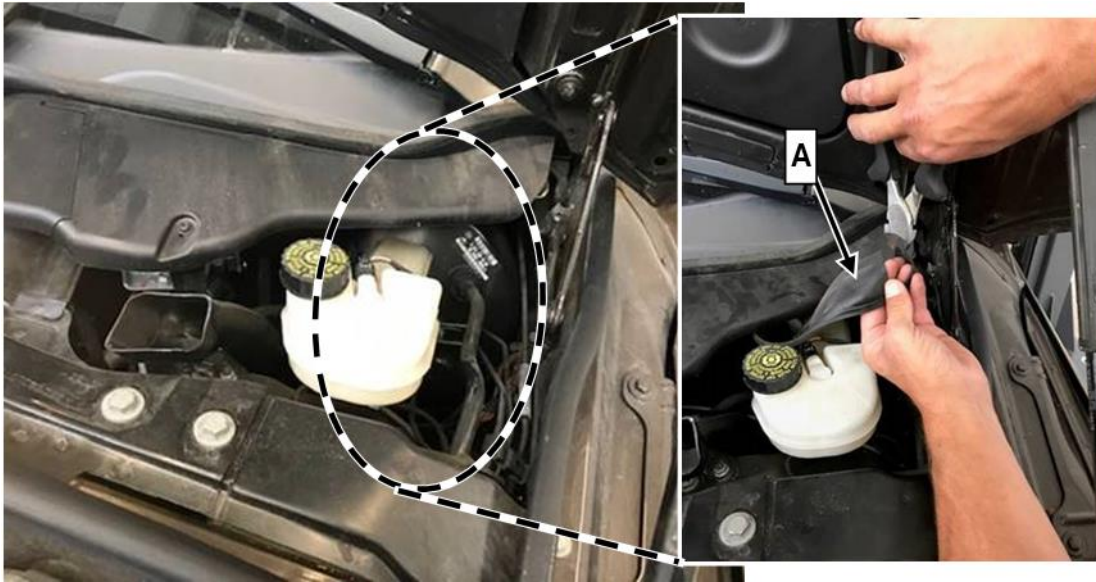
Figure 2

2. Remove the rubber sleeve wrapped around the brake booster (**A, figure 2**) with a suitable tool (hook and side cutting pliers). If the rubber sleeve is not present, please proceed to check/test procedure **A1**.
i The rubber sleeve should be separated above the barcode label on the brake booster as seen in (**A, figure 2** and **B, figure 4.1**).

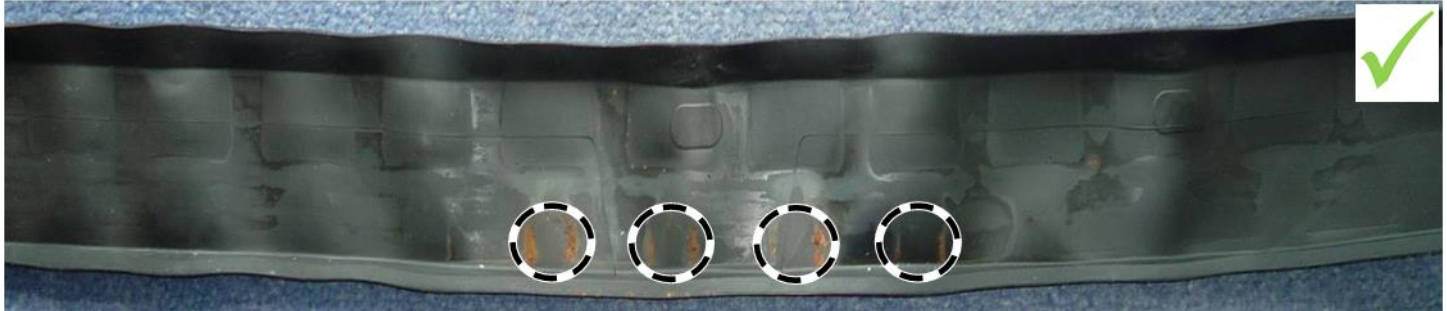
Figure 5 OK

Multiple point-shaped corrosion marks (**figure 5**) are permissible.

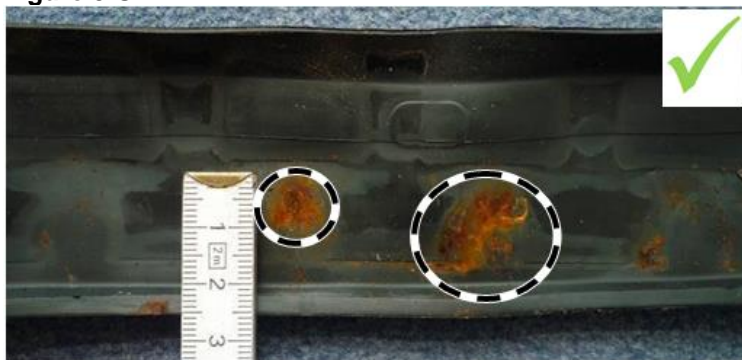
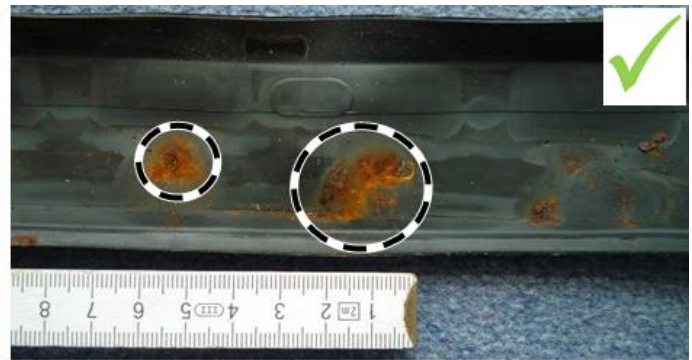
A maximum of **one point-shaped corrosion mark** with a diameter **greater than 15 mm** (**figures 6 and 7**) is permitted.

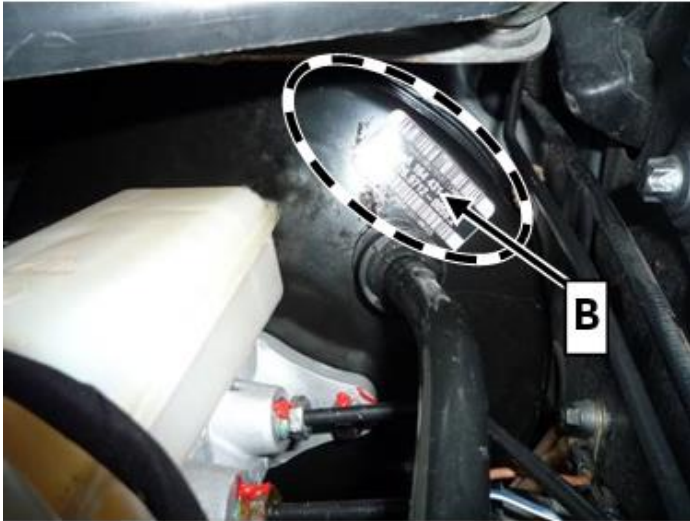
Figure 8

1. Take a photo of the barcode label (B, figure 8) on the brake booster and store to a local HDD/computer storage location with the vehicle service file and attach to the warranty claim in EVA.

i If the measure is ended, **do not** re-install a new rubber sleeve. Apply marking with **white touch-up paint pen** (**1, figure 8**) to the brake booster checked.
