TO: Mercedes-Benz Dealer Principals, General Managers, Sales Managers, Service Managers, Parts Managers	FROM: Gregory Gunther, Department Manager, Vehicle Compliance and Analysis, Engineering Services
RE: Updated Recall Campaign Launch Notification – STOP DRIVE Inspect Brake Booster with Pedal Rework MY07-08 GL-Class, ML-Class, R-Class (X164, W164, 251 platform)	UPDATE: June 3, 2022

Campaign No. 2022050014, May 2022

SUBJECT: **Model GL-Class, ML-Class, and R-Class (X164, W164 and 251 platform)
Model Year 2007-2008**

Inspect Brake Booster – with Pedal Rework

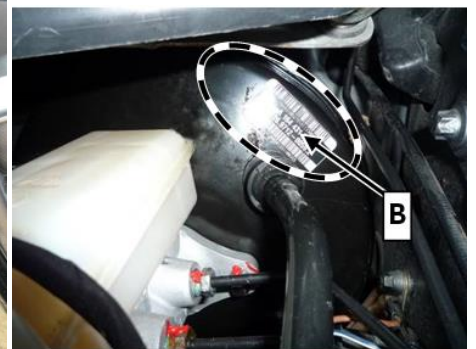
Figure 4.1

i The rubber sleeve should be separated above the barcode label on the brake booster as seen in (A, figure 2 and B, figure 4.1).

i If the rubber sleeve on the brake booster is **not** present, please take a photo of the barcode label (**B, figure 4.1**) on the brake booster and store to a local HDD/computer storage location with the vehicle service file and attach to the warranty claim in EVA. Then continue with **check/test procedure A1**.

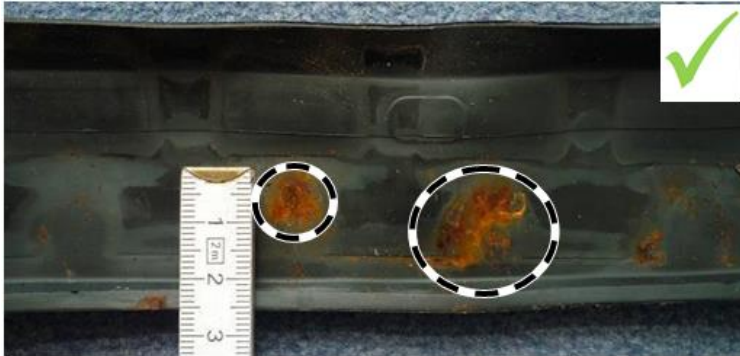
Figure 6 Ok

A maximum of **one point-shaped corrosion mark** with a diameter **greater than 15 mm** (**figures 6 and 7**) is permitted.

- a. Corrosion measurements **Exceeds thresholds-NOK**: Carry out **check/test procedure B - XENTRY/DAS**.
- b. Corrosion measurements **Does not exceed threshold-OK** (figure 5, 6 or 7): **End measure**.
(**Certificate of Passed Initial Diagnostic Brake Test not required**).

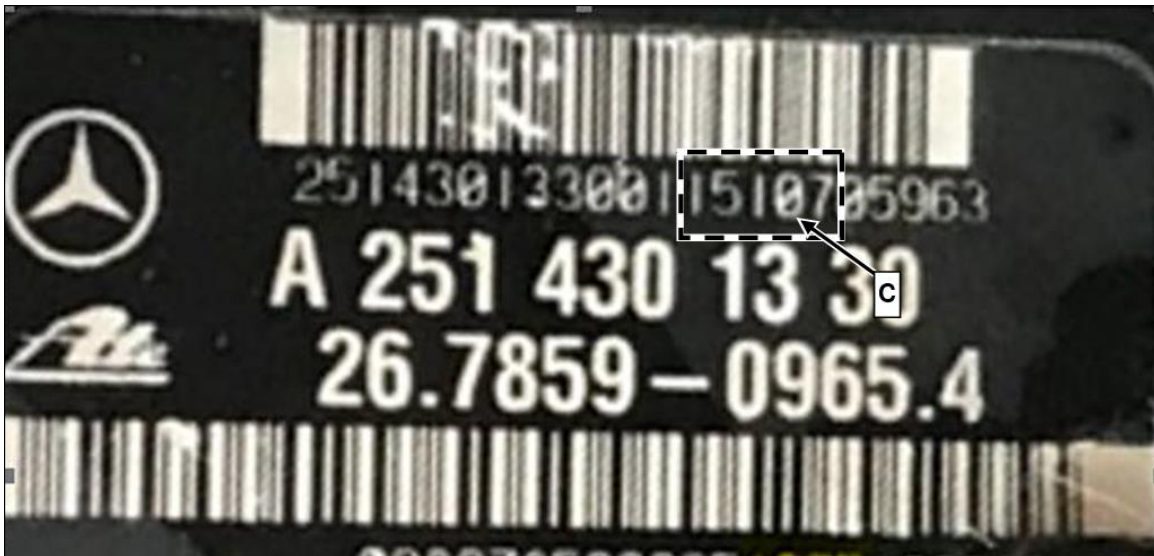
Figure 4.2

1. Check sequence of numbers on the barcode label (**C, figure 4.2**).

- a. IF the sequence of numbers is **less than** "15126" starting from the 13th number: Perform **check/test procedure B - XENTRY/DAS**.
- b. If the sequence of numbers is **greater than or equal to** "15126" starting from the 13th number: **End the measure**.
