| RE: Updated Recall Campaign Launch Notification STOP DRIVE Inspect and Replace Brake Booster without Pedal Rework MY06-12 GL-Class, ML-Class, R-Class (X164, W164, V251 platform) | UPDATE: March 24, 2023 |

| Recall Campaign Launch Notification | | | March 24, 2023 |
|--|---|---|---|
| Campaign No. : | NHTSA ID | Campaign Desc. : | Inspect and Replace Brake Booster Without Pedal Rework |

Recall Campaign Bulletin

Inspect Brake Booster – without Pedal Rework

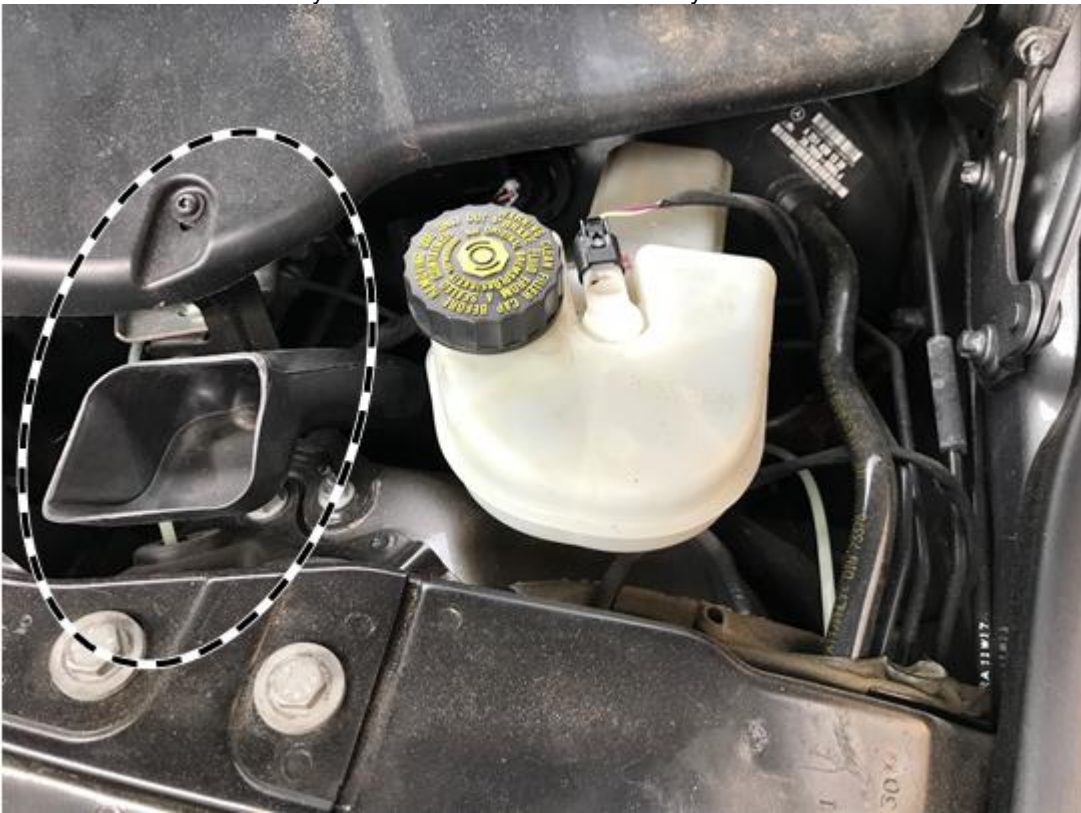
Figure 1

1. Open the hood and check the water drains (**marking, Figure 1**) for correct installation and ability to drain.
 - i** Only for model 251
 - i** Clean and correctly install water drains if necessary.

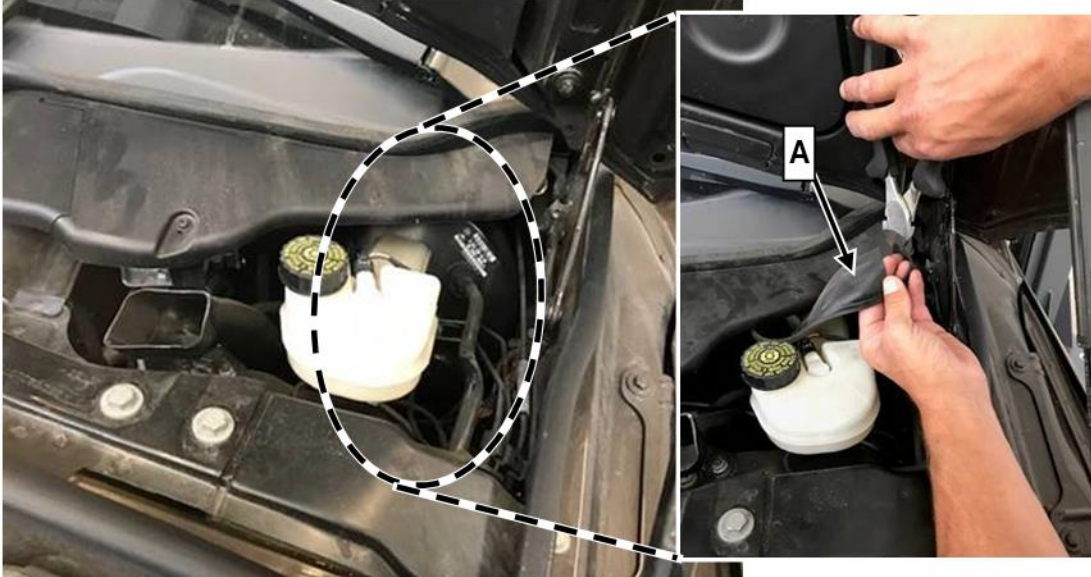
Figure 2

2. Remove the rubber sleeve wrapped around the brake booster (**A, Figure 2**) with a suitable tool (hook and side cutting pliers).
 - i** If the rubber sleeve on the brake booster is missing or **not** present, then continue with **check/test procedure A1**.
 - i** The rubber sleeve should be separated above the barcode label on the brake booster as seen in (**A, Figure 2**).

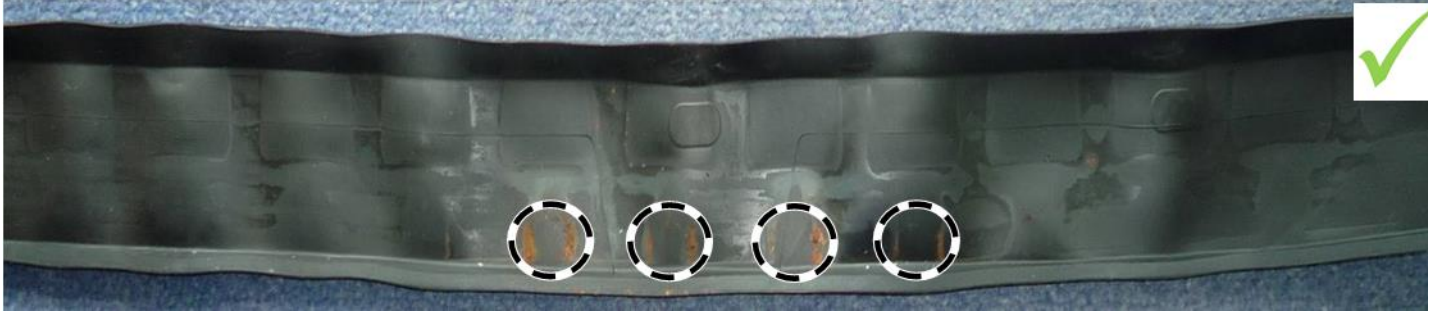
Figure 5 (OK)

Multiple point-shaped corrosion marks (Figure 5) are permissible.

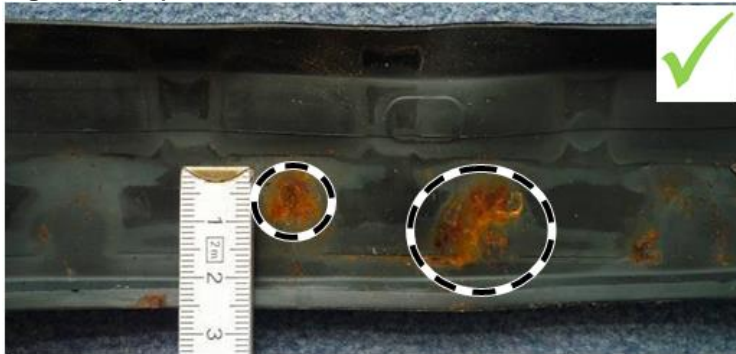
Figure 6 (OK)

A maximum of **one point-shaped corrosion mark** with a diameter **greater than 15 mm** (Figures 6 and 7) is permitted.

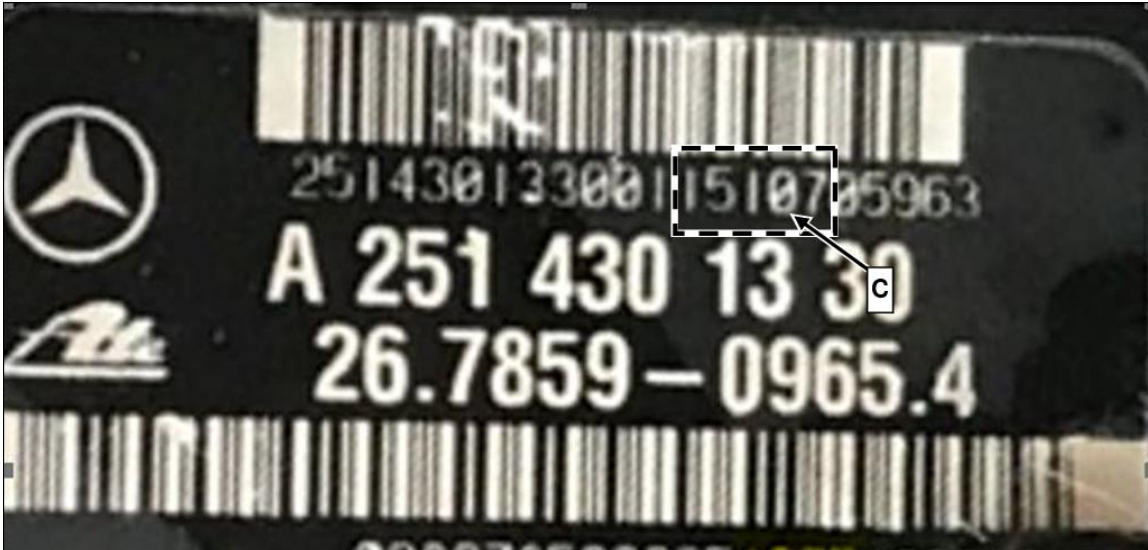
Figure 9

2. Check sequence of numbers on the barcode label (**C**, Figure 9).
 - a. If the numeric sequence between the 13th and 17th digits are **less than** "15126": Carry out **work procedure below**.
 - b. If the numeric sequence between the 13th and 17th digits are **greater than or equal to** "15126": **End measure**.
