TO: Mercedes-Benz Dealer Principals, General Managers, Sales Managers, Service Managers, Parts Managers	FROM: Gregory Gunther, Department Manager, Vehicle Compliance and Analysis, Engineering Services
RE: <b>Updated Recall Campaign Launch Notification – STOP DRIVE</b> <b>Inspect Brake Booster without Pedal Rework MY06-12 GL-Class, ML-Class, R-Class (X164, W164, V251 platform)</b>	UPDATE: March 10, 2023

Campaign No. 2022050015, May 2022

SUBJECT: **Model GL-Class, ML-Class, and R-Class (X164, W164 and 251 platform)  
Model Year 2006-2012**

## **Inspect Brake Booster – without Pedal Rework**

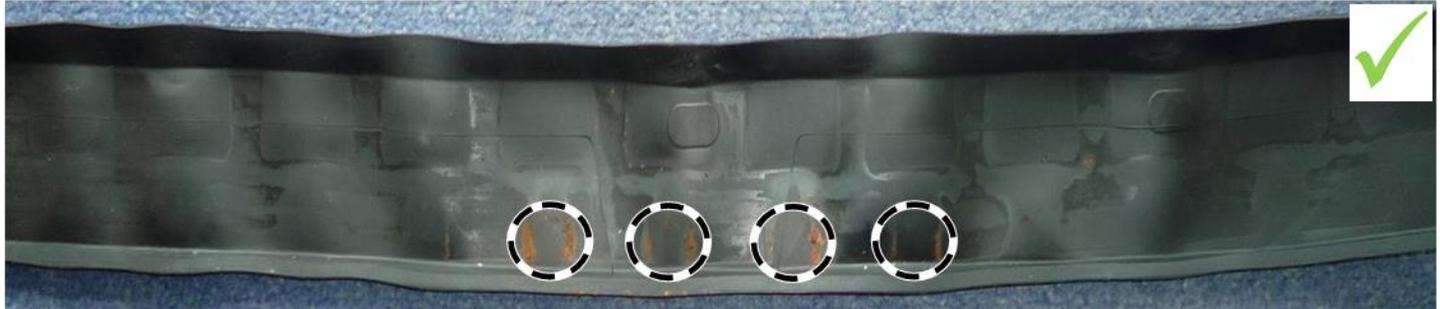
Figure 5 OK

Multiple point-shaped corrosion marks (**figure 5**) are permissible.

- Corrosion measurements **Exceeds thresholds-NOK**: Carry out **check/test procedure B - XENTRY/DAS**.
- Corrosion measurements **Does not exceed threshold-OK** (figure 5, 6 or 7): **End measure**.

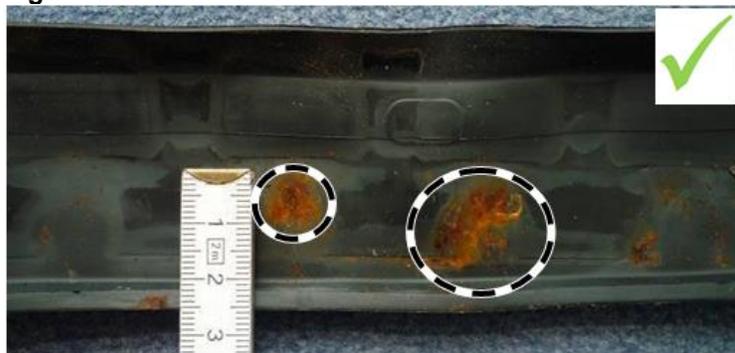
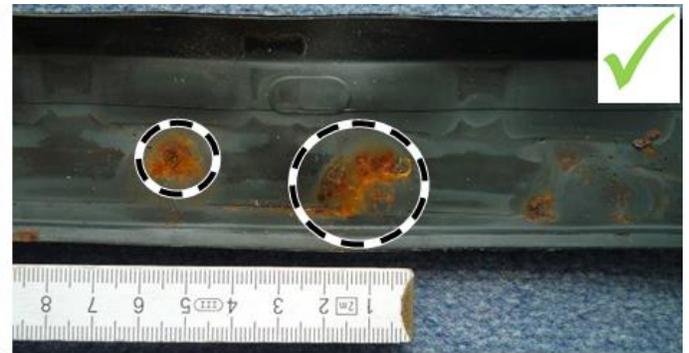
Figure 6 OK

A maximum of **one point-shaped corrosion mark** with a diameter **greater than 15 mm** (**figures 6 and 7**) is permitted.

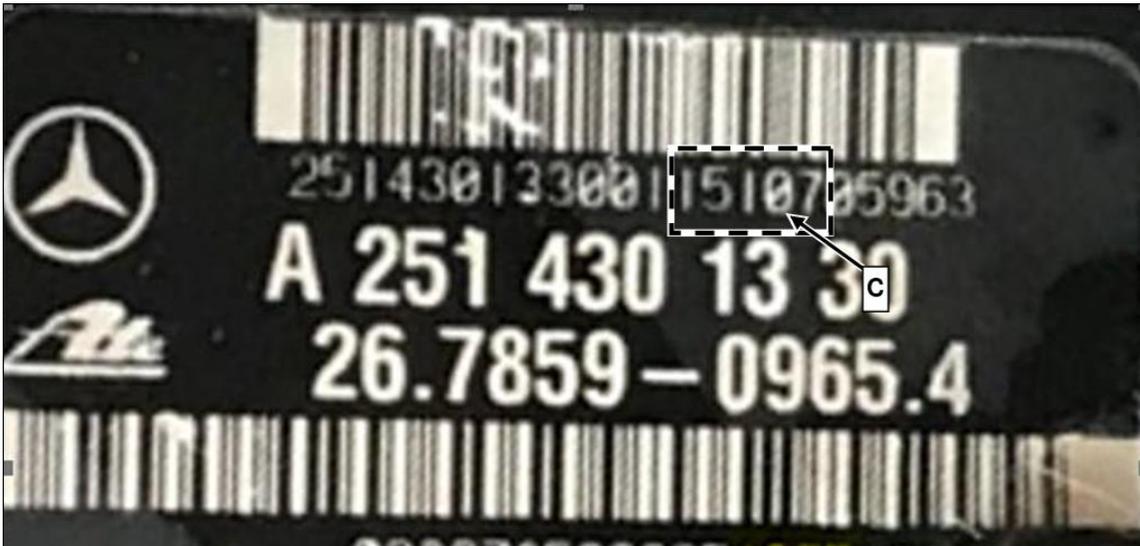
Figure 9

1. Check sequence of numbers on the barcode label (C, figure 9).
  - a. If the numeric sequence between numbers 13 and 17 is **less than** "15126": Carry out **scope of testing B - XENTRY/DAS**.
  - b. If the numeric sequence between numbers 13 and 17 is **greater than or equal to** "15126": **End measure**.
