TO: Mercedes-Benz Dealer Principals, General Managers, Sales Managers, Service Managers, Parts Managers	FROM: Gregory Gunther, Department Manager, Vehicle Compliance and Analysis, Engineering Services
RE: Updated Recall Campaign Launch Notification – STOP DRIVE Inspect Brake Booster with Pedal Rework MY07-08 GL-Class, ML-Class, R-Class (X164, W164, 251 platform)	UPDATE: September 23, 2022

IMPORTANT RECALL CAMPAIGN UPDATE

Campaign No. 2022050014, May 2022

Inspect Brake Booster – with Pedal Rework

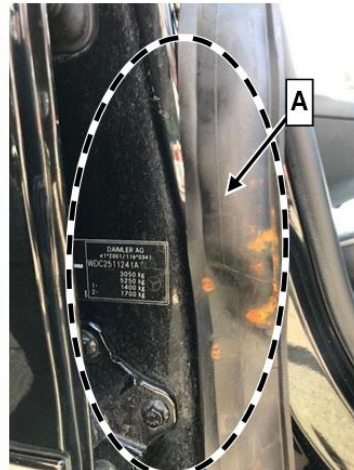
3. Take a photo of the rubber sleeve with the VIN label of the B-pillar (**A, figures 3 and 4**) and store to a local HDD/computer storage location with the vehicle service file and attach it to the warranty claim in EVA.
 - i** These pictures serve as documentation of the current condition of the brake booster.
