IMPORTANT RECALL CAMPAIGN UPDATE

Recall Campaign Bulletin

Campaign No. 2022050015, May 2022

Inspect Brake Booster – without Pedal Rework

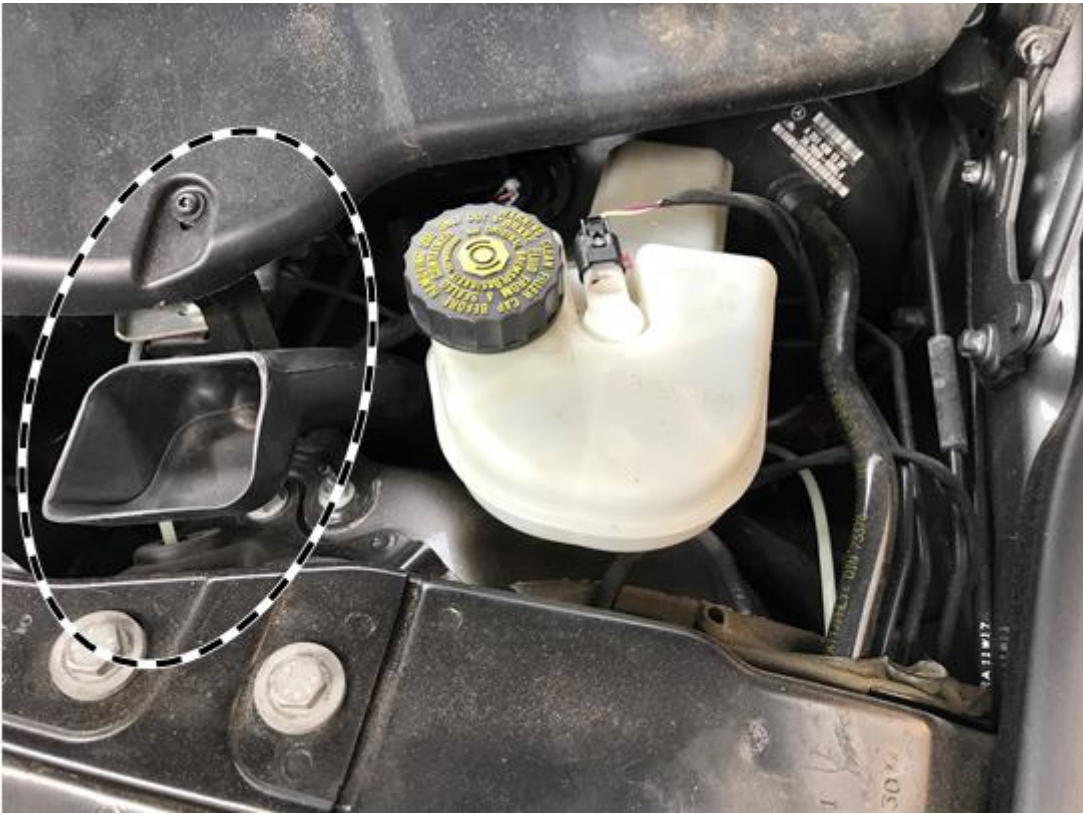
Figure 1

1. Open the hood and check the water drains (**marking, figure 1**) for correct installation and ability to drain.

i Clean and correctly install water drains if necessary.

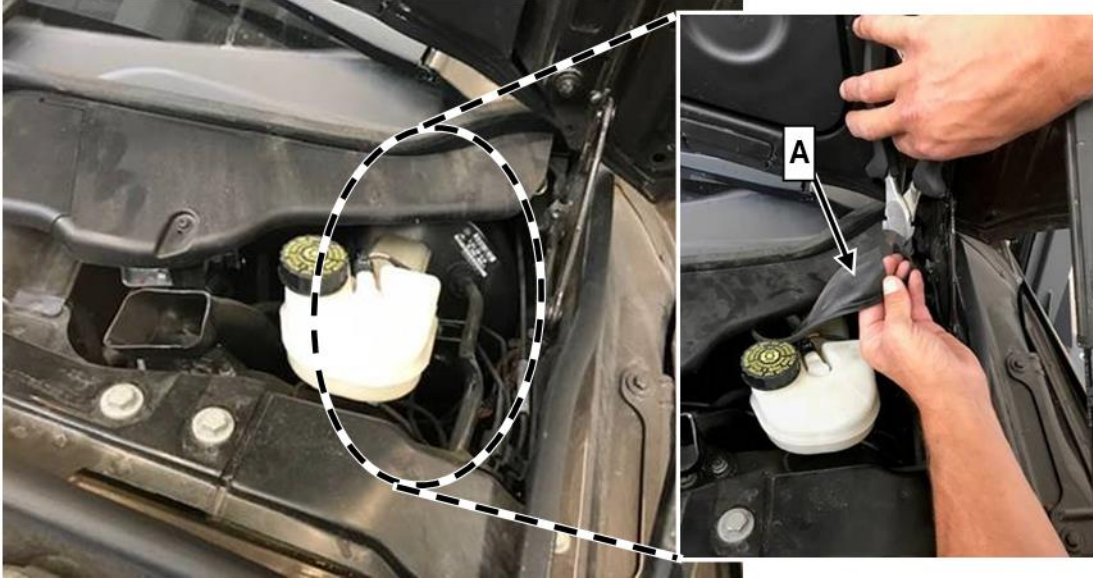
Figure 2

2. Remove the rubber sleeve wrapped around the brake booster (A, figure 2) with a suitable tool (hook and side cutting pliers). If the rubber sleeve is not present, please proceed to check/test procedure A1.

i The rubber sleeve should be separated above the barcode label on the brake booster as seen in (A, figure 2 and B, figure 4.1).

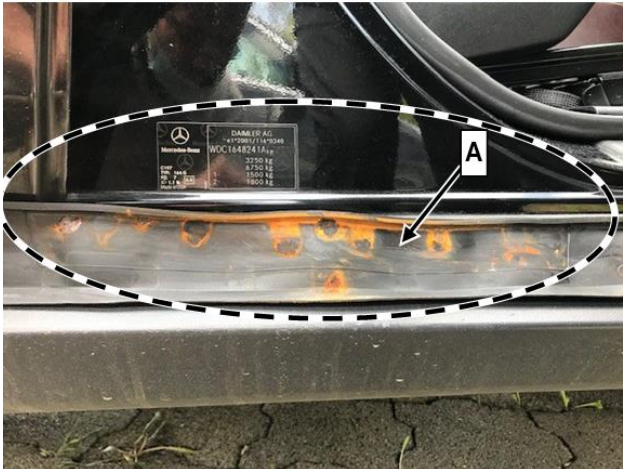
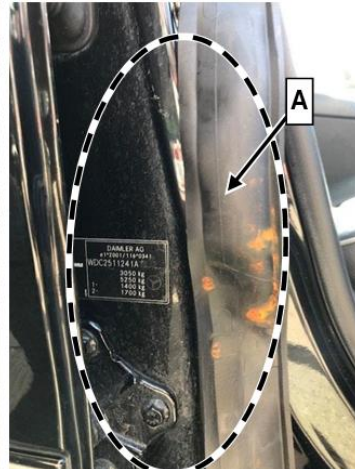
3. Take a photo of the rubber sleeve with the VIN label of the B-pillar (A, figures 3 and 4) and store to a local HDD/computer storage location with the vehicle service file and attach it to the warranty claim in EVA.

i These pictures serve as documentation of the current condition of the brake booster.

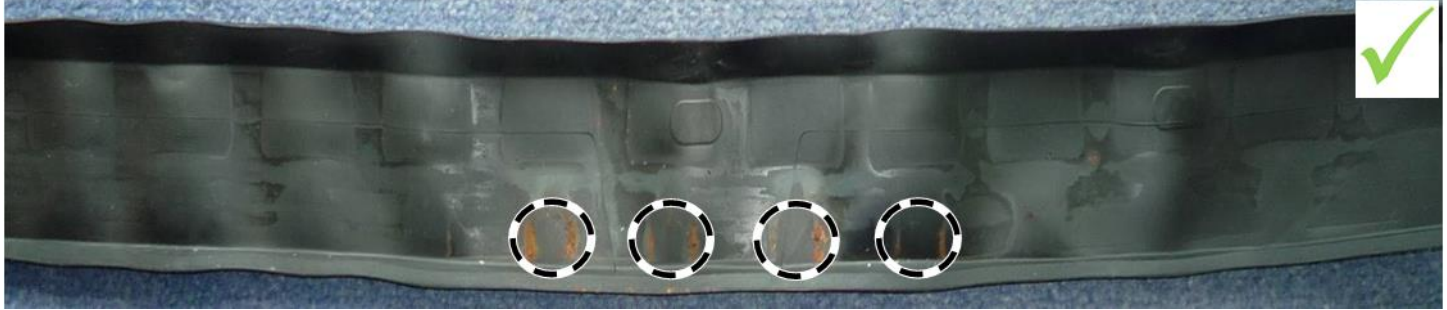
Figure 5 OK

Multiple point-shaped corrosion marks (**figure 5**) are permissible.

- Corrosion measurements **Exceeds thresholds-NOK**: Carry out **check/test procedure B - XENTRY/DAS**.
- Corrosion measurements **Does not exceed threshold-OK** (figure 5, 6 or 7): **End measure.**
(Certificate of Passed Initial Diagnostic Brake Test not required).

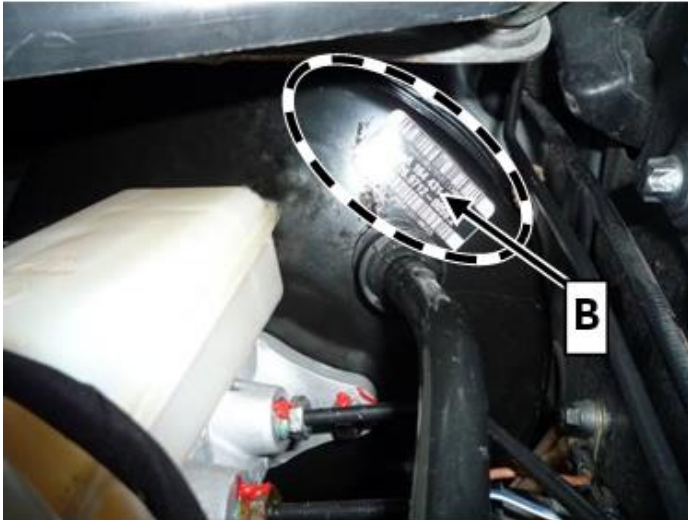
Figure 8

1. Take a photo of the barcode label (B, figure 8) on the brake booster and store to a local HDD/computer storage location with the vehicle service file and attach to the warranty claim in EVA.

i If the measure is ended, **do not** re-install a new rubber sleeve. Apply marking with **white touch-up paint pen** (**1, figure 8**) to the brake booster checked.

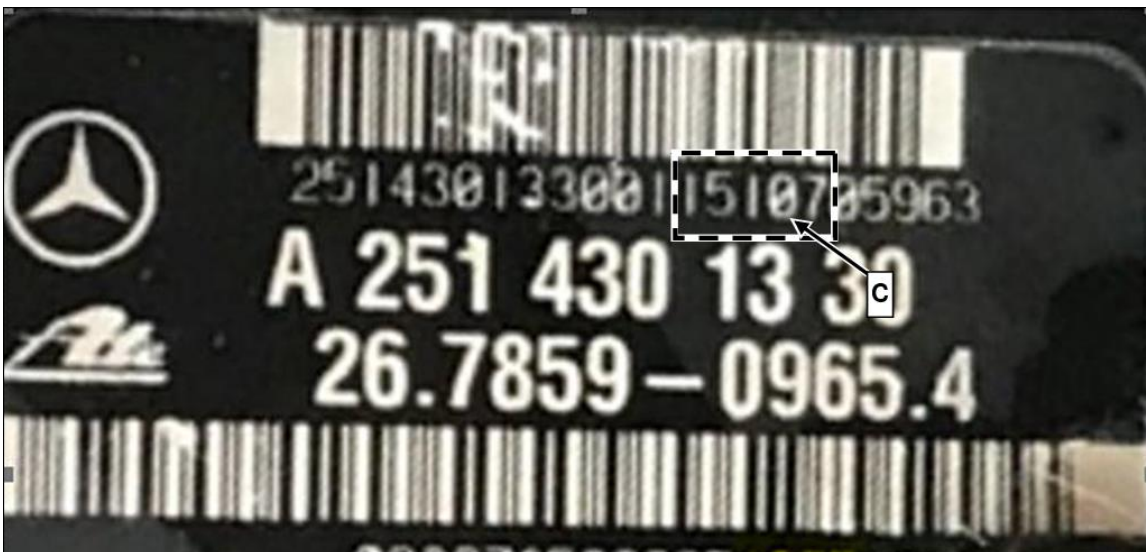
Figure 9

1. Check sequence of numbers on the barcode label (C, figure 9).
 - a. If the numeric sequence **between** numbers **13 and 17** is **less than** "15126": Carry out **scope of testing B - XENTRY/DAS**.
 - b. If the numeric sequence **between** numbers **13 and 17** is **greater than or equal to** "15126": **End measure**.

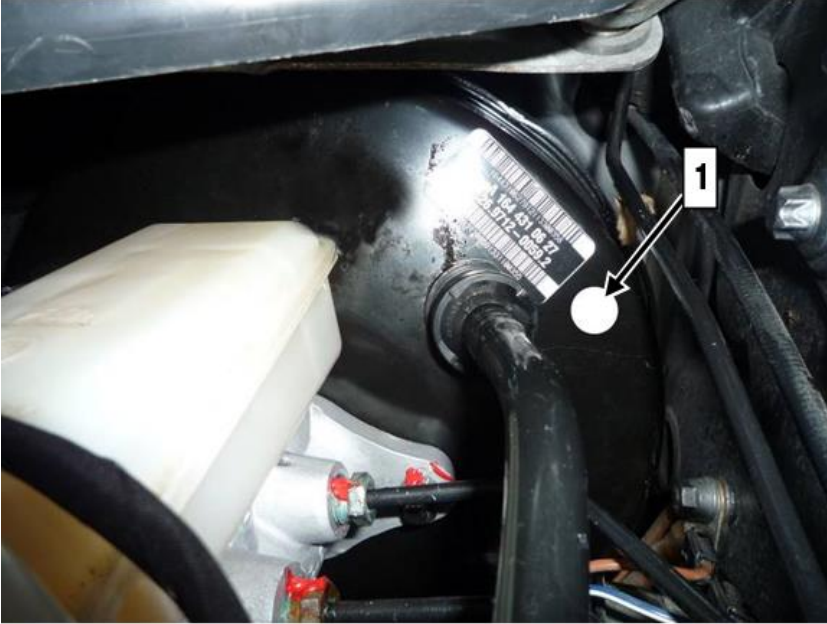
Figure 10

2. Apply marking with **white touch-up paint pen (1, figure 10)** to the inspected brake booster.

i Under no circumstances should you treat the brake booster with anti-corrosion agent/paint.
