TO: Mercedes-Benz Dealer Principals, General Managers, Sales Managers, Service Managers, Parts Managers	FROM: Gregory Gunther, Department Manager, Vehicle Compliance and Analysis, Engineering Services
RE: <b>Updated Recall Campaign Launch Notification – STOP DRIVE</b>  <b>Inspect Brake Booster with Pedal Rework MY07-08 GL-Class, ML-Class, R-Class (X164, W164, 251 platform)</b>	UPDATE: June 22, 2022

Campaign No. 2022050014, May 2022

SUBJECT: **Model GL-Class, ML-Class, and R-Class (X164, W164 and 251 platform)  
Model Year 2007-2008**

## **Inspect Brake Booster – with Pedal Rework**

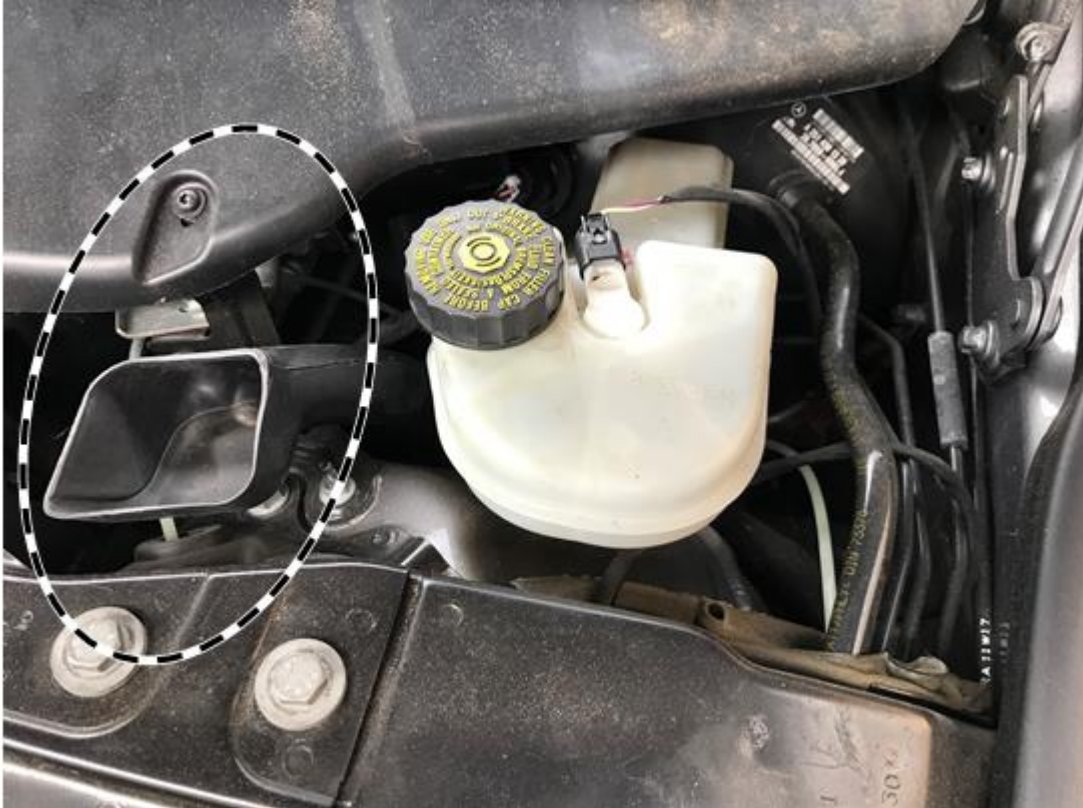
**Figure 1**

1. Open the hood and check the water drains (**marking, figure 1**) for correct installation and ability to drain.
  - i** **Only for model 251**
  - i** Clean and correctly install water drains if necessary.

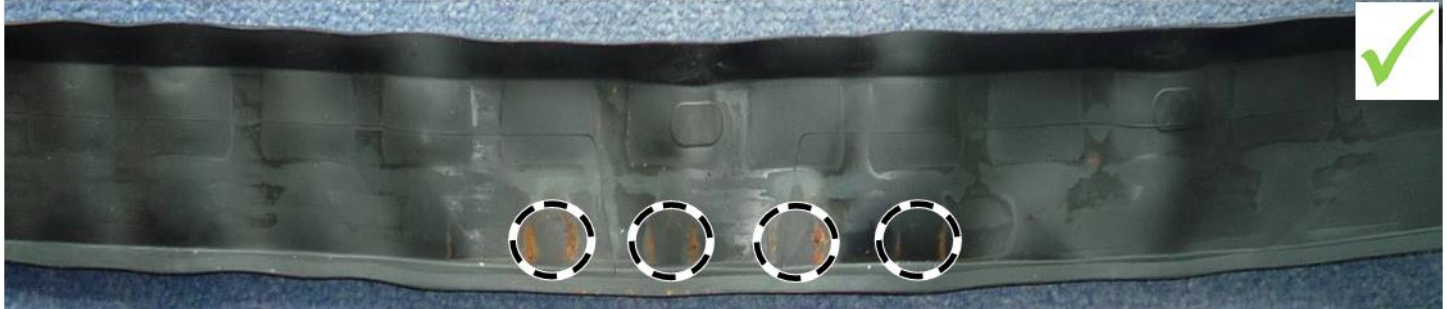
Figure 5 OK

Multiple point-shaped corrosion marks (**figure 5**) are permissible.

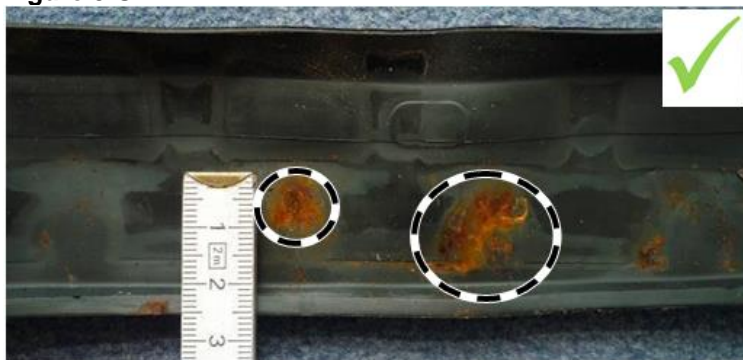
A maximum of **one point-shaped corrosion mark** with a diameter **greater than 15 mm** (**figures 6 and 7**) is permitted.

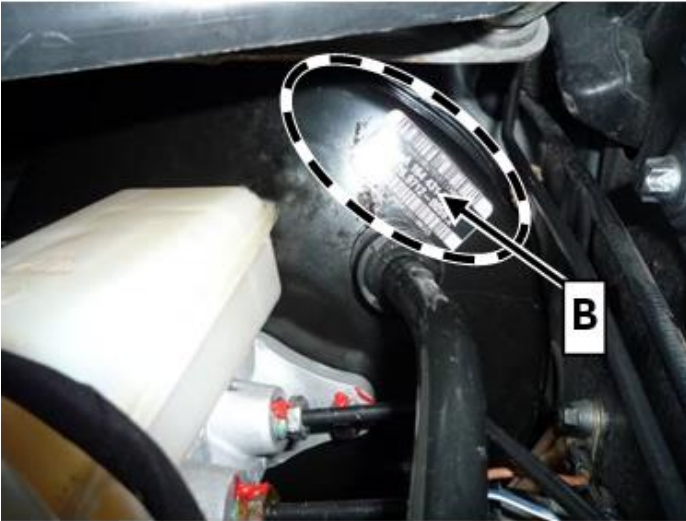
Figure 8

1. Take a photo of the barcode label (B, figure 8) on the brake booster and store to a local HDD/computer storage location with the vehicle service file and attach to the warranty claim in EVA.

**i** If the measure is ended, **do not** re-install a new rubber sleeve. Apply marking with **white touch-up paint pen** (1, **figure 8**) to the brake booster checked.
