Recall Campaign Bulletin

Campaign No. 2022050015, May 2022

SUBJECT: **Model GL-Class, ML-Class, and R-Class (X164, W164 and 251 platform)
Model Year 2006-2012**

Inspect Brake Booster – without Pedal Rework

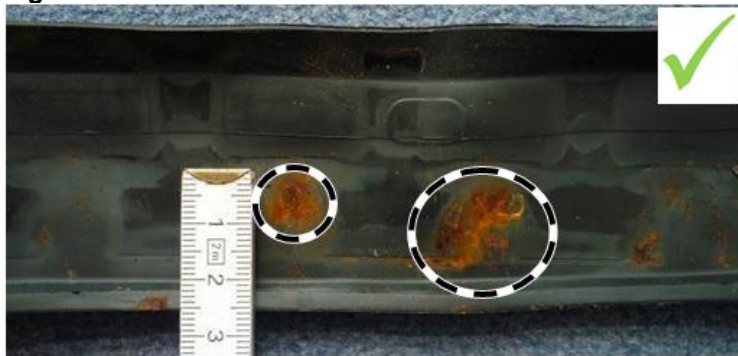
Figure 6 OK

A maximum of **one point-shaped corrosion mark** with a diameter **greater than 15 mm** (**figures 6 and 7**) is permitted.

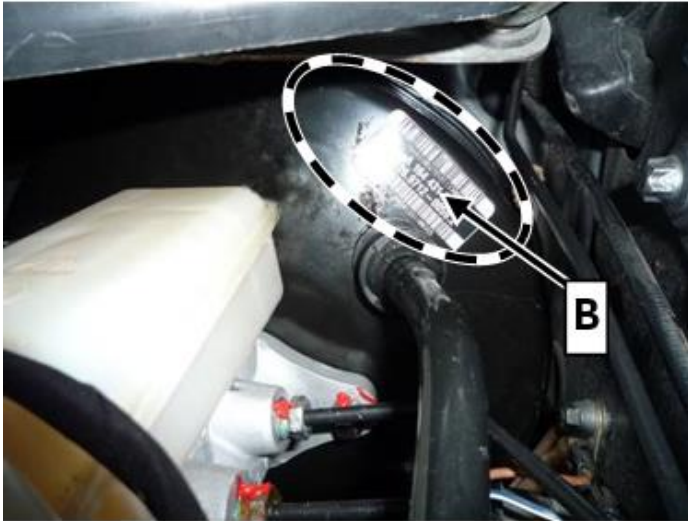
Figure 8

1. Take a photo of the barcode label (B, figure 8) on the brake booster and store to a local HDD/computer storage location with the vehicle service file and attach to the warranty claim in EVA.

i If the measure is ended, **do not** re-install a new rubber sleeve. Apply marking with **white touch-up paint pen (1, figure 8)** to the brake booster checked.
