Recall Campaign Bulletin

Campaign No. 2022050014, May 2022

SUBJECT: **Model GL-Class, ML-Class, and R-Class (X164, W164 and 251 platform)
Model Year 2007-2008**

Inspect Brake Booster – with Pedal Rework

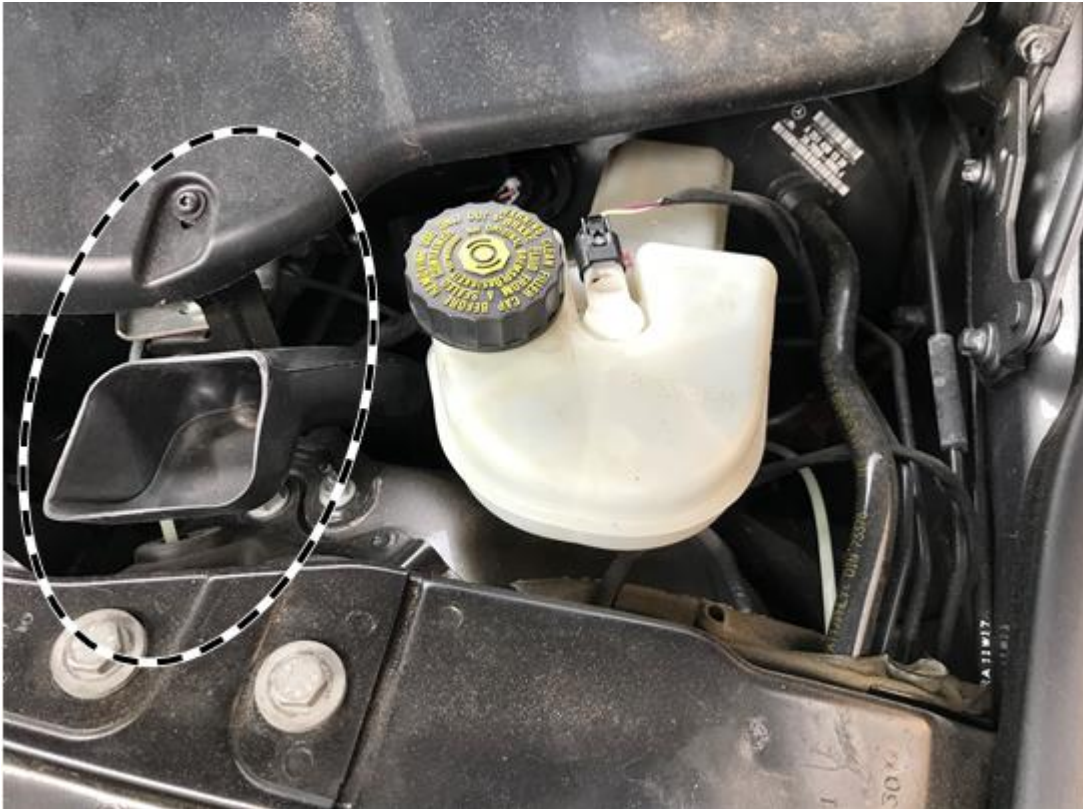
Figure 1

1. Open the hood and check the water drains (**marking, figure 1**) for correct installation and ability to drain.

i Clean and correctly install water drains if necessary.

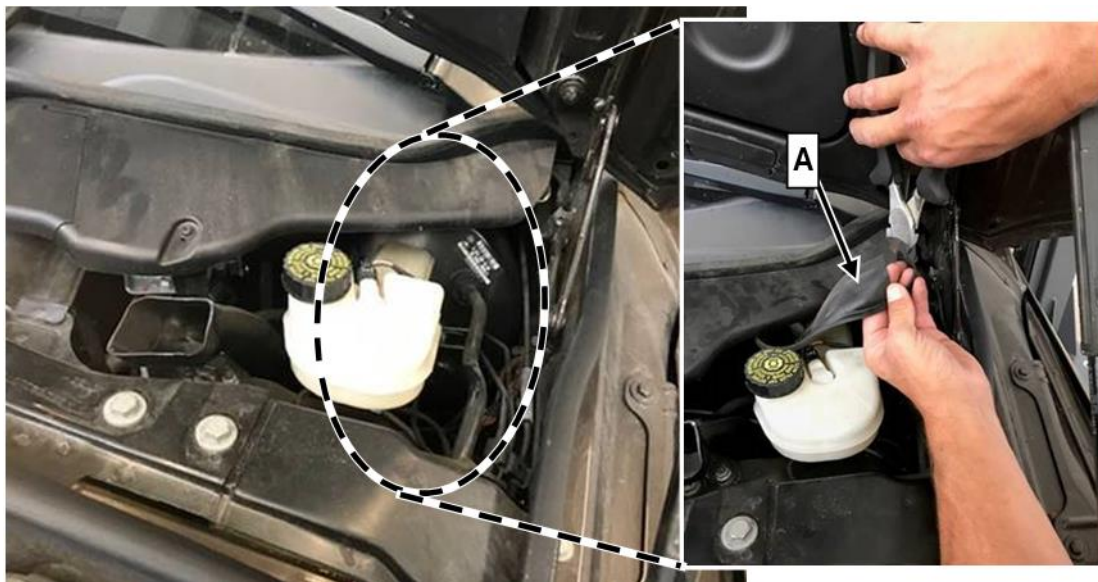
Figure 2

2. Remove the rubber sleeve wrapped around the brake booster (A, figure 2) with a suitable tool (hook and side cutting pliers). If the rubber sleeve is not present, please proceed to check/test procedure A1.
- i** The rubber sleeve should be separated above the barcode label on the brake booster as seen in (A, figure 2 and B, figure 4.1).

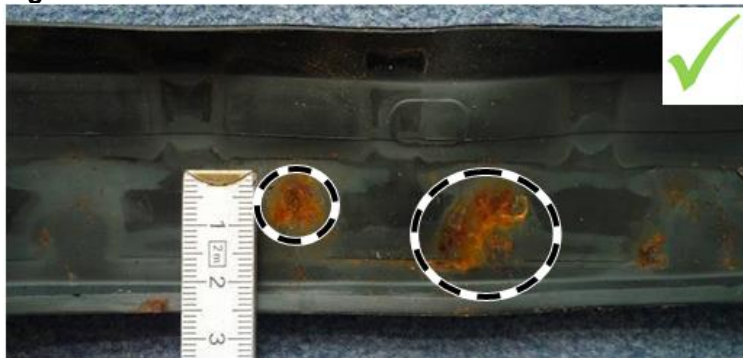
A maximum of **one point-shaped corrosion mark** with a diameter **greater than 15 mm** (**figures 6 and 7**) is permitted.

Figure 6 OK

Figure 7 OK

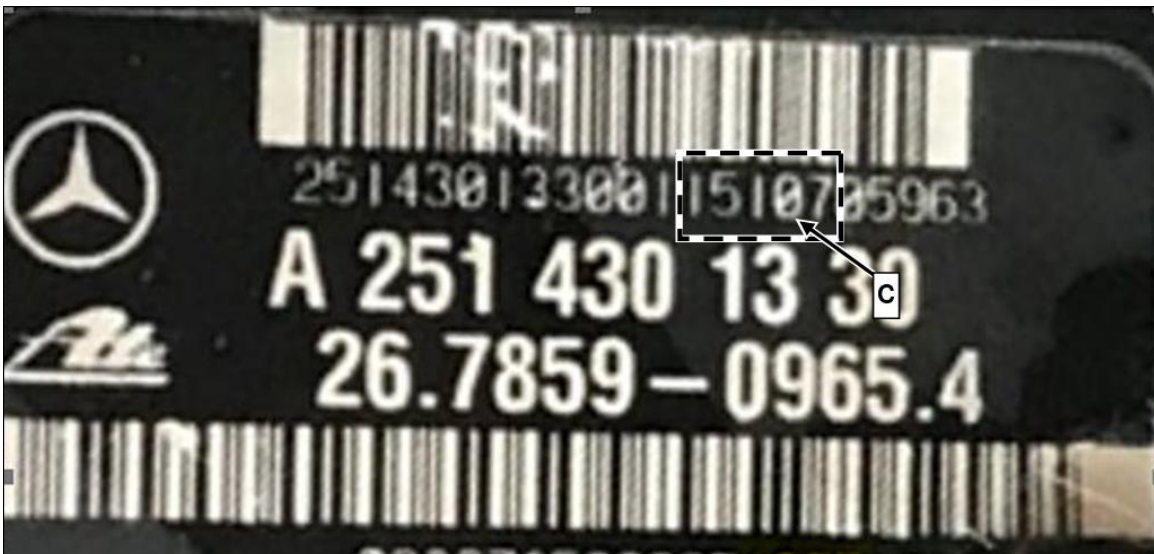
Figure 9

2. Check sequence of numbers on the barcode label (C, figure 9).
 - a. If the numeric sequence between numbers 13 and 17 is **less than** "15126": Carry out **scope of testing B - XENTRY/DAS**.
 - b. If the numeric sequence between numbers 13 and 17 is **greater than or equal to** "15126": **End measure**.
