Recall Campaign Bulletin

Campaign No. 2022050014, May 2022

SUBJECT: **Model GL-Class, ML-Class, and R-Class (X164, W164 and 251 platform)
Model Year 2007-2008**

Inspect Brake Booster – with Pedal Rework

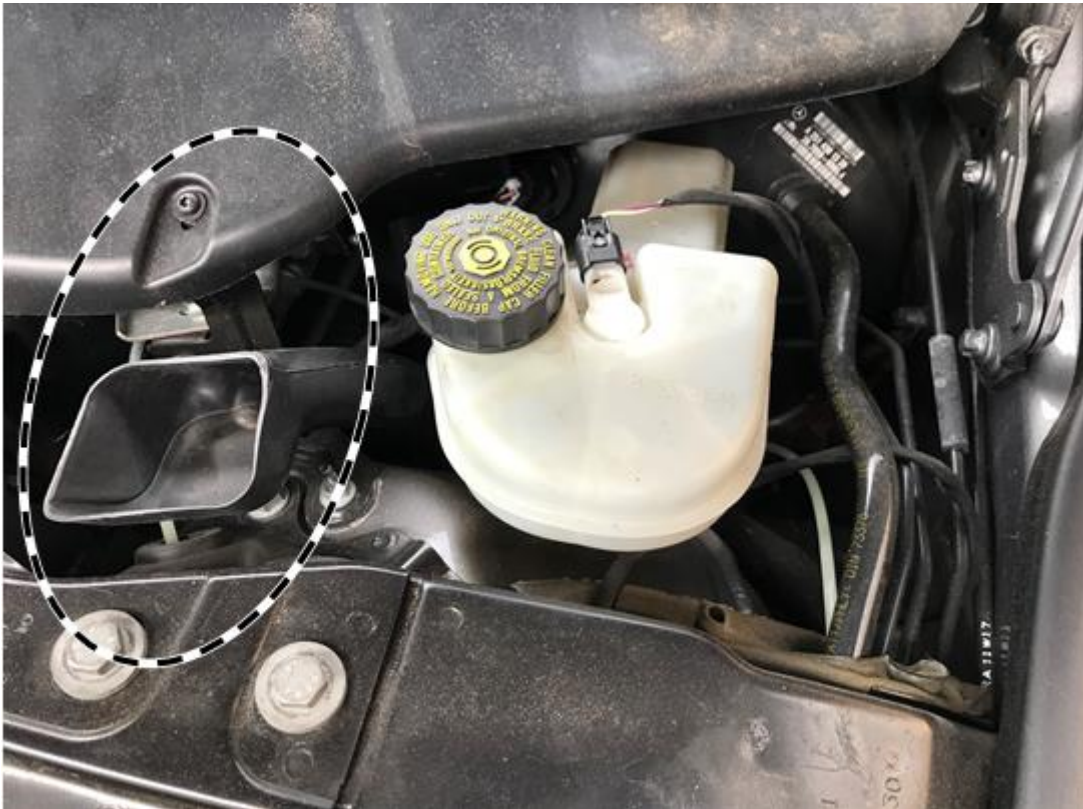
Figure 1

1. Open the hood and check the water drains (**marking, Figure 1**) for correct installation and ability to drain.

i Clean and correctly install water drains if necessary.

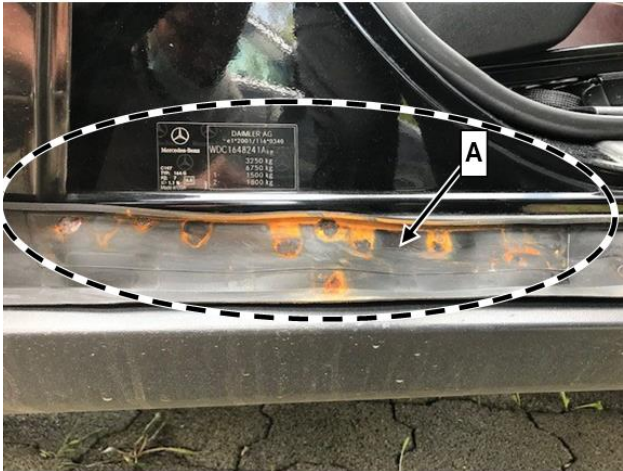
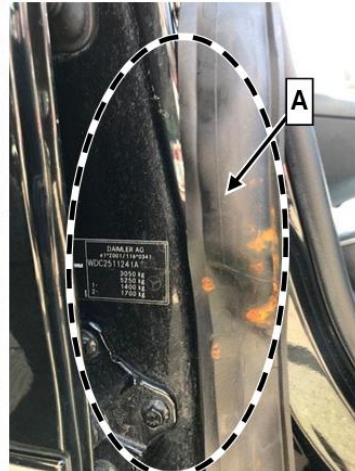
3. Take a photo of the rubber sleeve with the VIN label of the B-pillar (A, Figures 3 and 4) and store to a local HDD/computer storage location with the vehicle service file and attach it to the warranty claim in EVA.

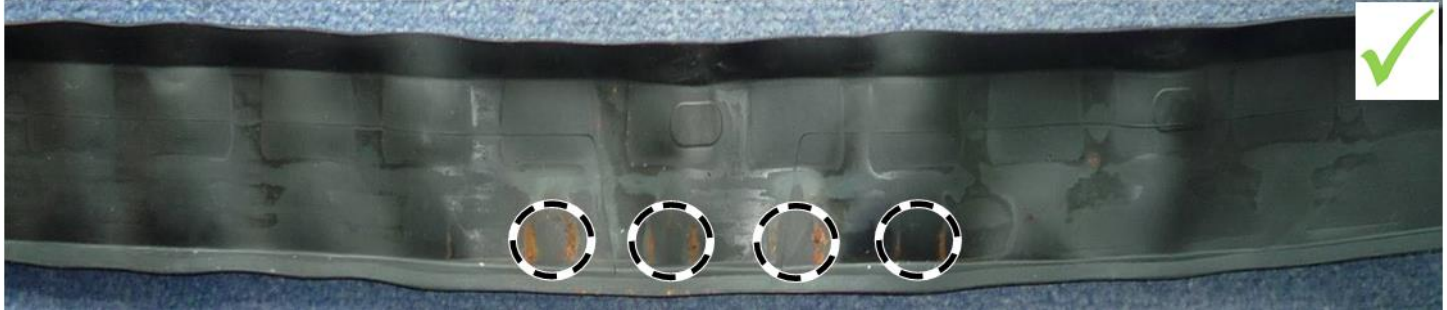
Figure 5 (OK)

Multiple point-shaped corrosion marks (Figure 5) are permissible.

- Corrosion measurements **Exceeds thresholds - Not OK:** Carry out work procedure
- Corrosion measurements **Does not exceed threshold - OK** (Figures 5, 6 or 7): End measure.

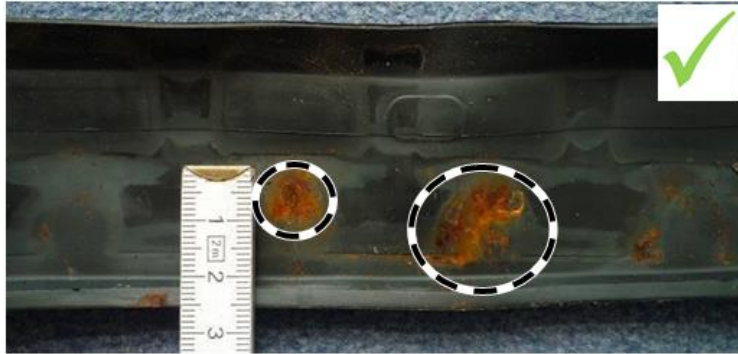
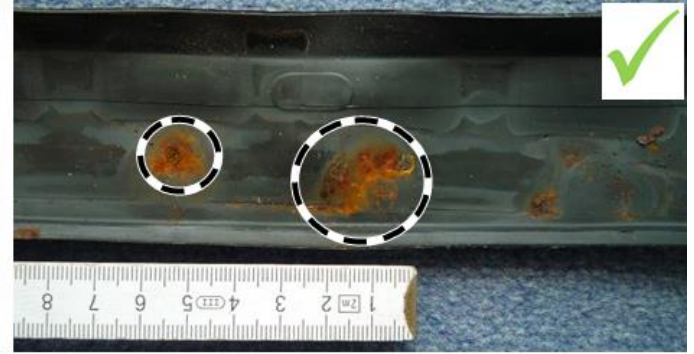
A maximum of **one point-shaped corrosion mark** with a diameter **greater than 15 mm** (Figures 6 and 7) is permitted.

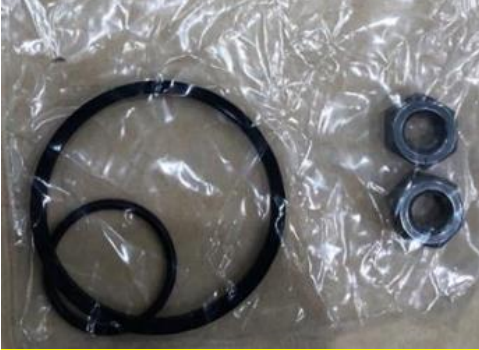
Figure 11

i The new brake booster contains a small parts kit (**Figure 11**).

4. Install pedal conversion small parts kit A 251 290 00 00.

i The pedal conversion small parts kit consists of the separate parts bushing, fit bolt and retainer.
