May 2022

Dealer Service Instructions for:

Safety Recall Z43 / NHTSA 22V-326 Tail Lamp

2022 (JL) Jeep® Wrangler

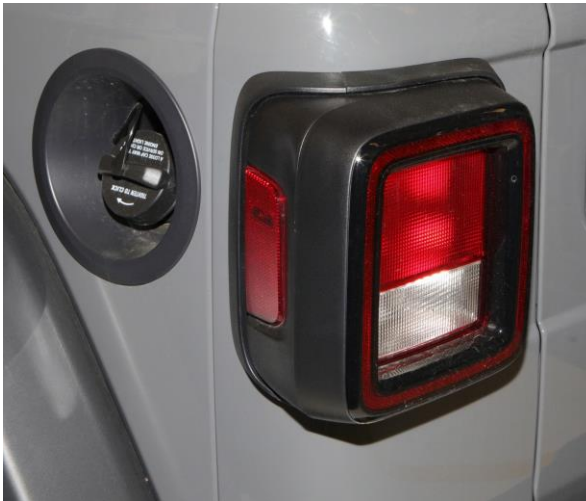
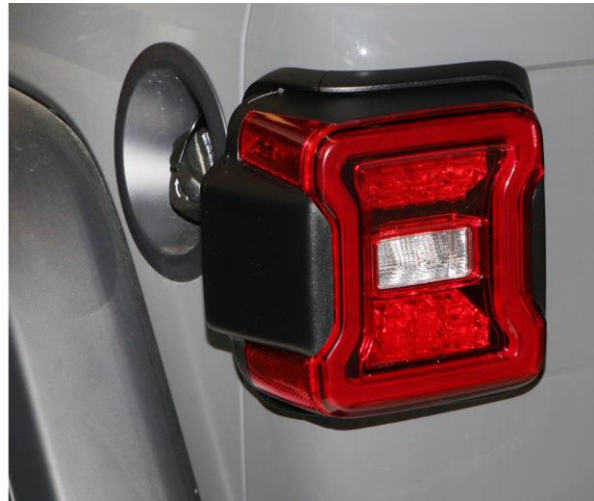
Figure 1 – Replace Incandescent Tail Lamps with LED Tail Lamps

The vehicle wiring harness on about 15 of the above vehicles may be incompatible with the tail lamp assembly, which results in nonfunctional side marker lamps within the tail lamp assembly. Vehicles with nonfunctional side marker lamps may cause an approaching vehicle to be unaware of the position and dimensions of the vehicle, increasing the risk of a crash without prior warning.

The condition described above does not comply with Federal Motor Vehicle Safety Standard (FMVSS) No. 108 Table 1-a which requires that side marker lamps shall be "steady burning." Vehicles that do not activate the side marker lamps when the vehicle lighting is activated are not steady burning.

Incandescent Tail Lamp

LED Tail Lamp

Replace incandescent tail lamps with Light Emitting Diode (LED) tail lamps and reconfigure the Body Control Module (BCM) to add LAY sales code, to allow the LED lamps to work.
