David J. Johnson
 Director
 Service Engineering Operations
 Ford Customer Service Division

August 5, 2022

**SUBJECT: NEW VEHICLE DEMONSTRATION / DELIVERY HOLD –
 Safety Recall 22S36 – Supplement #4**
 Certain 2021 Model Year Expedition and Lincoln Navigator Vehicles equipped with a
 Standard Duty Cooling Fan
 Underhood Fire

**REF: NEW VEHICLE DEMONSTRATION / DELIVERY HOLD –
 Safety Recall 22S48 – Supplement #2**
 Certain 2021 Model Year Expedition and Lincoln Navigator Vehicles equipped with a Heavy
 Duty Cooling Fan
 Underhood Fire

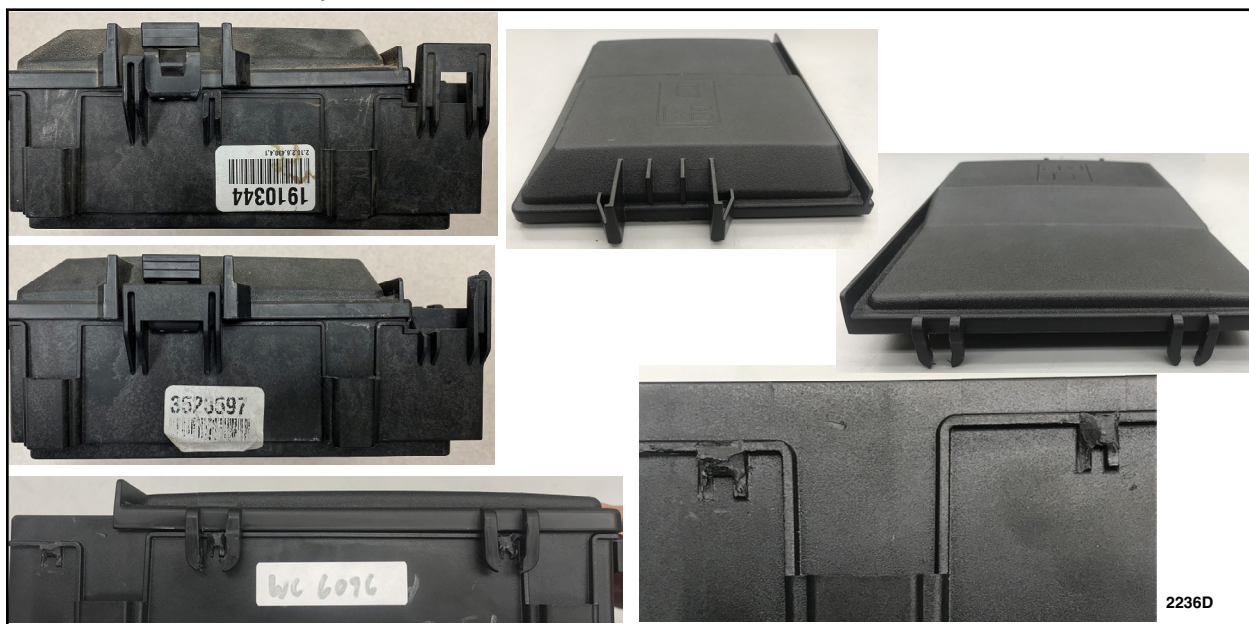
FIGURE 4

4. Check for any damage such as cracks, excessive warping, melting, broken hoop(s), and/or broken latch(es) on both covers. Is there any damage present on either cover? See Figure 4.
