David J. Johnson
 Director
 Service Engineering Operations
 Ford Customer Service Division

SUBJECT: **NEW VEHICLE DEMONSTRATION / DELIVERY HOLD – Safety Recall 22S36 – Supplement #3**
 Certain 2021 Model Year Expedition and Lincoln Navigator Vehicles equipped with a Standard Duty Cooling Fan
 Underhood Fire

REF: **NEW VEHICLE DEMONSTRATION / DELIVERY HOLD – Safety Recall 22S48 – Supplement #1**
 Certain 2021 Model Year Expedition and Lincoln Navigator Vehicles equipped with a Heavy Duty Cooling Fan
 Underhood Fire

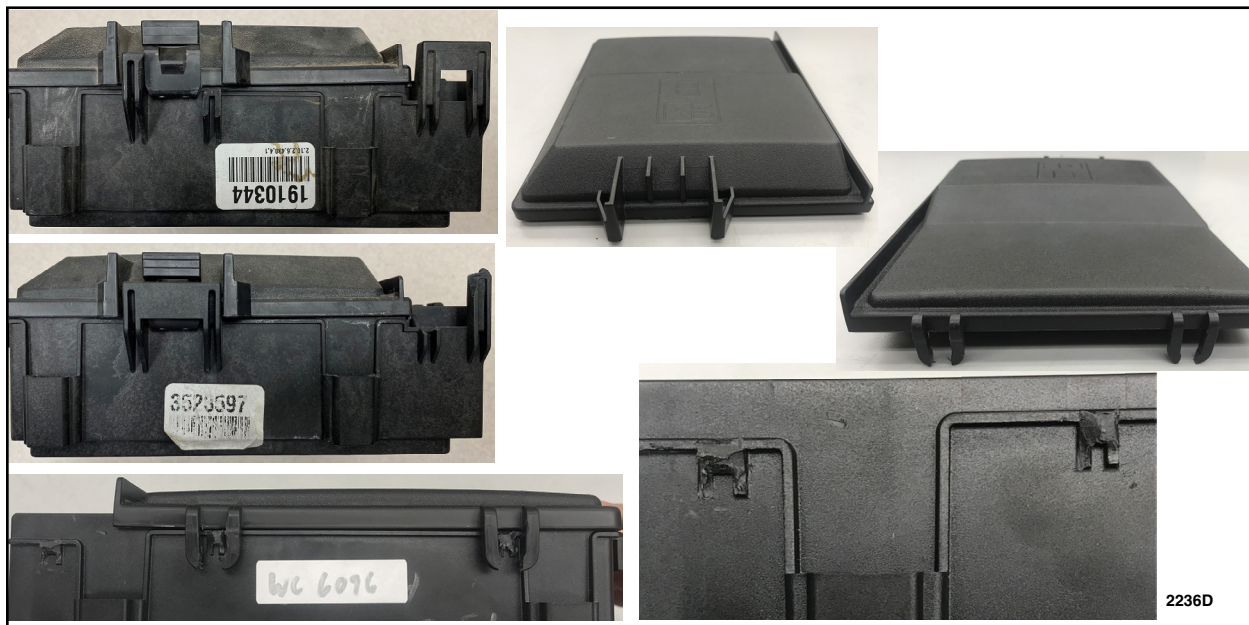
FIGURE 4

4. Check for any damage such as cracks, excessive warping, melting, broken hoop(s), and/or broken latch(es) on both covers. Is there any damage present on either cover? See Figure 4.

Yes - Replace damaged cover(s), proceed to Step 5.

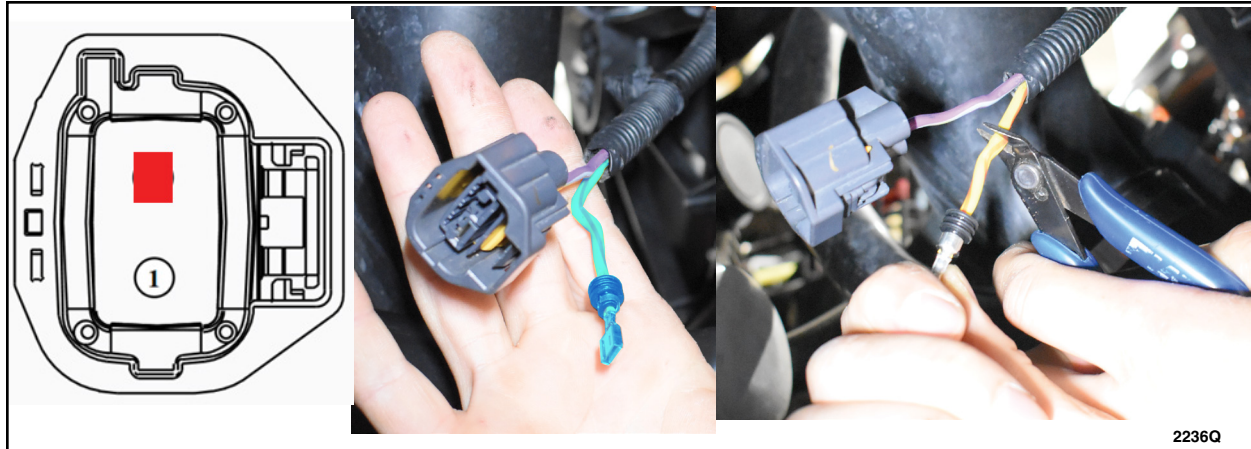
FIGURE 23

CAUTION: Both the aux box harness and the cooling fan harness contain a yellow wire with an orange tracer. Ensure that the cooling fan harness is the one being modified.
