**SUBJECT: NEW VEHICLE DEMONSTRATION / DELIVERY HOLD –  
 Safety Recall 22S48**

Certain 2021 Model Year Expedition and Lincoln Navigator Vehicles equipped with a Heavy-Duty Cooling Fan  
 Underhood Fire

**REF: NEW VEHICLE DEMONSTRATION / DELIVERY HOLD –  
 Safety Recall 22S36 – Supplement #2**

Certain 2021 Model Year Expedition and Lincoln Navigator Vehicles equipped with a Standard-Duty Cooling Fan  
 Underhood Fire

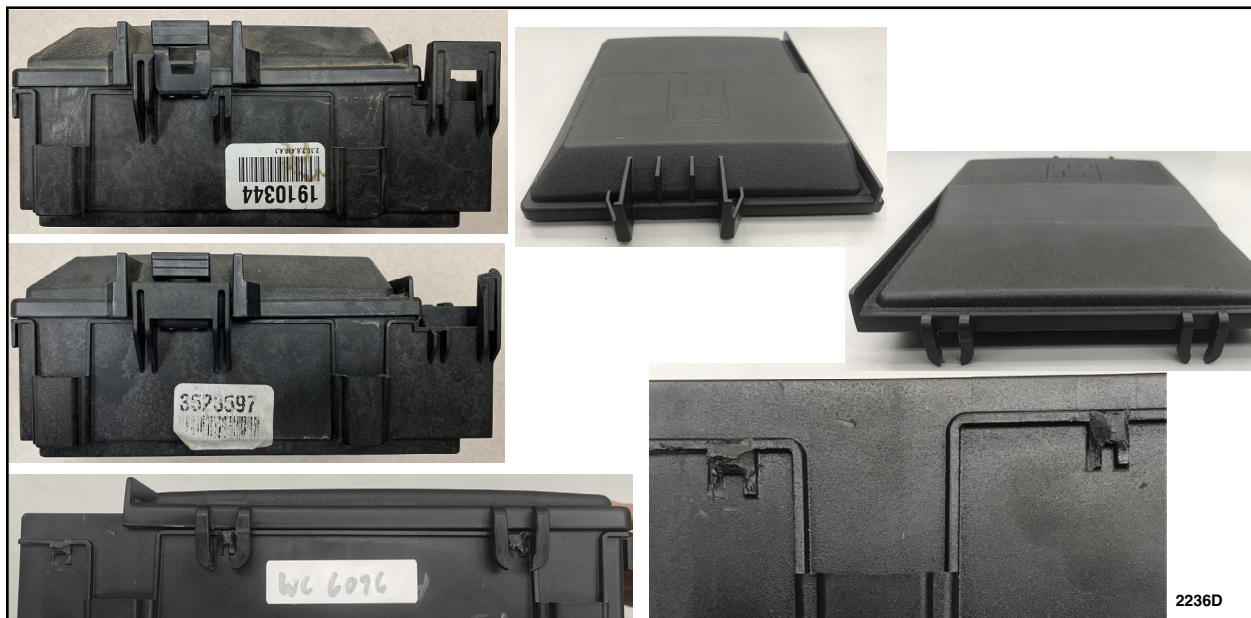
FIGURE 4

3. Check for any damages such as cracks, excessive warping, melting, broken hoop(s), and/or broken latch(es) on both covers. Is there any damage present on either cover? See Figure 4.

Yes - Replace damaged cover(s), proceed to Step 4.

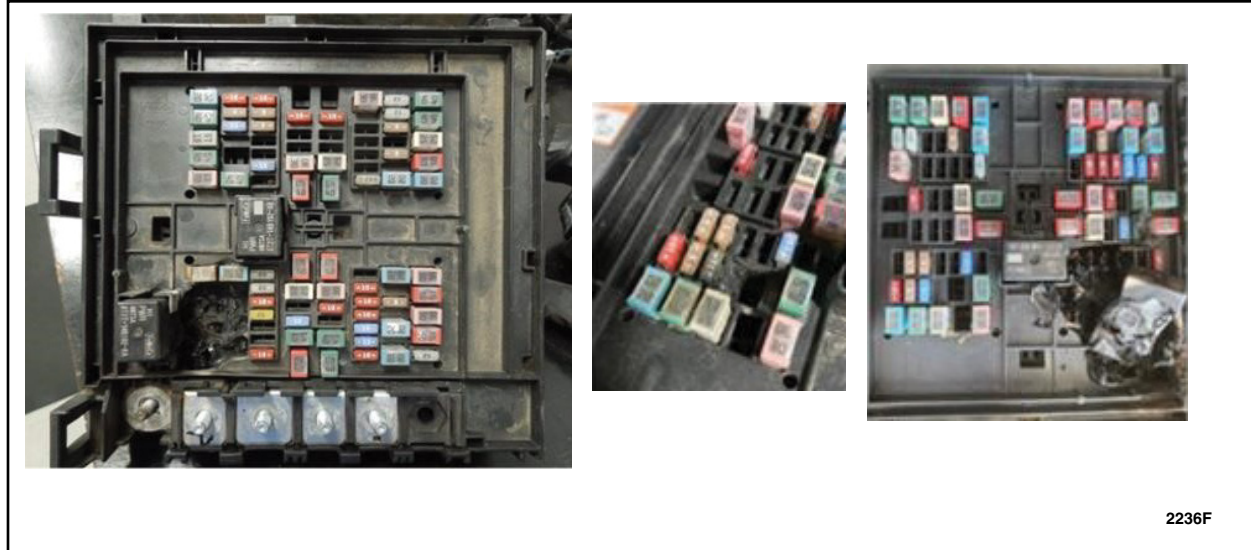
**FIGURE 5**

4. Remove covers and inspect BJB. Is there any evidence of melted fuse(s), melted relay(s), or melted plastic in the BJB? See Figure 5.
  - Yes - Replace BJB, proceed to Step 5.
  - No - Proceed to Step 6.

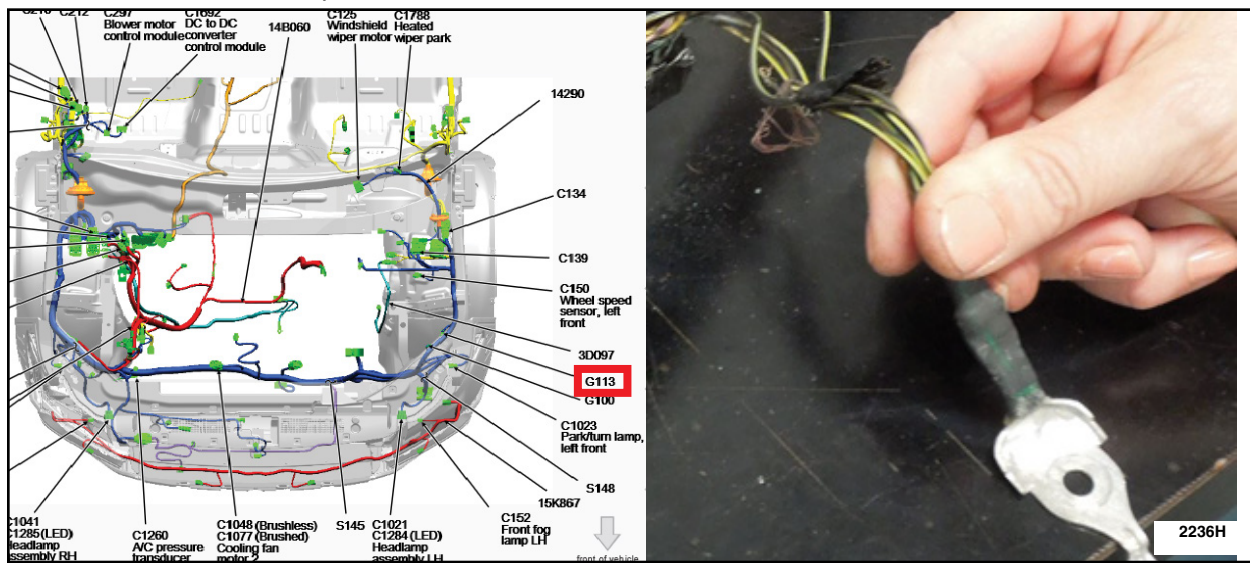
**FIGURE 6**

5. On driver's side, inspect ground #113 and associated wires for damage. Is there evidence of chafing, melting, or discoloration? See Figure 6.
  - Yes - Contact Special Service Support Center (SSSC).
  - No - Proceed to Step 6.
