David J. Johnson
 Director
 Service Engineering Operations
 Ford Customer Service Division

September 7, 2022

SUBJECT: **NEW VEHICLE DEMONSTRATION / DELIVERY HOLD – Safety Recall 22S36 – Supplement #6**
 Certain 2021 Model Year Expedition and Lincoln Navigator Vehicles equipped with a Standard Duty Cooling Fan
 Underhood Fire

REF: **NEW VEHICLE DEMONSTRATION / DELIVERY HOLD – Safety Recall 22S48 – Supplement #2**
 Certain 2021 Model Year Expedition and Lincoln Navigator Vehicles equipped with a Heavy Duty Cooling Fan
 Underhood Fire

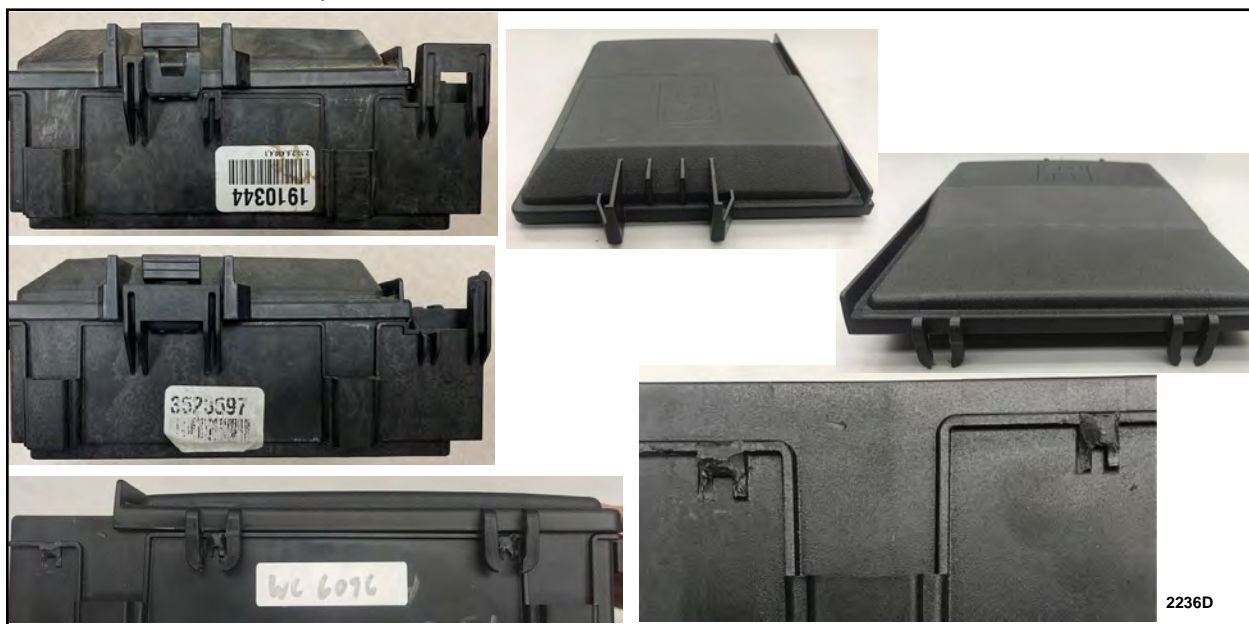
FIGURE 4

4. Check for any damage such as cracks, excessive warping, melting, broken hoop(s), and/or broken latch(es) on both covers. Is there any damage present on either cover? See Figure 4.

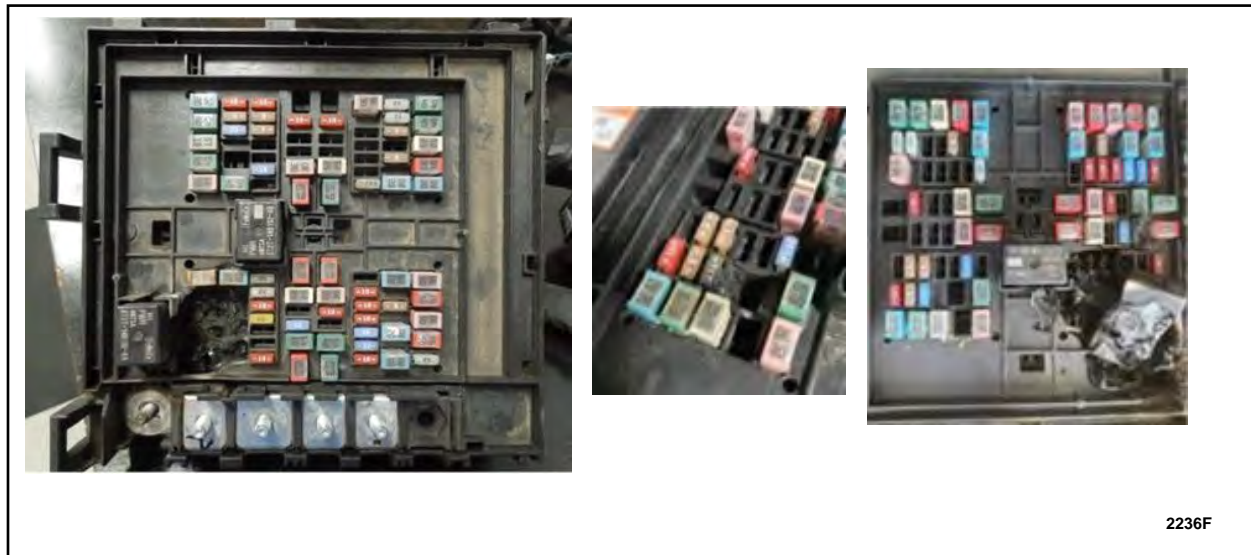
FIGURE 5

5. Remove covers and inspect BJB. Is there any evidence of melted fuse(s), melted relay(s), or melted plastic in the BJB? See Figure 5.
 - Yes - Replace BJB, (photos and Special Service Support Center (SSSC) approval required to proceed. Is the part available?
 - Yes - Proceed to Step 6.
 - No - Part is on back-order. Park vehicle outside, disconnect negative battery cable, and contact the SSSC for approval for rental vehicle for customer.
 - No - Proceed to Step 6.
